# CAMPAIGN BULLETIN

## Seat Belt Buckle Bracket Dealer Inventory

Reference: PC849

## PC849 - 2022 FRONTIER REAR SEAT BELT BRACKET BOLT

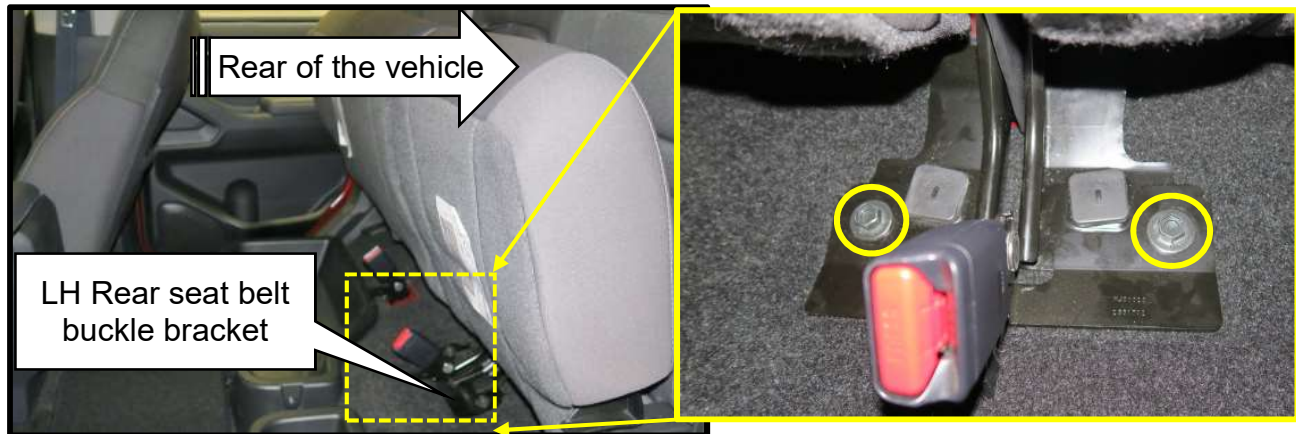
Figure 1

1. Lift both rear seat cushions to the upright position.
  - Open the rear doors
  - Pull the release handles and lift the seat cushions upward until they lock into place
2. Locate the LH rear seat belt buckle bracket bolts. (Figure 1)

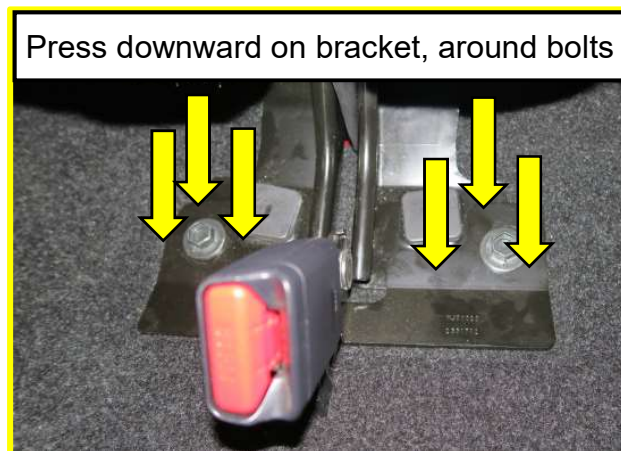
Figure 2

3. Following the three steps below, inspect both bolts that secure the LH rear seat belt buckle bracket to verify they are fully seated.
  - a) Verify the bolts are flush with the seat belt bracket, if the either of the bolts are not flush with the bracket, the bolt is not fully seated
  - b) Attempt to turn the bolt washers by hand, if the washer turns, the bolt is not fully seated
  - c) Push downward on the seat belt buckle bracket around each bolt to check for bracket looseness, If the bracket has movement around the bolt, the bolt is not fully seated (Figure 2)
