## Volvo Chassis - FSB 891 - 021, Center Fairing, Repair

## 89004-9 FSB 891-021, Center Fairing, Repair

(May 2019)

On some VOLVO trucks, the fixed chassis fairing rails can come loose from the truck. This is due to the fairing rails rubbing and thus wearing faster than acceptable. To correct this issue follow the instructions outlined in the documents below.

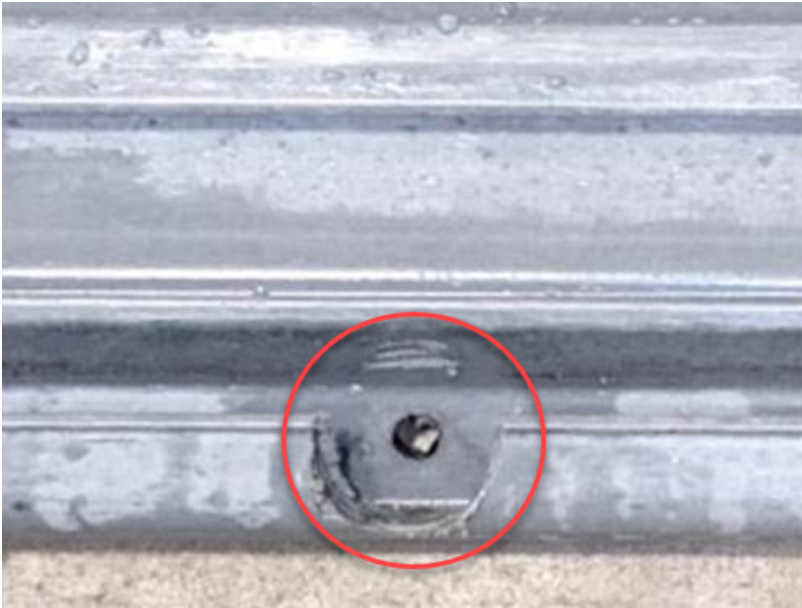
Hole saw should remove only the outboard portion of the support.

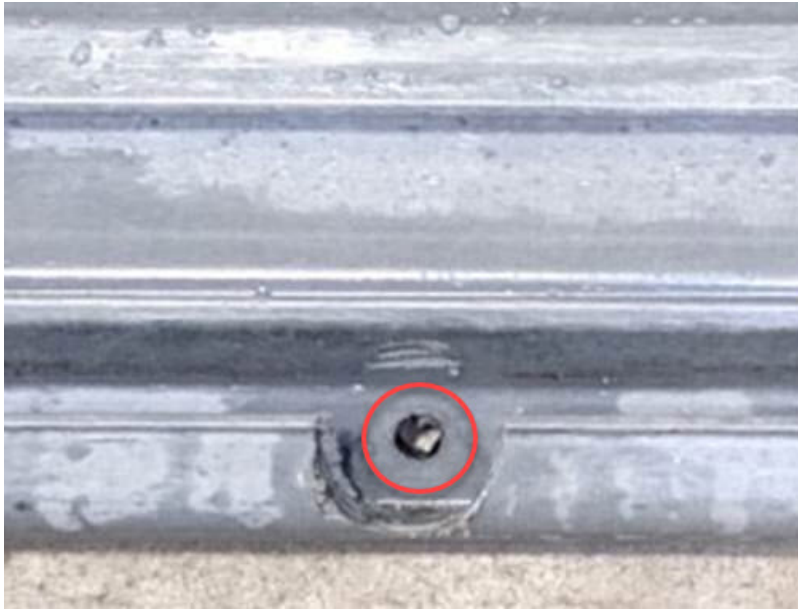
Pilot bit should drill through back of support to make a pilot hole to use reference once the fairing is placed back on the vehicle.

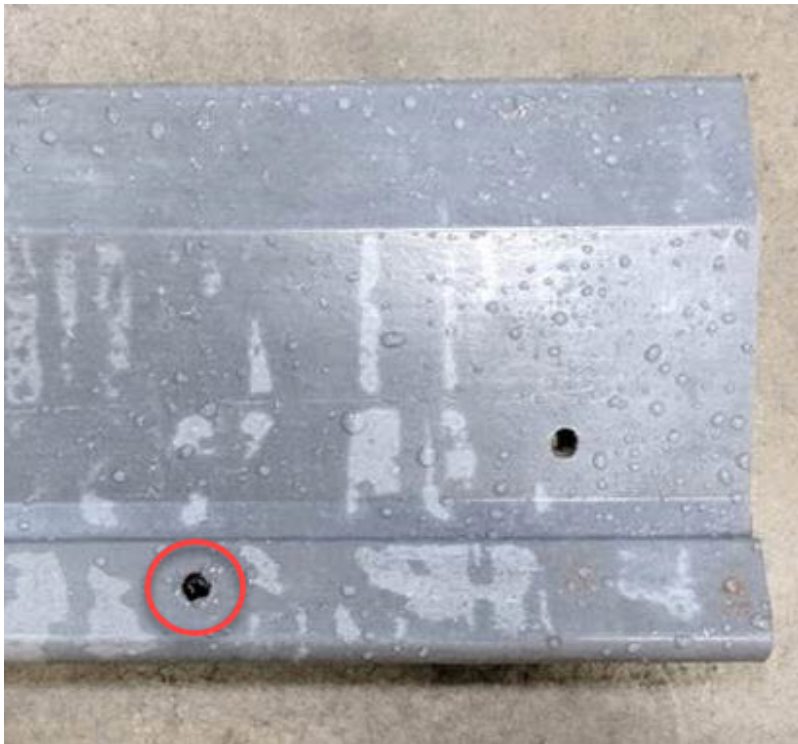
Pilot hole on rear side of support.
