## Technical Service Bulletin

<b>GROUP</b> <b>CAMPAIGN</b>	<b>NUMBER</b> <b>21-01-079G</b>
<b>DATE</b> <b>December, 2021</b>	<b>MODEL(S)</b> <b>G80 (DH)</b>

**SUBJECT:** FIRMWARE FOR MISSING USIM INFORMATION AVN 4.5 (SERVICE CAMPAIGN 904G)

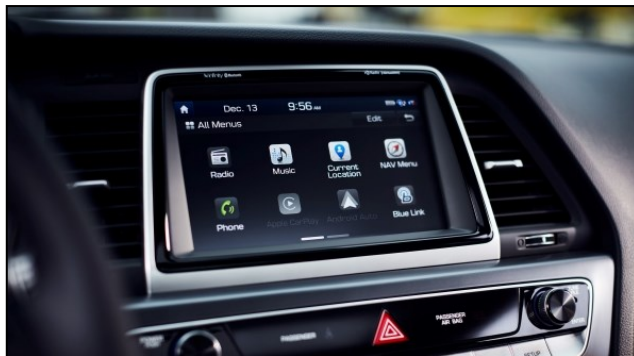
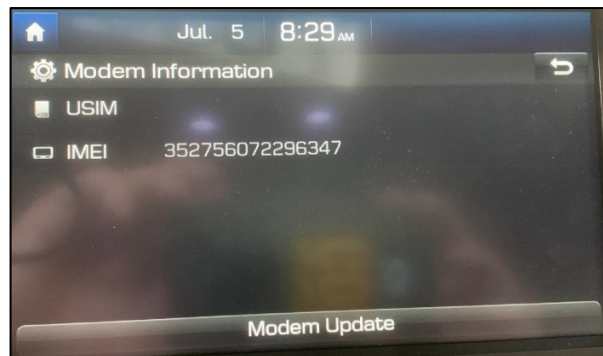
**Description:** When asked to provide the Modem Information, the Universal Subscriber Identity Module (USIM) information is not available. This bulletin describes the 3-part Software to correct this condition and activate Genesis Connected Services (GCS).

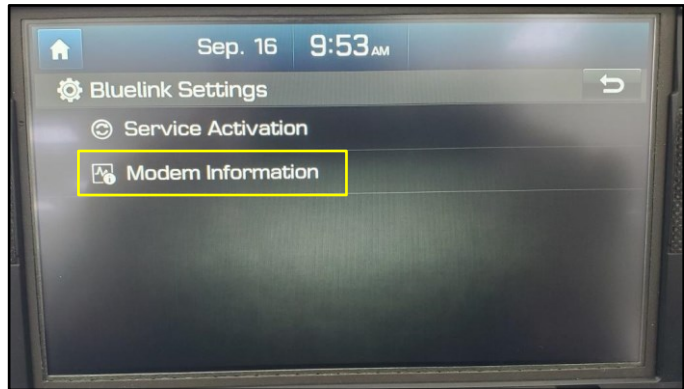
4. Select **Modem Information** and verify USIM and IMEI are displaying.

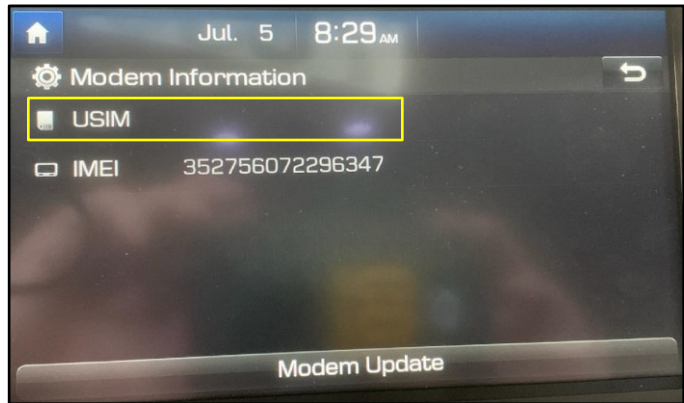
5. If USIM information is missing, capture photo using STUI in the GDS and proceed to **Section B**.

Ensure RO or last 6 digits of the VIN are written in the background of the photo. Data must be clear and visible.

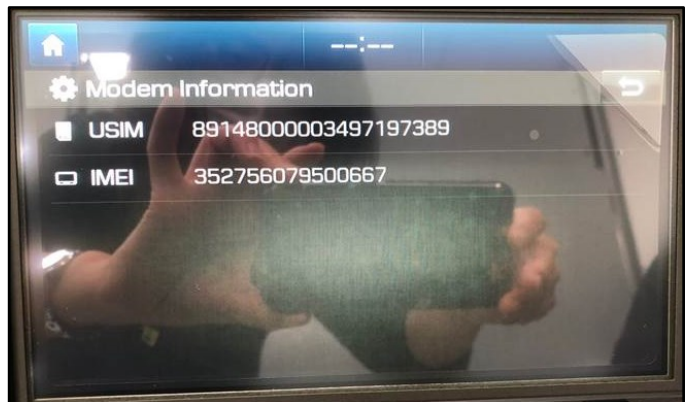
7. Confirm USIM data is present after the update.
