Technical Service Bulletin

GROUP CAMPAIGN	NUMBER 21-01-079HG
DATE December, 2021	MODEL(S) G80 (DH)

SUBJECT: FIRMWARE FOR MISSING USIM INFORMATION AVN 4.5 (SERVICE CAMPAIGN 904G)

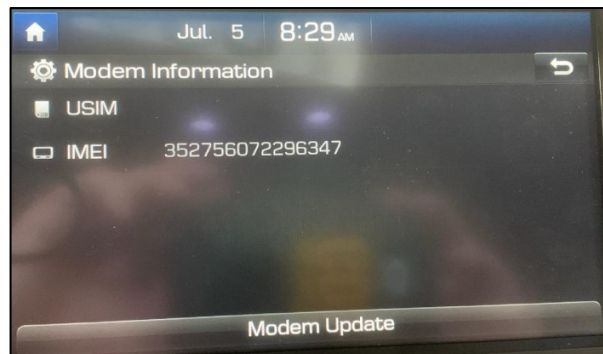
Description: When asked to provide the Modem Information, the Universal Subscriber Identity Module (USIM) information is not available. This bulletin describes the 3-part Software to correct this condition and activate Genesis Connected Services (GCS).

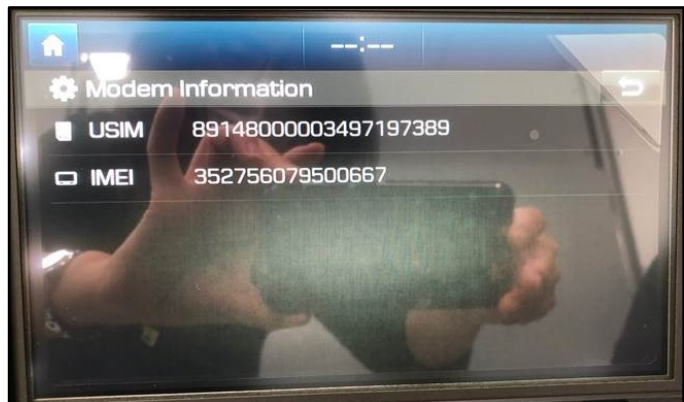
7. Confirm USIM data is present after the update.
