HYUNDAI Technical Service Bulletin	GROUP CAMPAIGN	NUMBER 21-01-080H
	DATE DECEMBER, 2021	MODEL(S) Elantra (AD/ADa), Ioniq Hybrid/Electric (AE HEV/ EV), Santa Fe Sport (AN), Santa Fe (NC), Sonata/ Sonata Hybrid/Sonata Plug-in (LFA/LF HEV/LF PHEV), Tucson (TL)
SUBJECT: FIRMWARE FOR MISSING USIM INFORMATION AVN 4.0 (SERVICE CAMPAIGN 972)

Description: When asked to provide the Modem Information, the Universal Subscriber Identity Module (USIM) information is not available. This bulletin describes the 3-part Software to correct this condition and activate Blue Link Services.

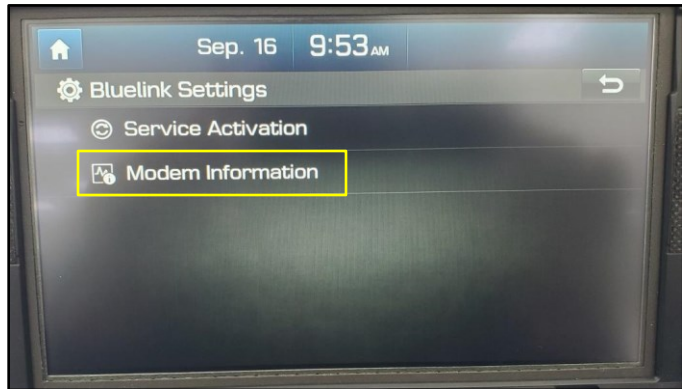
4. Select **Modem Information** and verify USIM and IMEI are displaying.

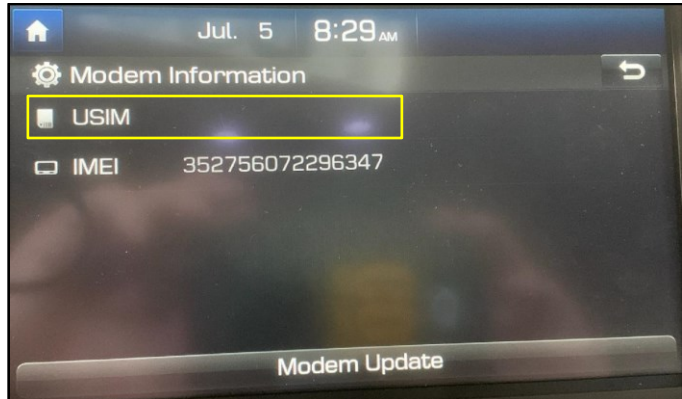
5. If USIM information is missing, capture photo using STUI in the GDS and proceed to **Section B**.

Ensure RO or last 6 digits of the VIN are written in the background of the photo. Data must be clear and visible.

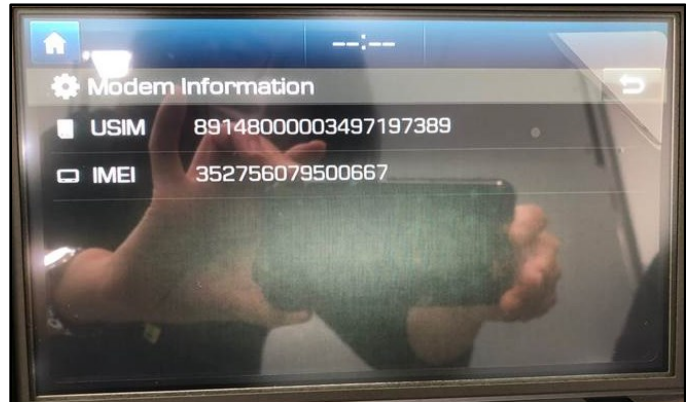
7. Confirm USIM data is present after the update.
