SERVICE BULLETIN

Classification: AT21-012	Reference: NTB21-109	Date: December 6, 2021
-----------------------------	-------------------------	---------------------------

DTC P0805 FOR CLUTCH POSITION SENSOR A STORED IN TCM

APPLIED VEHICLES: 2022 Pathfinder (R53)
APPLIED DATES: Built before October 21, 2021

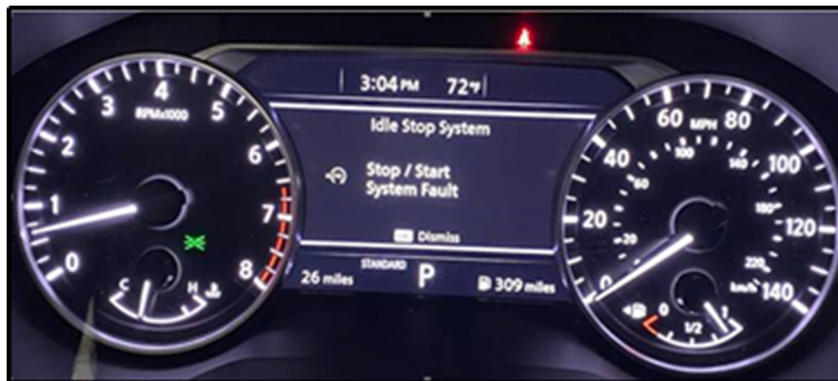
Figure 1

DTC P0805 (Clutch Position Sensor A) is stored in the TCM.

- The MIL was ON.
- The Idle Stop System Fault message (Figure 1) was displayed.
- They experienced a drivability concern.

1. Confirm the current TCM part number.
2. Reprogram the TCM, if applicable.
