SERVICE BULLETIN

Classification: AT21-008	Reference: NTB21-117	Date: December 17, 2021
-----------------------------	-------------------------	----------------------------

OIL LEAK AT REAR OF TRANSMISSION

APPLIED VEHICLES: 2019-2021 Armada (Y62)
APPLIED DRIVELINES: 2WD only

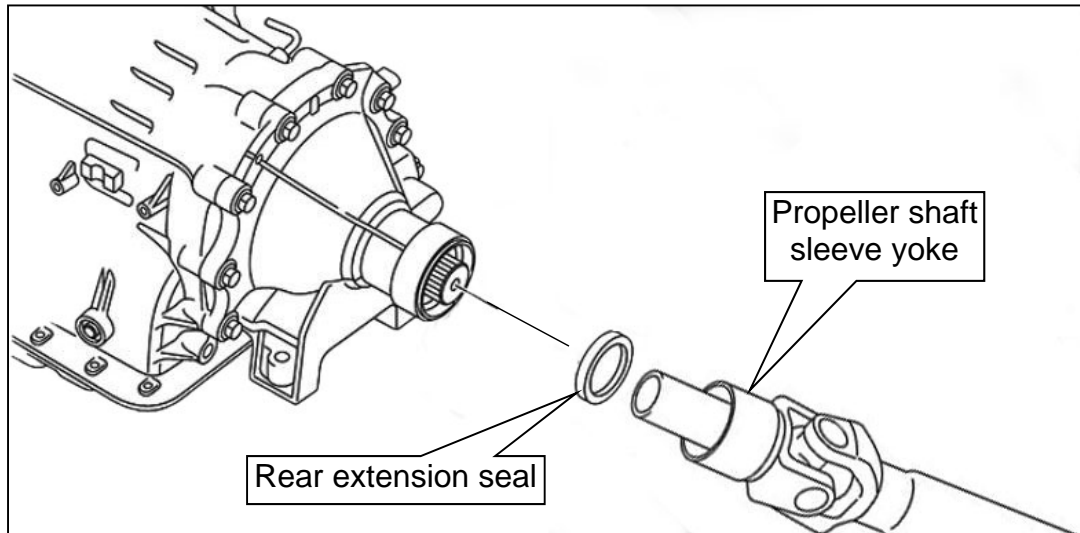
Figure 1

When diagnosing an oil leak at the rear of the transmission on an applied vehicle, follow the **SERVICE PROCEDURE** in this bulletin to determine if the origin of the leak is at the rear extension seal, or at the pressed-in plug of the propeller shaft sleeve yoke (Figure 1).

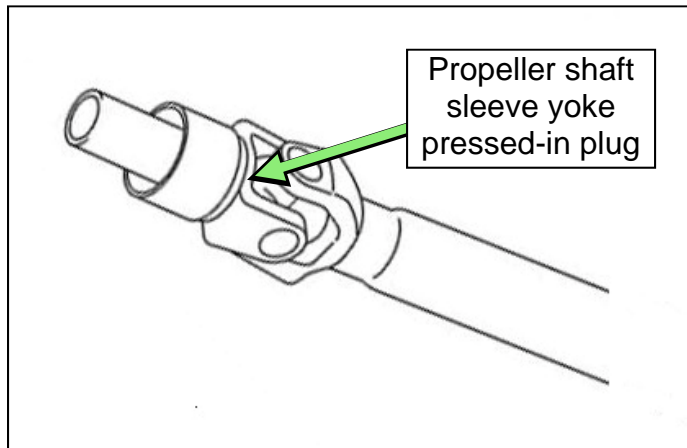
Figure 2

1. Without removing any components, closely inspect for the origin of the leak at the rear extension seal, and also at the propeller shaft sleeve yoke pressed-in plug (Figure 2 and Figure 3).

If necessary, clean the area around the rear extension seal and propeller shaft sleeve yoke and reinspect for the leak.

- If the leak does not appear to be coming from the rear extension seal, continue to step 2.
- If the leak is confirmed to be coming from the rear extension seal and not the propeller shaft sleeve yoke pressed-in plug, replace the rear extension seal with the one listed in **PARTS INFORMATION** on the last page.
 - Refer to the ESM: **REPAIR > TRANSMISSION & DRIVELINE > TRANSAXLE & TRANSMISSION > REMOVAL AND INSTALLATION > REAR OIL SEAL**

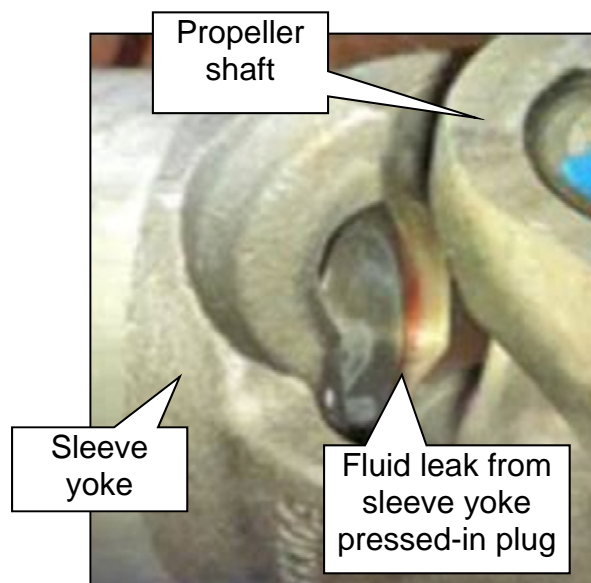
Figure 3

2. Check the propeller shaft sleeve yoke pressed-in plug for leaks.

- If the leak is confirmed to be coming from this area and not the rear extension seal, replace the propeller shaft with the one listed in **PARTS INFORMATION** on the last page.
 - Refer to the ESM: **REPAIR > TRANSMISSION & DRIVELINE > DRIVELINE > REMOVAL AND INSTALLATION > REAR PROPELLER SHAFT**
