SERVICE BULLETIN

Classification: BT21-027	Reference: NTB21-118	Date: December 17, 2021
-----------------------------	-------------------------	----------------------------

RESIDUE ON OUTER SURFACE OF FRONT DOOR GLASS

- APPLIED VEHICLES:** 2022 Frontier (D41)
APPLIED GRADES: SV with Convenience Package
All PRO-X and PRO-4X
APPLIED SYSTEMS: All vehicles with external Intelligent Key door request switches

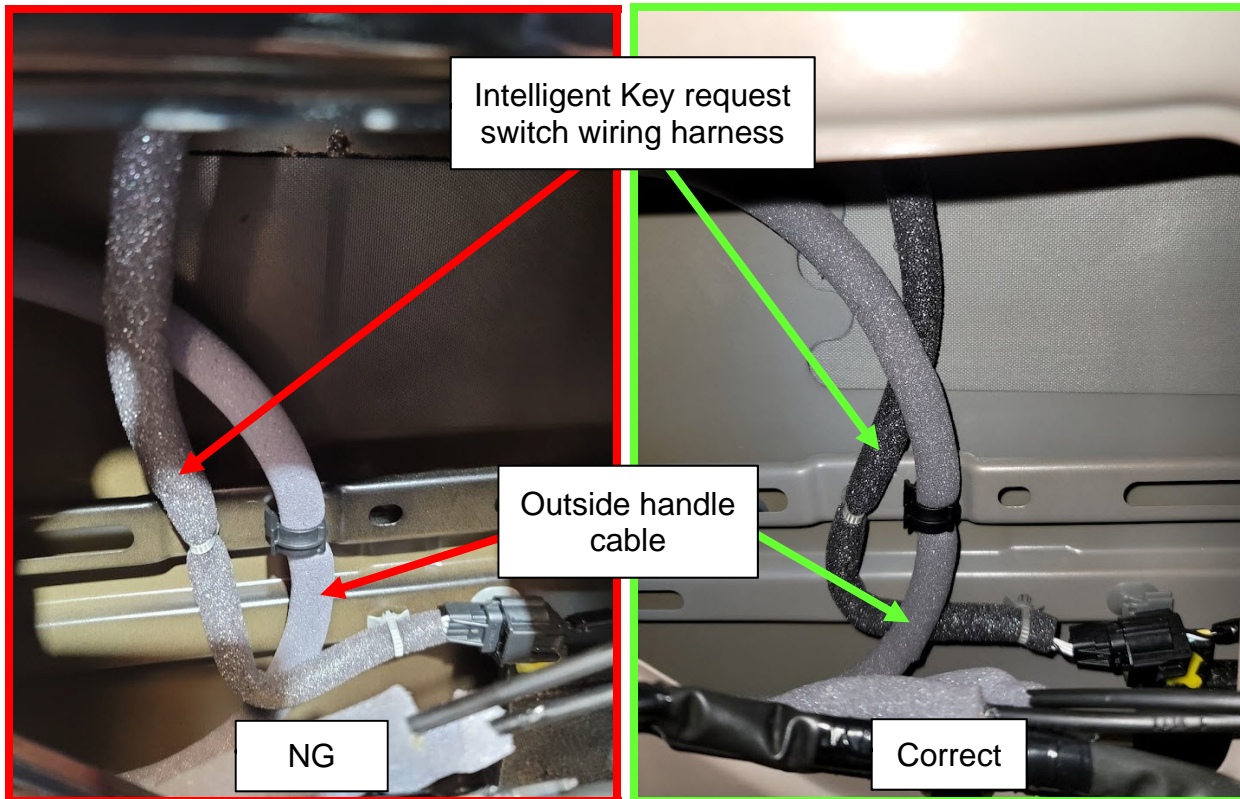
Figure 1

Adhesive residue is found on the outer surface of front driver (LH) side and/or front passenger (RH) side window glass.

1. Remove the door finisher on the affected side.
 - Refer to the **ESM: BODY INTERIOR > INTERIOR > REMOVAL AND INSTALLATION > DOOR FINISHER**
2. Inspect the routing of the Intelligent Key request switch wiring harness and confirm if it is routed as shown in Figure 1.
 - If routed as shown in Figure 1, proceed to step 3.
 - If routed as shown in Figure 2, skip to step 5.

3. Reroute the harness behind the outside handle cable, as shown in Figure 2.
4. Confirm that neither the harness or cable are no longer contacting the glass.
5. Reassemble the door finisher.
