SERVICE BULLETIN

Classification: FA99-001F	Reference: NTB99-001F	Date: December 7, 2021
------------------------------	--------------------------	---------------------------

STRUT AND SHOCK ABSORBER REPLACEMENT GUIDELINES

APPLIED VEHICLES: 1990-2022 Nissan vehicles except those listed below

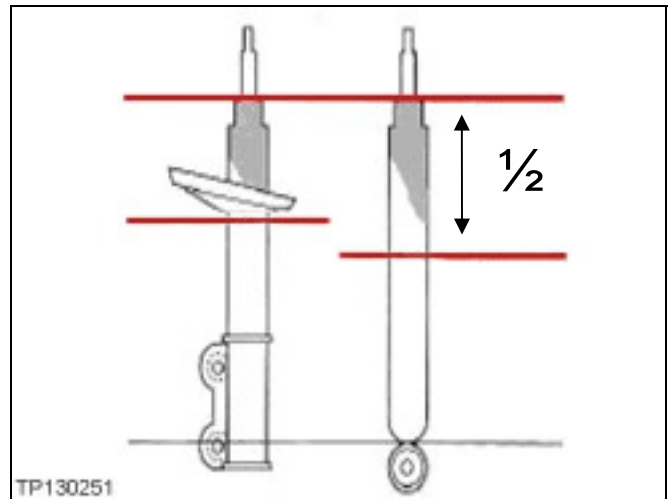
Figure 1

If oil does NOT extend beyond the spring seat or upper 1/2 of shock:

- This is **slight oil seepage**. The strut/shock absorber should NOT be replaced.

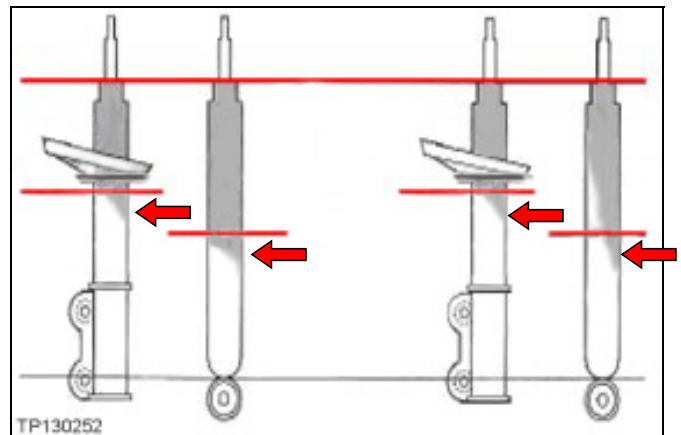
Figure 2

If oil does extend beyond the spring seat or upper 1/2 of shock:

- Use a finger to touch the oil that has extended beyond the spring seat or upper 1/2 of shock.

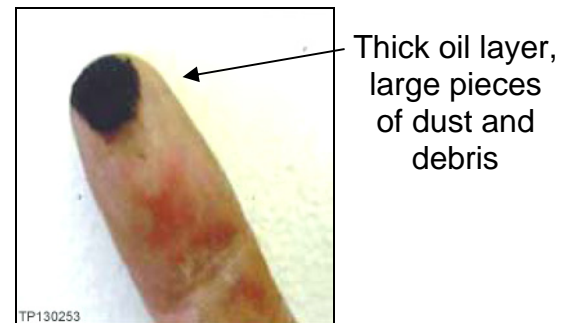
Figure 3

- If you confirm the oil layer is thick and contains large pieces of dust and debris, the strut/shock absorber **should be replaced**.

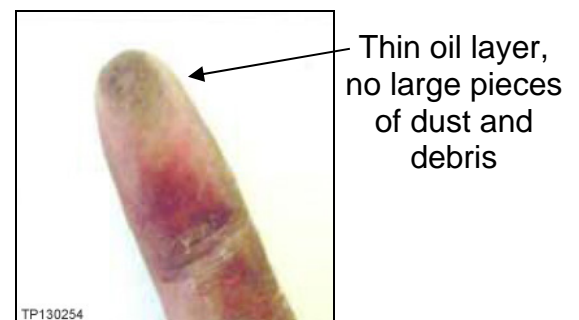
Figure 4

- If you confirm the oil layer is thin and does NOT contain large pieces of dust and debris, the strut/shock absorber should NOT be replaced.
