Technical Service Bulletin: TSB210187	Released Date: 02-Dec-2021
Fault Codes 3868, 4572 and 4677 Caused by Diesel Exhaust Fluid (DEF) Header Malfunction

Fault Codes 3868, 4572 and 4677 Caused by Diesel Exhaust Fluid (DEF) Header Malfunction

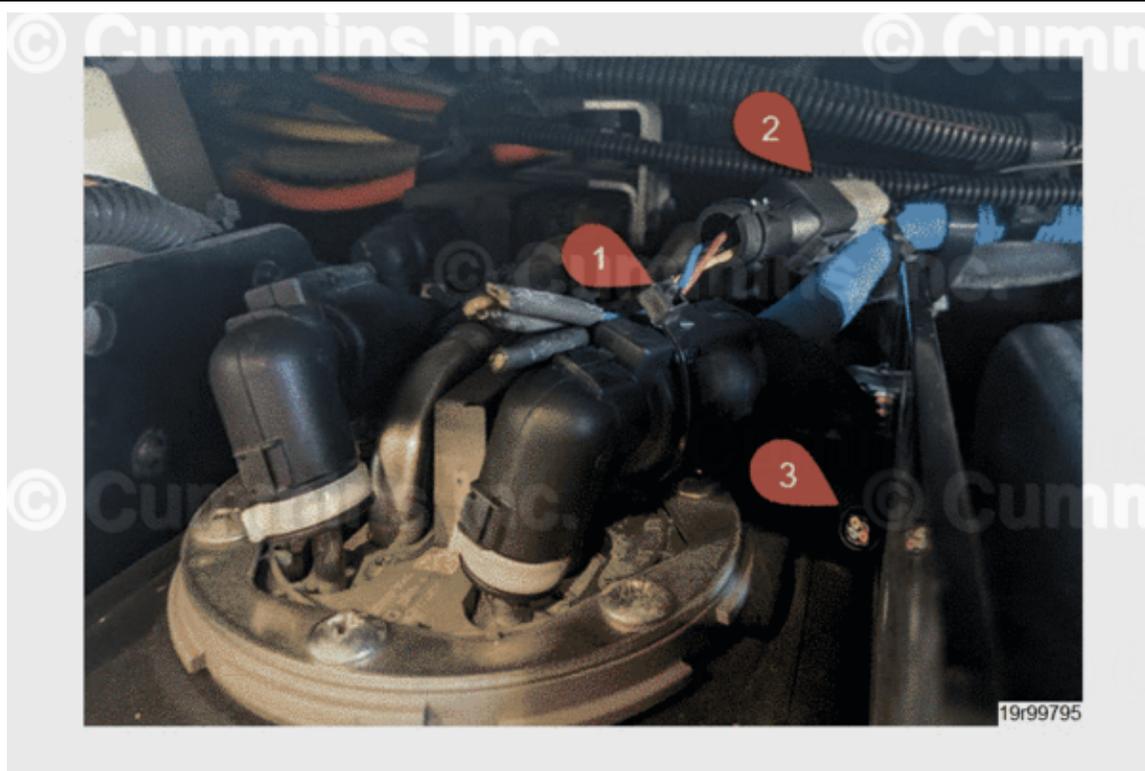
Figure 4, OEM Wiring Harness.

1. Zip tie securing the harness
 2. Pigtail connected to chassis connector
 3. Harness to DEF header left unsealed
9. Verify new ECM calibration code download is completed.

7. After the four wires are sealed, reconnect the pigtail to the OEM wiring harness connector.
8. Secure the wiring harness using a zip tie. See Figure 4 below.
