# Technical Service Bulletin

| <b>Technical Service Bulletin:</b> TSB210280 | <b>Released Date:</b> 17-Dec-2021 |
| <b>High Voltage Cable Exposed Shielding</b> | |

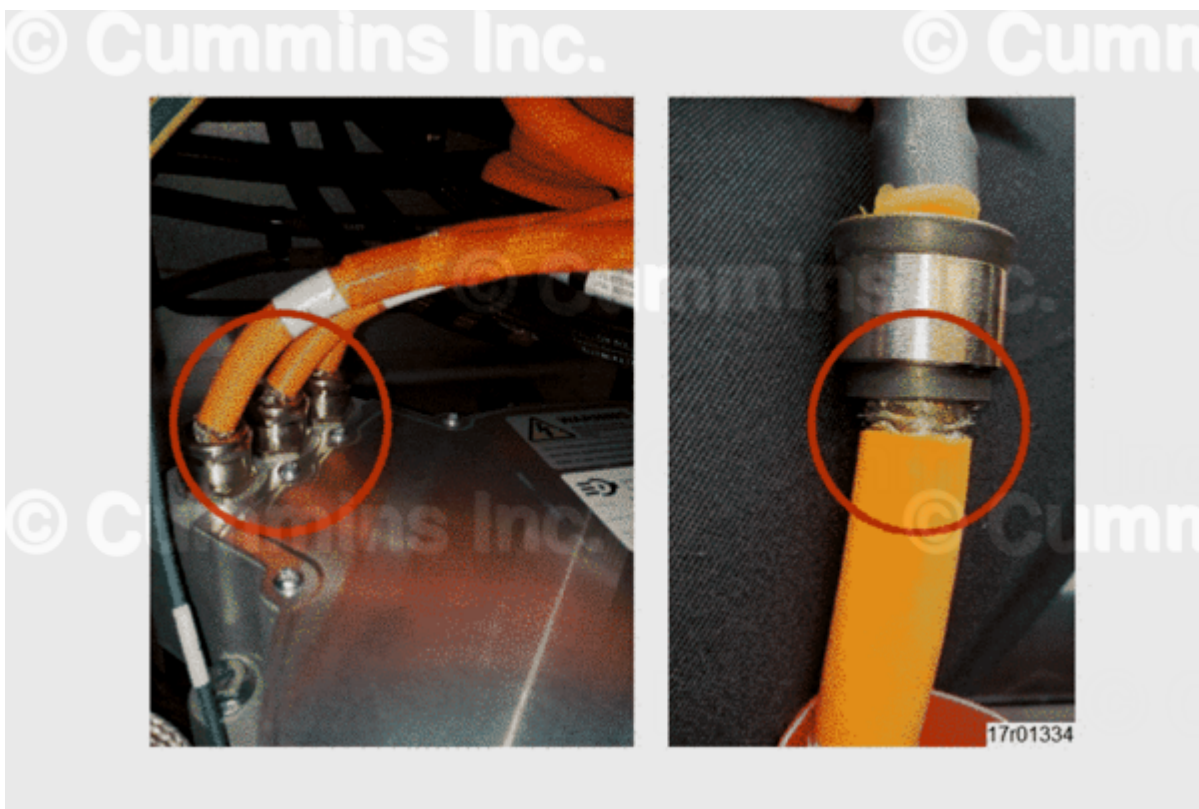
There are several areas where a high voltage cable has been manufactured with exposed shielding, which can lead to moisture intrusion. These are the areas where the issue is most commonly found:

- Exposed high voltage cable shielding

Figure 1, Example of Exposed High Voltage Cable Shielding.

1. Remove the high voltage cable with exposed shielding as identified in the above steps.
2. Apply heat shrink using 3.81 cm [ 1.5 in ] inside diameter (before shrinking) heat shrink tubing, taking the crimp apart is **not** necessary. Heat shrink can be purchased through Grainger®, item number 33VH20.
3. After application of heat shrink to the high voltage cable, slide nut on and assemble.

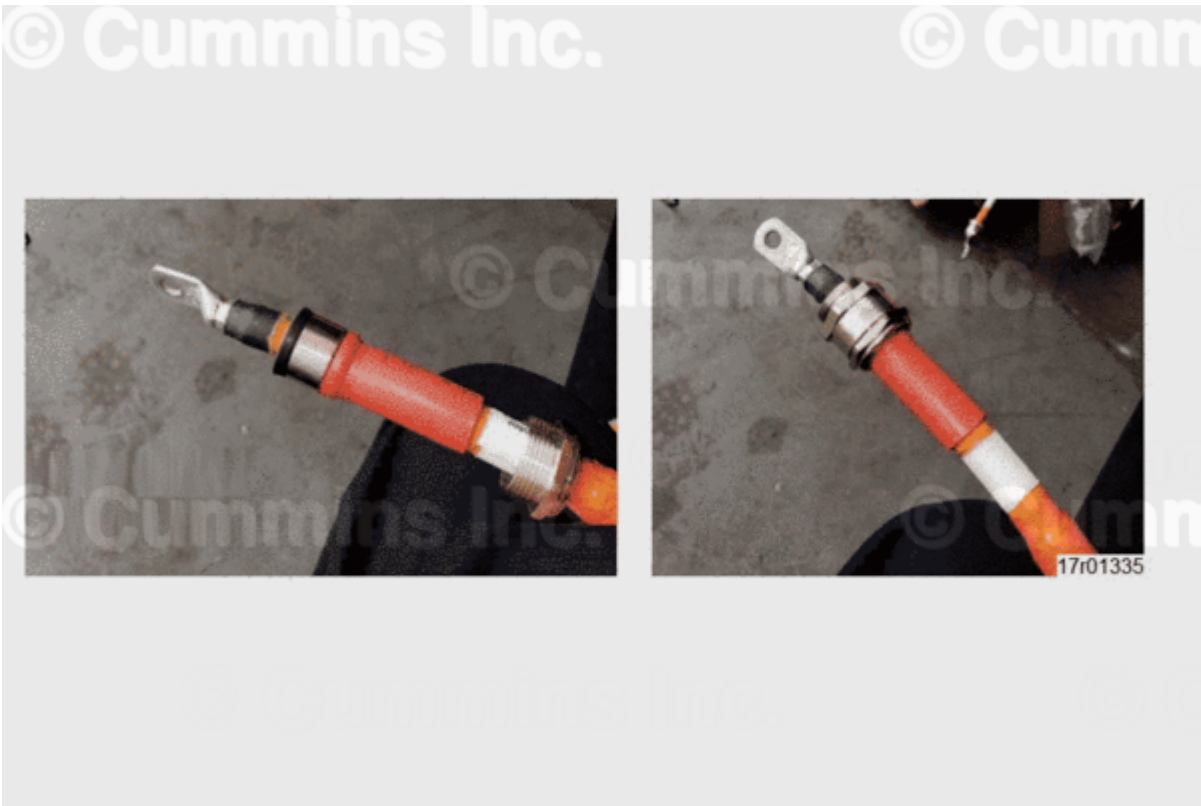
Figure 2, Heat Shrink Applied to High Voltage Cable.
