Tech Tip T-TT-0679-21

Potential ATF Leak - Cleaning & Inspection Procedure

2022 Tundra 2WD

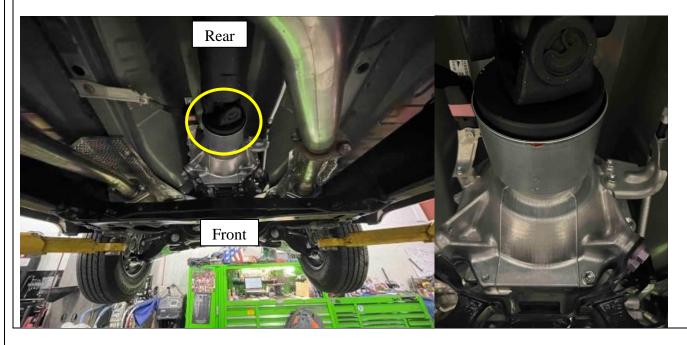
For some 2WD 2022 MY Tundra vehicles, there may appear to be an ATF leak from the extension shaft area at the rear of the transmission. This condition is specifically focused on new vehicles and is typically found during the PDS inspection. See picture below for reference how condition appears:

Please do not remove the transmission assembly for further diagnosis. Perform the cleaning/inspection procedure below for further direction:

1. Inspect the extension shaft area at the rear of the transmission for transmission fluid.

2. Spray Toyota Brake Parts cleaner, CRC "Brakleen", or equivalent into the area between the extension housing and the propeller shaft.

- 3. Blow shop air into that area.
- 4. Wipe the area clean with a clean shop towel.
- 5. Drive the vehicle for 5-10 miles at varying speeds, including highway speed, if available. If vehicle cannot be driven, please follow the pattern below:
 - a. Set parking brake
 - b. Start the engine
 - c. Move gear selector through each gear, pausing at each gear for ~10 seconds
 - d. After engine has run for 10-15 minutes, turn off the vehicle
- 6. Recheck the area for any leaks.
 - a. If a leak is found, please create a TAS case and contact TAS for instruction prior to diagnosing or repairing of the vehicle. If it is a weekend or holiday, continue with diagnosis and repair. Please save all parts and/or details and contact TAS on the next available workday.
 - b. If residue is no longer present, then the procedure is complete.
