PANORAMIC SUNROOF DIAGNOSIS

This Service Information Bulletin (Revision 4) replaces SI B54 11 19 **dated July 2021**.

SUNROOF DIAGNOSIS

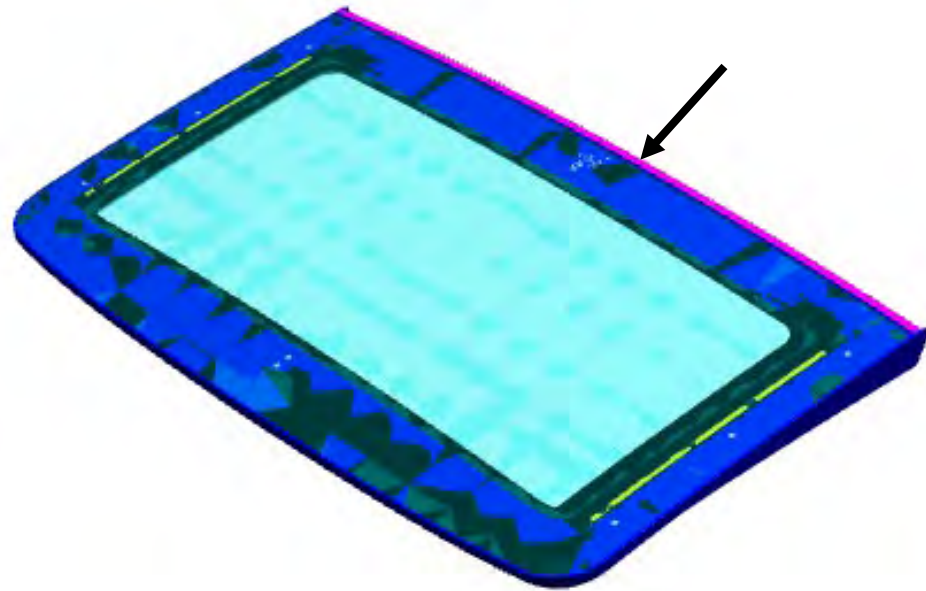
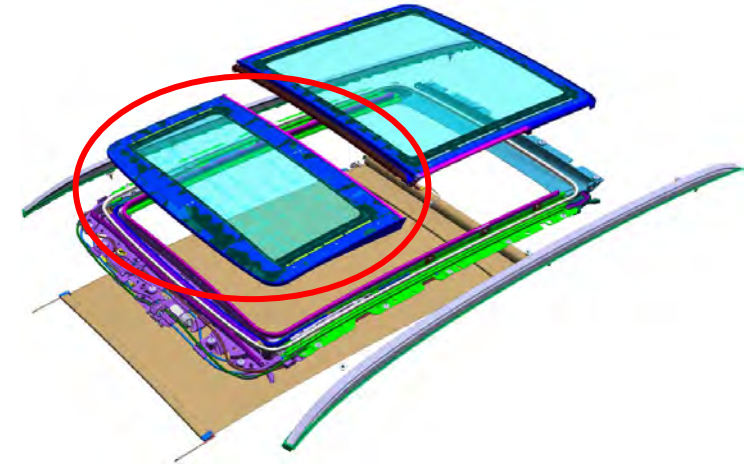
FRONT CENTER SEAL LOOSE/SHRINKING

Defect: separated

Defect: shrunken / gap

Situation: Excessive water enters through the sunroof seals.

Repair: Look for gap near end of the seal on front glass. If found, replace seal according to ISTA/AIR instructions REP 54 13 052. Also refer to B54 04 21.

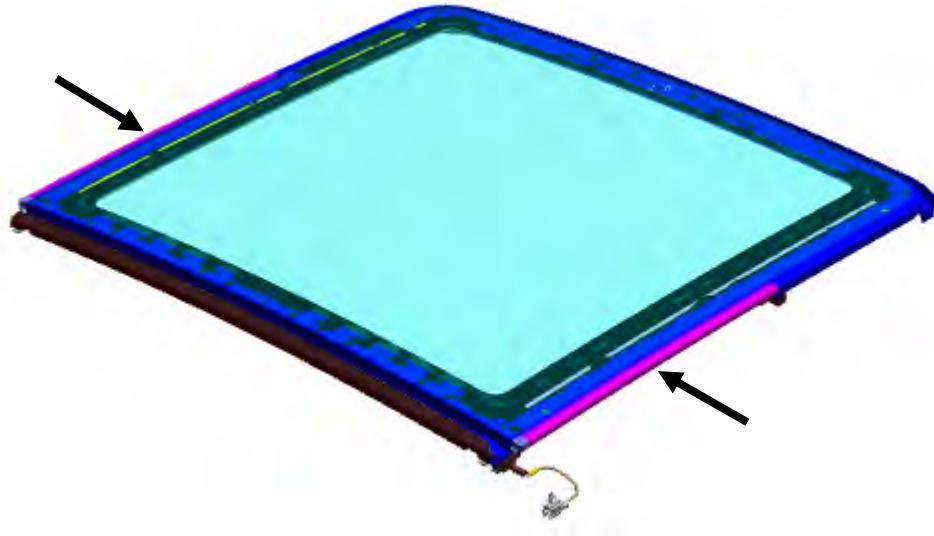
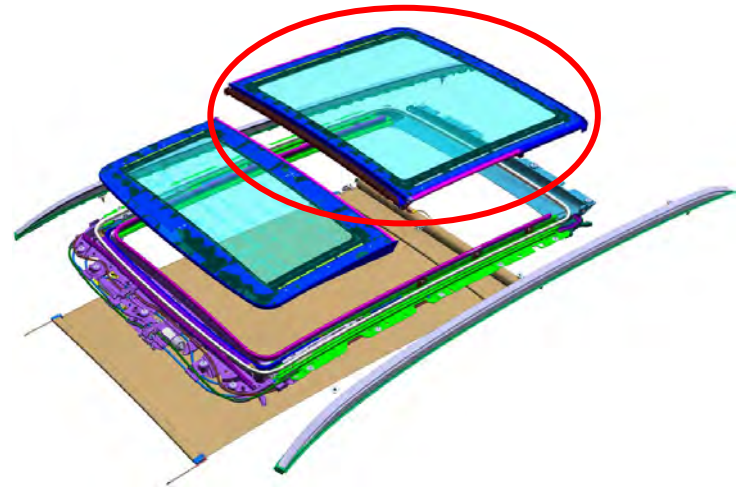
SIDE SEAL LOOSE/SHRINKING

Defect: gap

Defect: twist

Defect: loose

Situation : Excessive water enters through the sunroof seals. (see pictures)

Repair: Look for gap near ends or twist in seal. If found, replace seal according to ISTA/AIR instructions.
REP 54 13 050

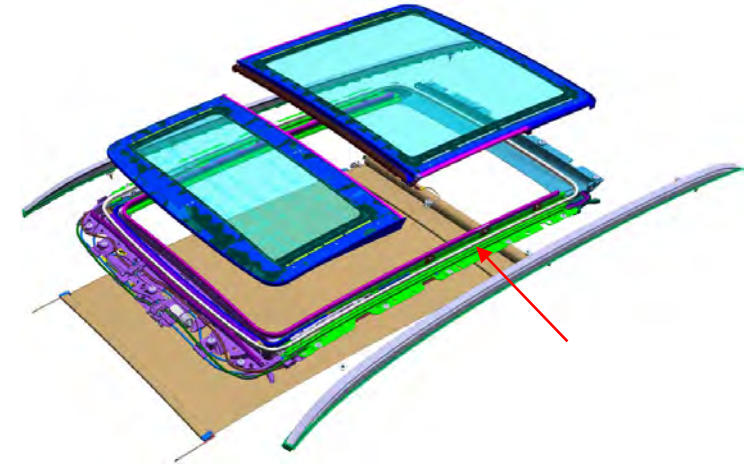
BODY SEAL NOT ATTACHED

example: gap/not flush

Situation : Excessive water enters through the sunroof seals.

Repair: Inspect the sunroof perimeter seal for defects. Replace body seal according to ISTA/AIR instructions REP 54 13 055.

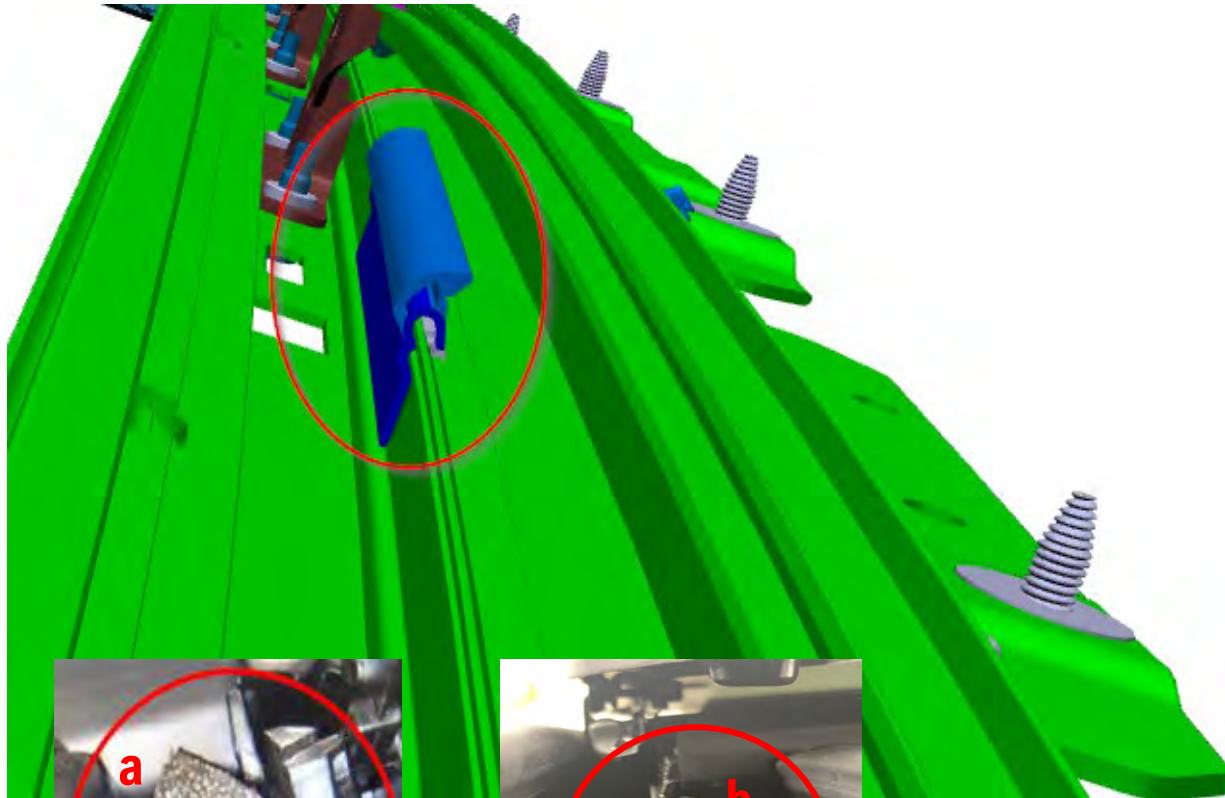
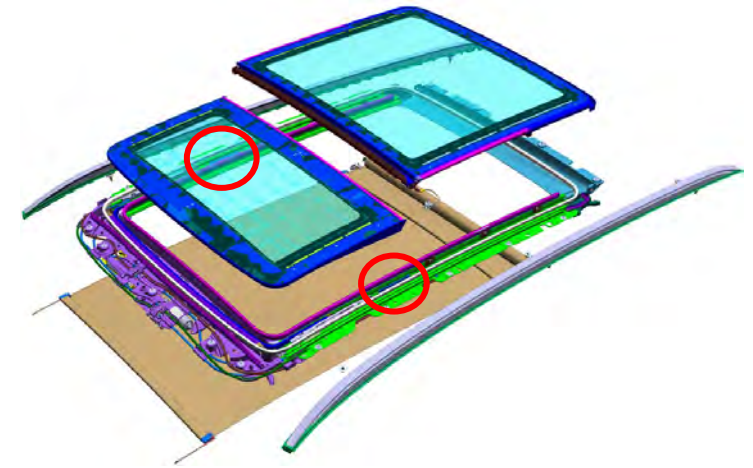
FOAM/SEAL NOT POSITIONED CORRECTLY

Defect picture foam (a)

Defect picture seal (b)

Situation: Water leaks near the middle drain channel

(!) Missing foam/seal is not the root cause of a water leak. Missing foam/seal will NOT CAUSE A WATER LEAK!! DO NOT REPLACE THE FRAME FOR THIS.

Repair: Check position of the seal/foam.
Remove foam/seal If deformed or damaged. Improved seal being developed. SI B will publish when available.

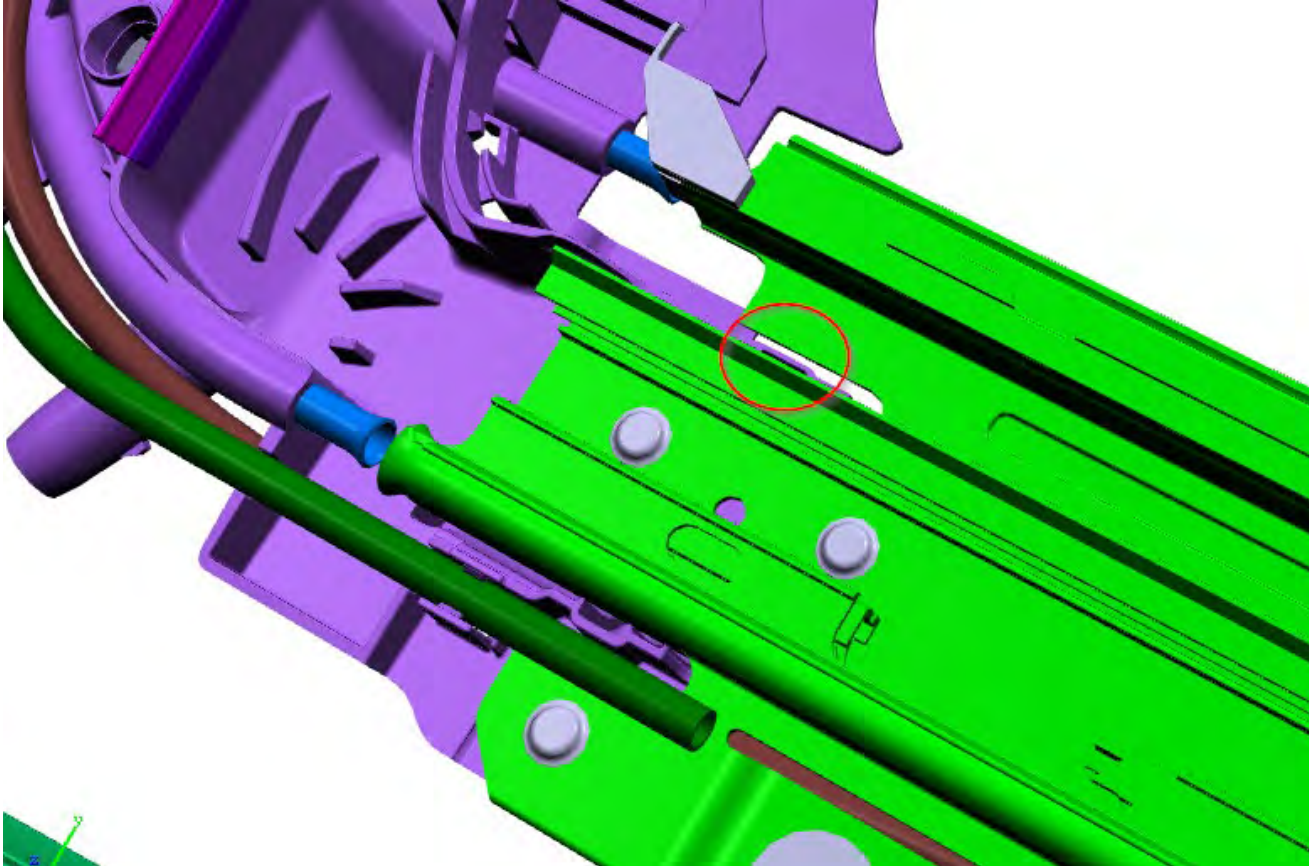
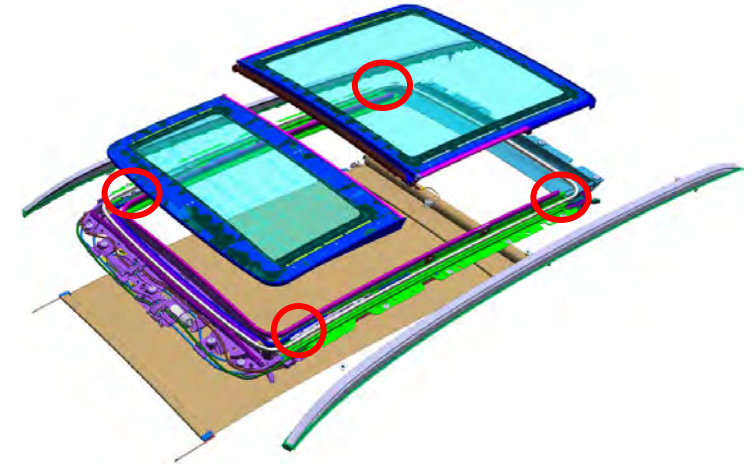
MISSING BUTYL BETWEEN SIDE GUIDES AND BEAM

Situation : There is a water leak running between front/rear beam and side guide.

Repair: There may be missing butyl sealer. ENSURE ALL OTHER WATER MANAGEMENT (SEALS, DRAINS) ARE CHECKED FIRST. ENSURE PROPER WATER TESTING PROCEDURES ARE BEING FOLLOWED (DO NOT OVERFLOW THE SEALED TRACK)

Replace frame according to ISTA/AIR instructions REP 54 13 261.

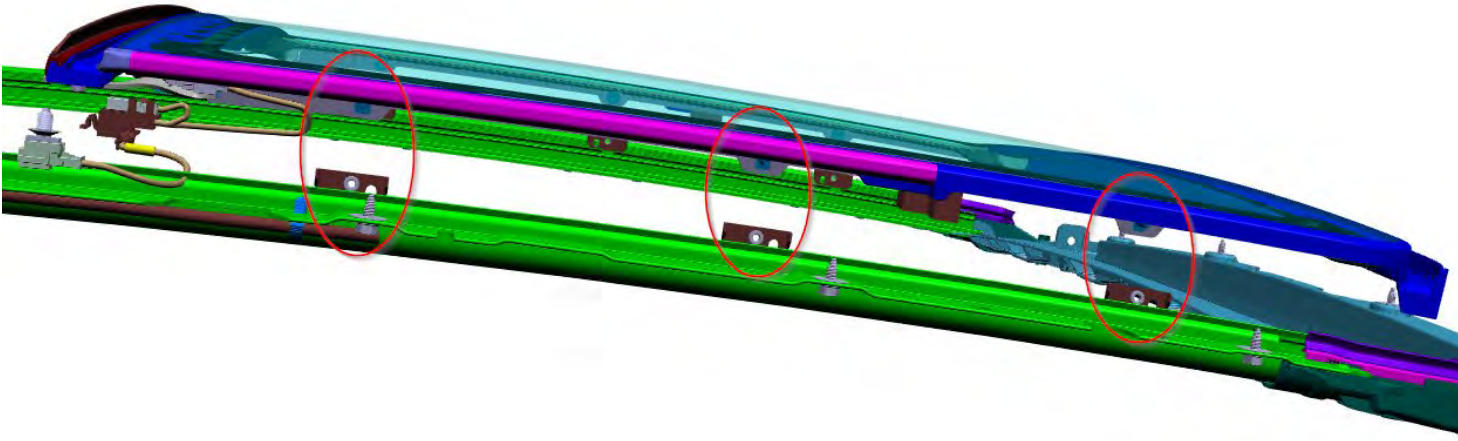
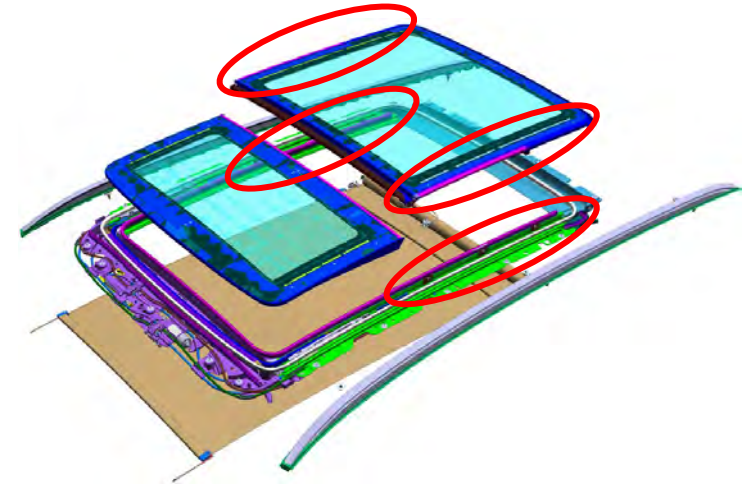
REAR GLASS NOT ALIGNED LEFT TO RIGHT

Situation: Excessive water enters a gap between the side seals and body.

Repair: Check the seals. If seals are OK, check left to right alignment of rear glass (minimal adjustment possible).

Adjust the rear sunroof glass and recheck left to right adjustment. Potential adjustment is very minor. If issue persists then replace frame according to ISTA/AIR instructions REP 54 13 261.

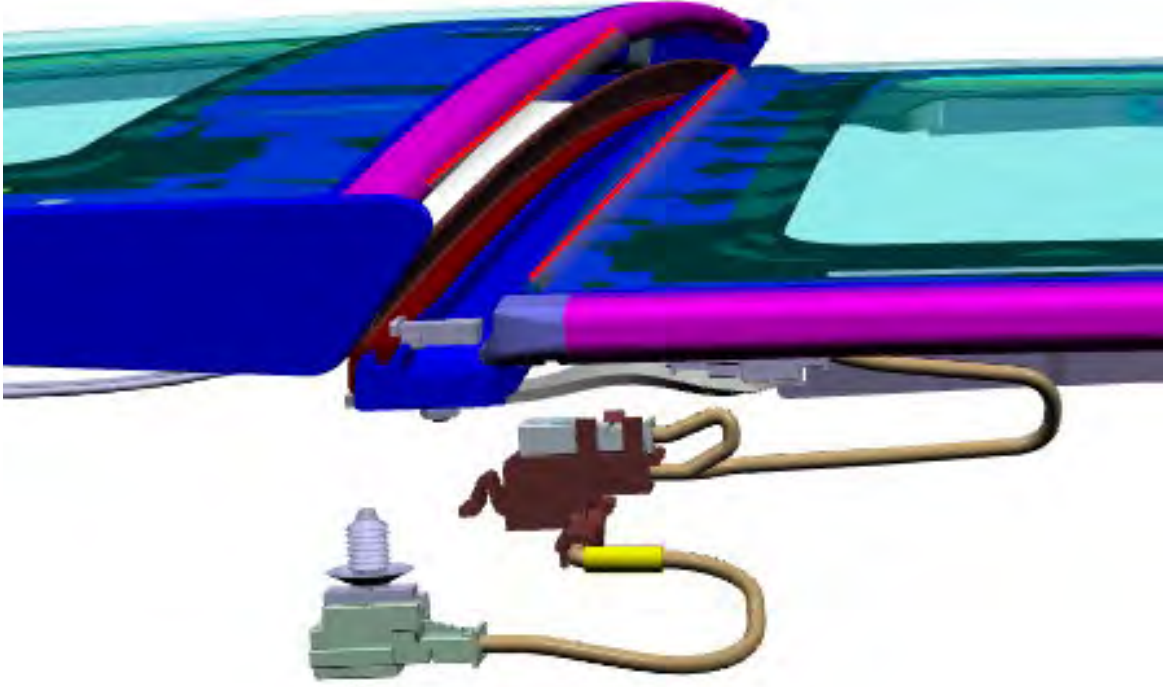
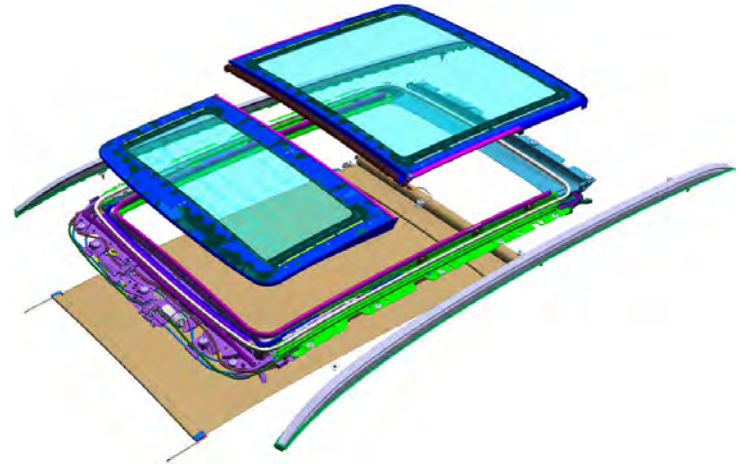
FRONT/REAR GLASS NOT ALIGNED IN X

Situation: Excess water enters the perimeter of the glass. Front and/or rear glass panels misadjusted front to rear.

Repair: Adjust both sunroof glass panels according to ISTA/AIR instructions REP 54 13 002.

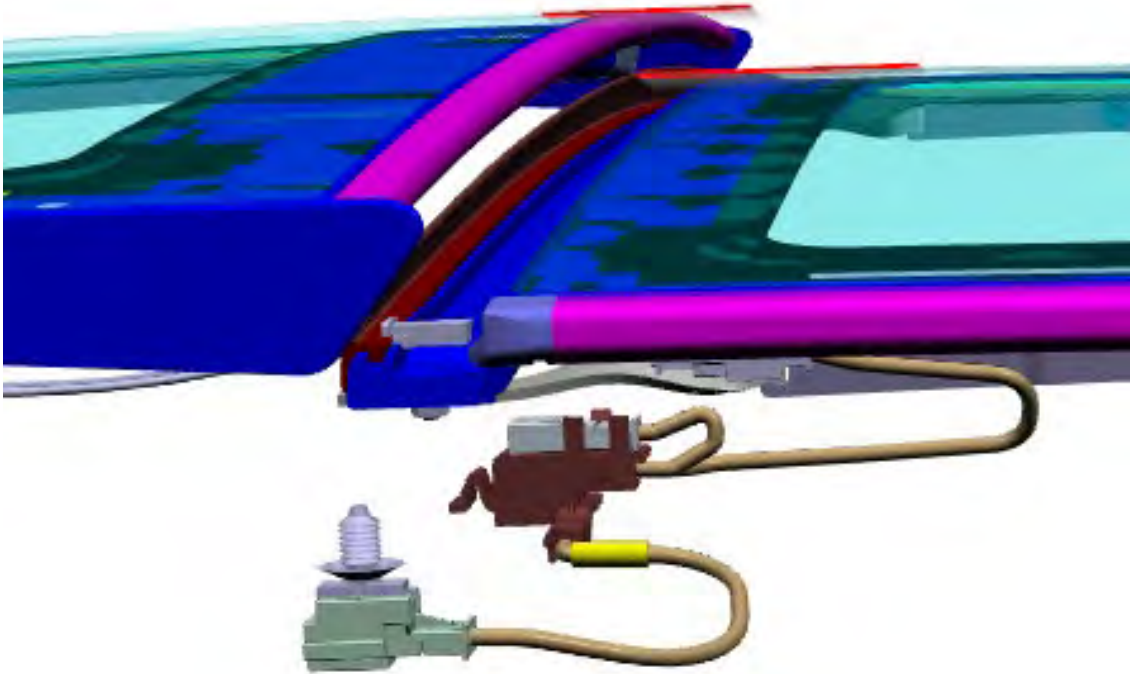
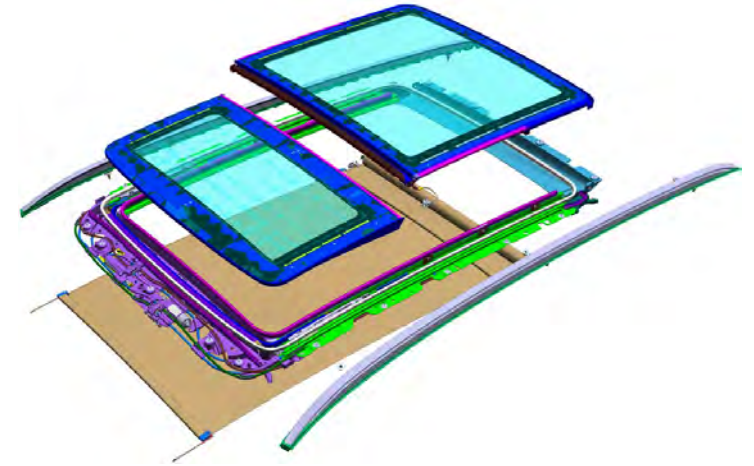
FRONT/REAR GLASS NOT ALIGNED IN Z

Situation: Excess water enters between the glass panels. Front and/or rear glass panel height misadjusted.

Repair: Adjust both sunroof glass panels according to ISTA/AIR instructions REP 54 13 002.

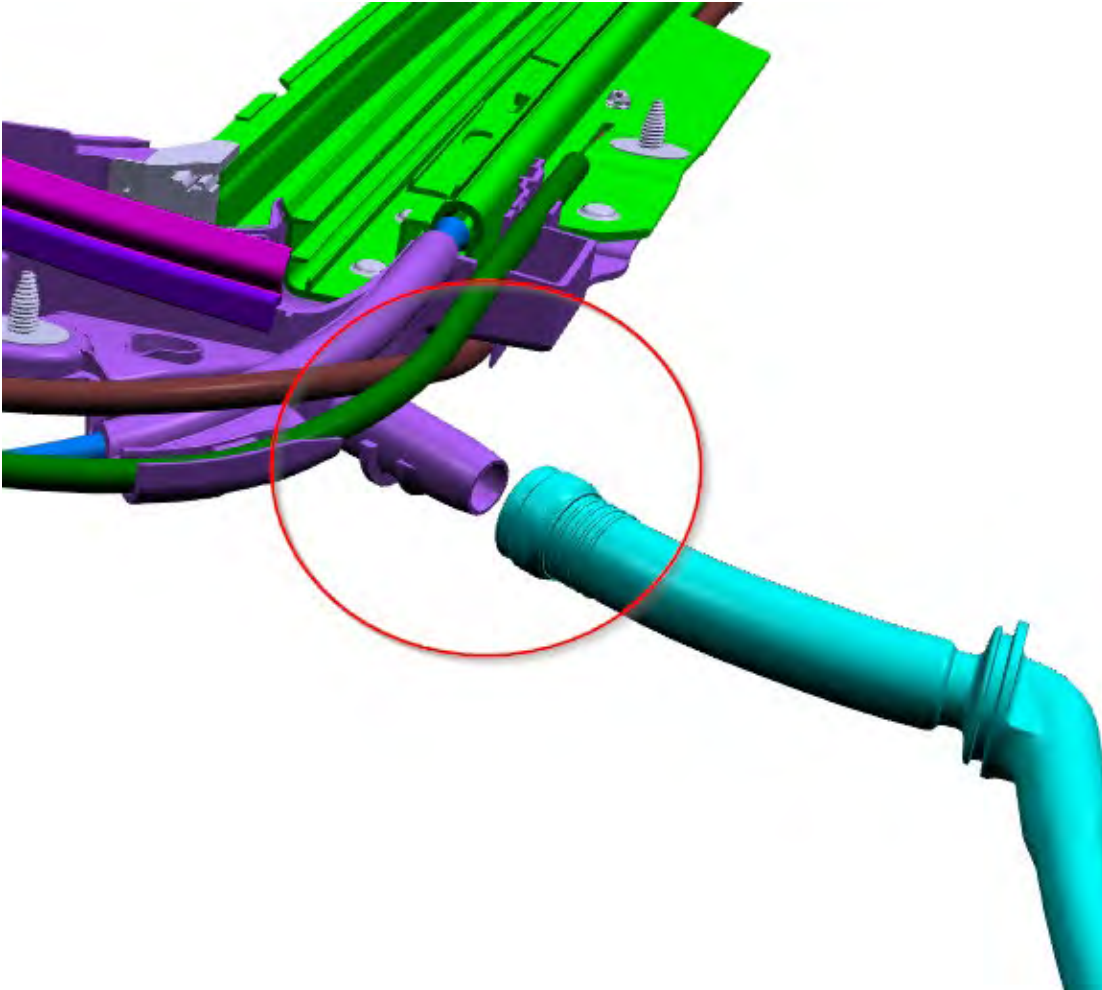
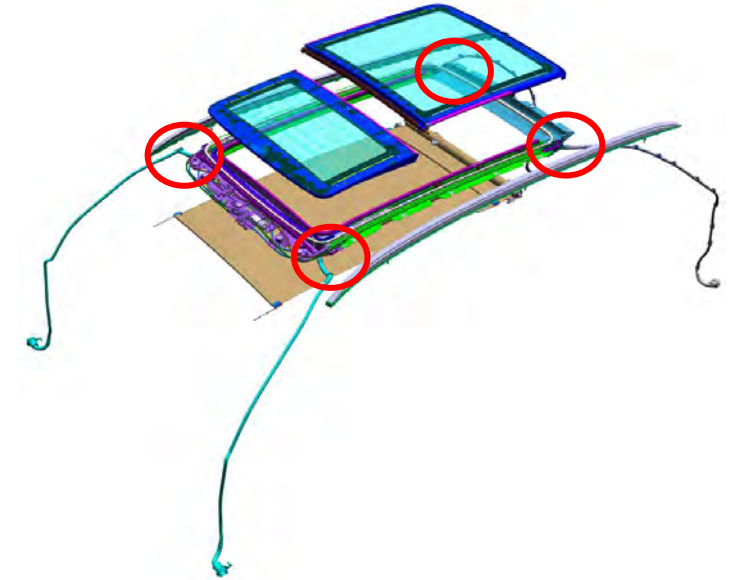
DRAIN TUBE NOT CONNECTED AT TOP

Situation: There is a water leak near the trunk area or you have a water leak near the front carpets. The drain tubes may not be properly connected at the sunroof frame (the top).

Repair: Check the drain tube connections at the sunroof. Reconnect if necessary.

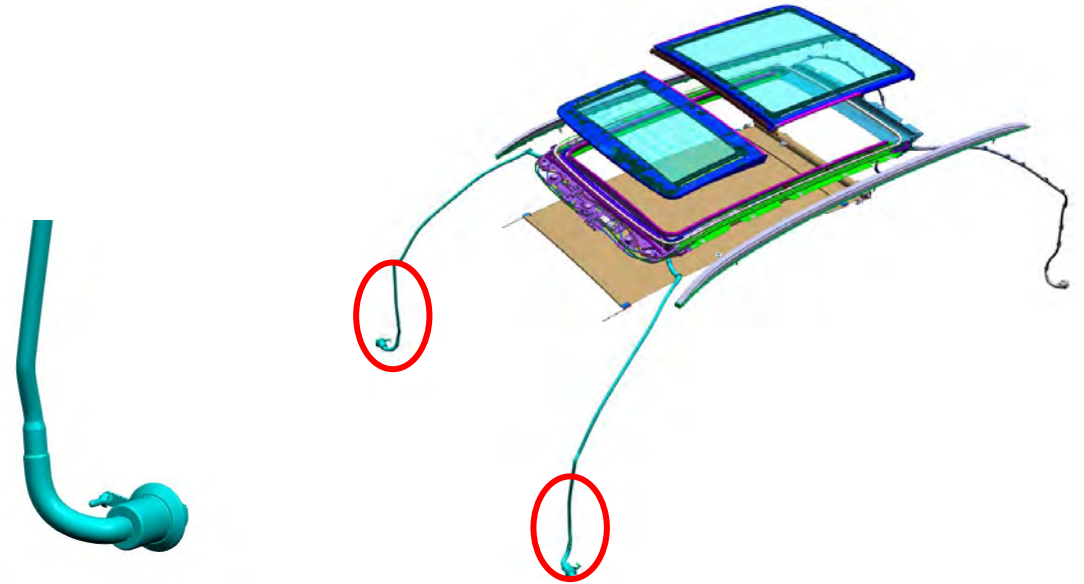
FRONT DRAIN TUBE TWISTED/KINKED

twisted

kinked

Slightly kinked

Situation: There is a water leak near the front or rear carpets. The drain tubes may be twisted. Remove A-pillar kick panels to check if front drain tube is twisted/kinked. Use borescope if needed.

!!This situation is one of the more common issues. Investigate thoroughly!!

Repair: Reposition hose to remove kink. If kink can't be removed, refer to B54 11 19 Attachment 1 for repair instructions.

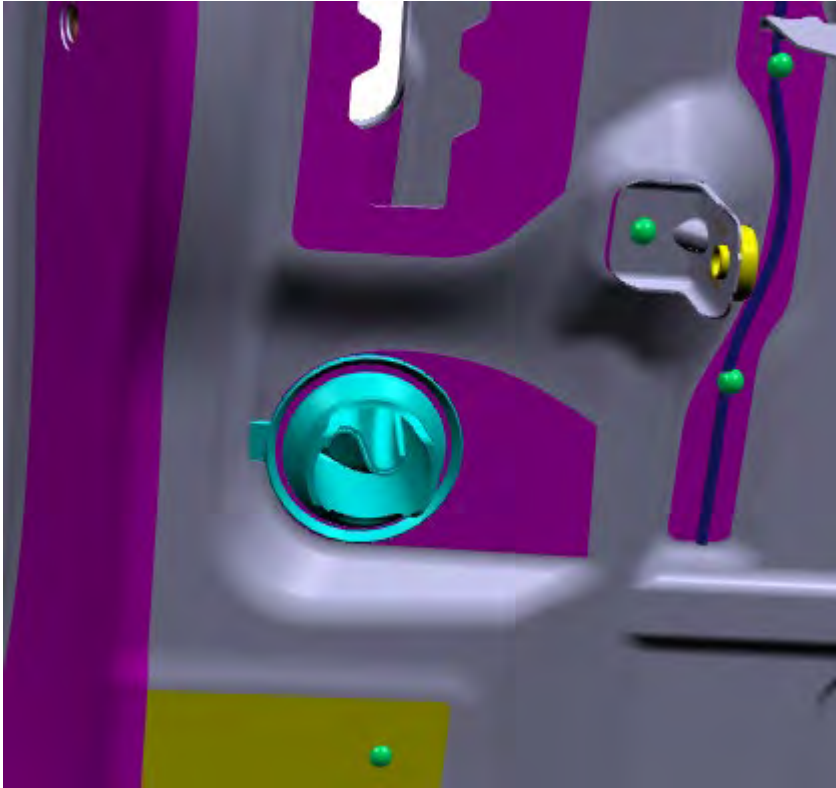
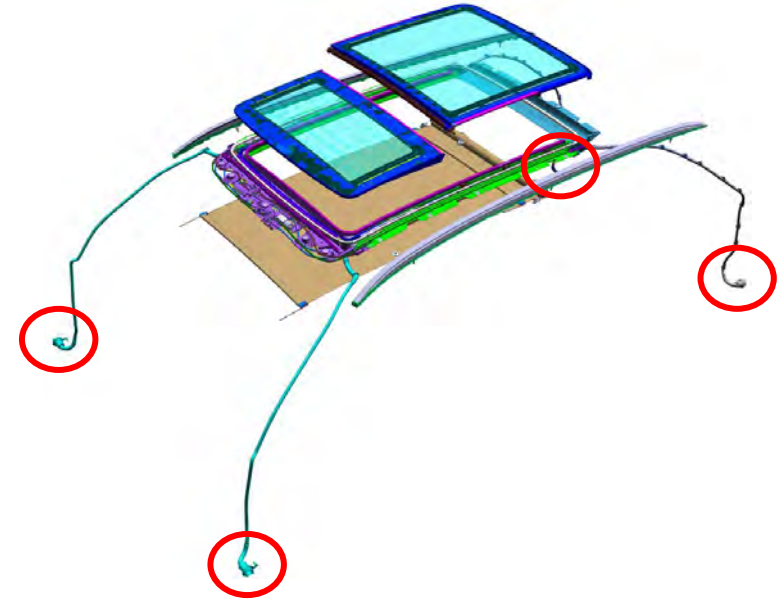
DRAIN TUBES NOT CONNECTED AT BOTTOM

Situation: There is a water leak near the trunk area or you have a water leak near the front carpets. The drain tubes may not be properly connected at the A-Pillar or D pillar at the bottom

Repair: Make sure that drain grommet is seated correctly in the A-Pillar. If not, correctly seat grommet.

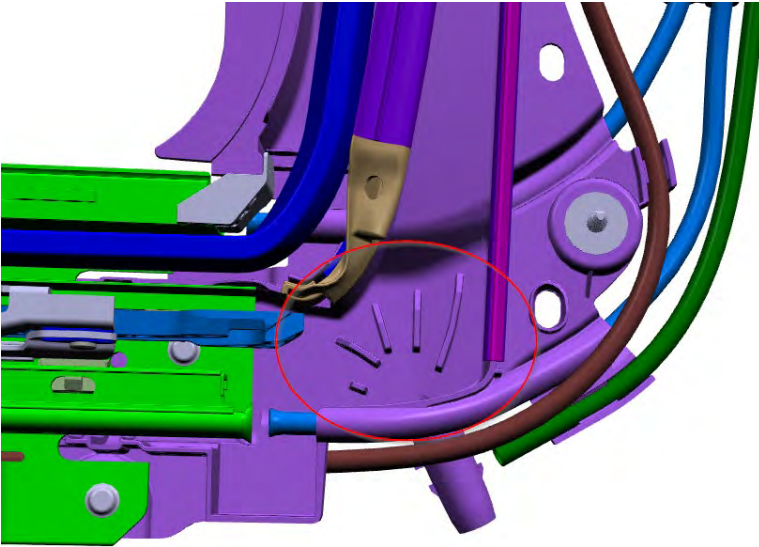
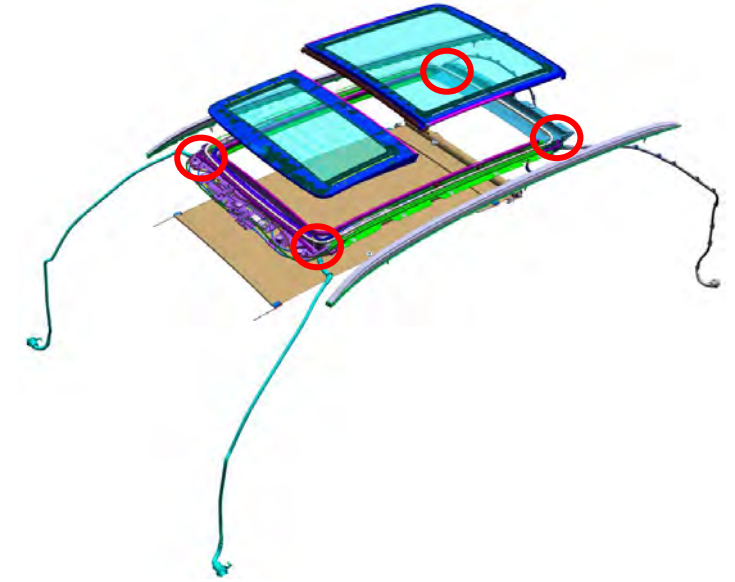
DRAIN TUBES CLOGGED (DIRT/DEBRIS)

Situation: There is a water leak onto the carpets. The drain tubes may be clogged.

Repair: Verify water flow through drain tube. Check for twist/kinks in drain hoses first. If no defect is found, gently blow air through drain tube to force debris to come out. Submit TSARA case for assistance if clog cannot be cleared.

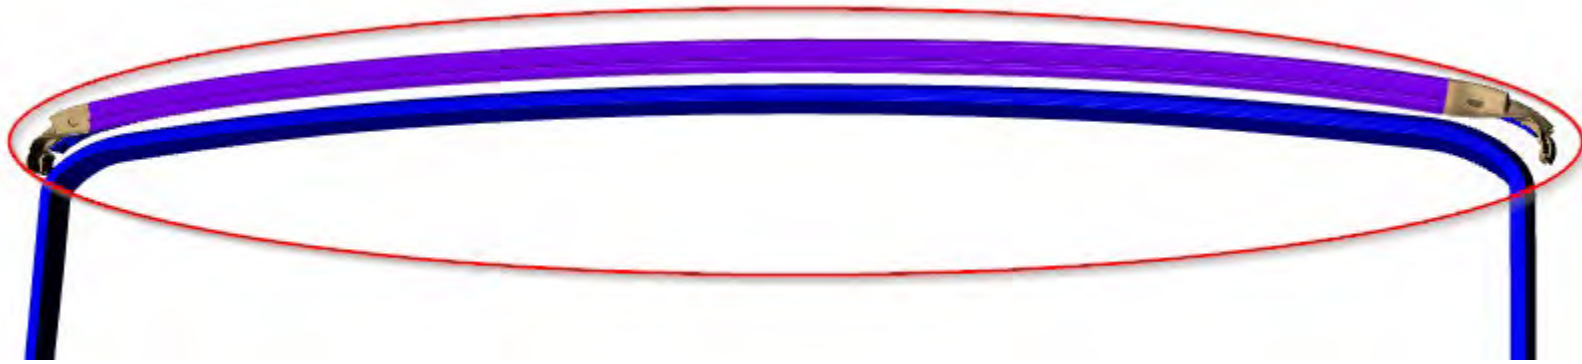
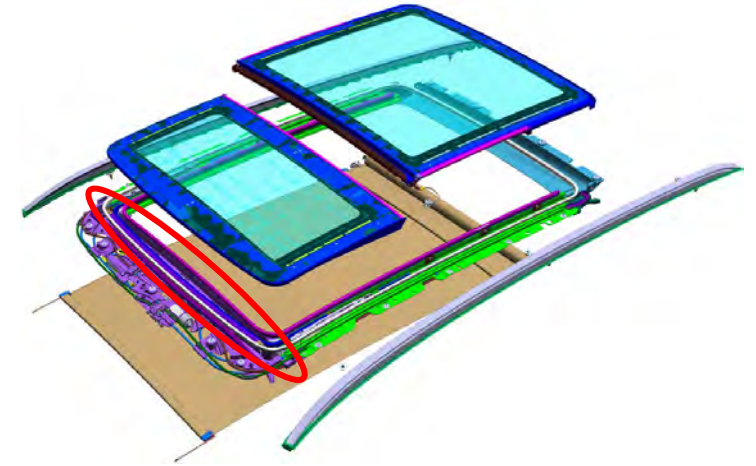
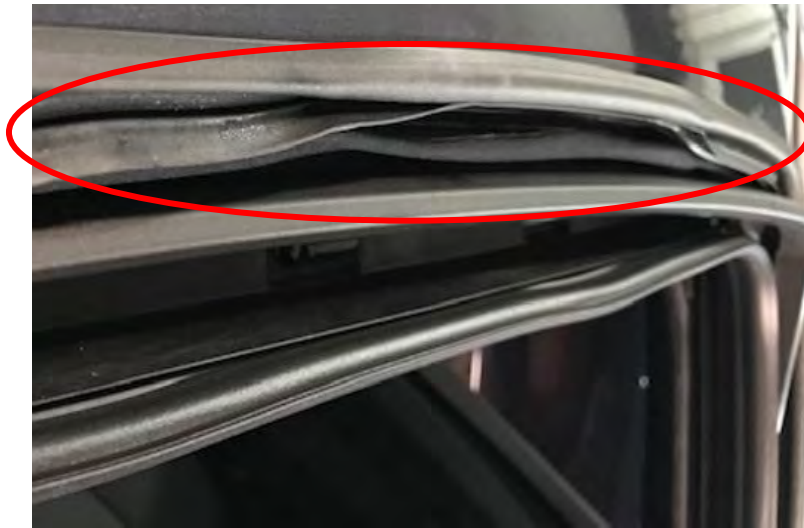
AERO ACOUSTIC SEAL NOT INSTALLED / STUCK

Situation: There is a water leak in the front. The aero-acoustic seal may be incorrectly installed or deformed.

Repair: Check if seal is properly seated and in good condition. If not, then reseal or replace the aero-acoustic seal and replace the body seal according to ISTA/AIR instructions REP 54 13 055.

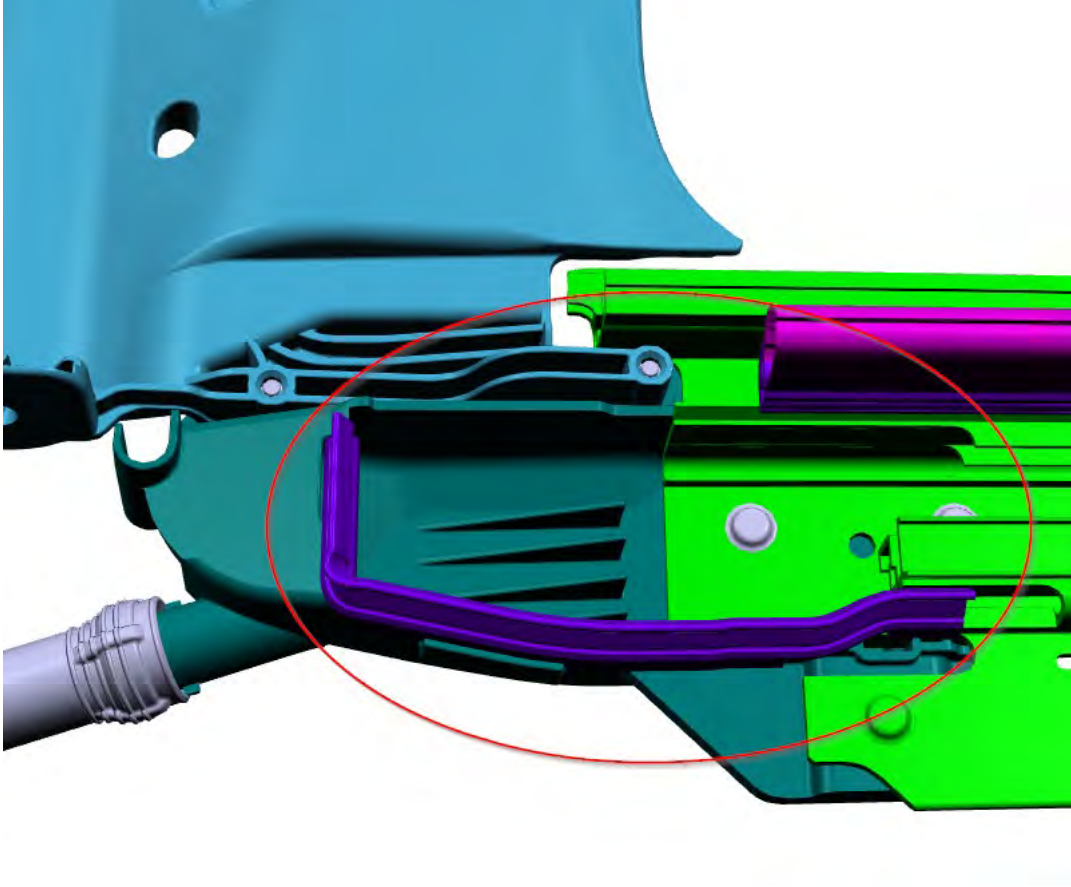
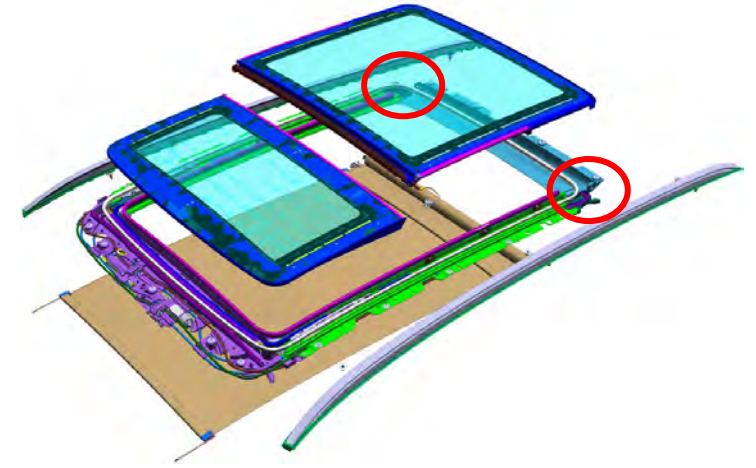
REAR BEAM DYKO SEAL NOT INSTALLED

Situation: There is water ingress in the trunk area. The rear beam seal may not be installed.

Repair: Check if seal is properly seated. Loosen bolts to lower the frame in order to properly inspect seal. If seal is completely missing then replace frame according to ISTA/AIR instructions REP 54 13 261.

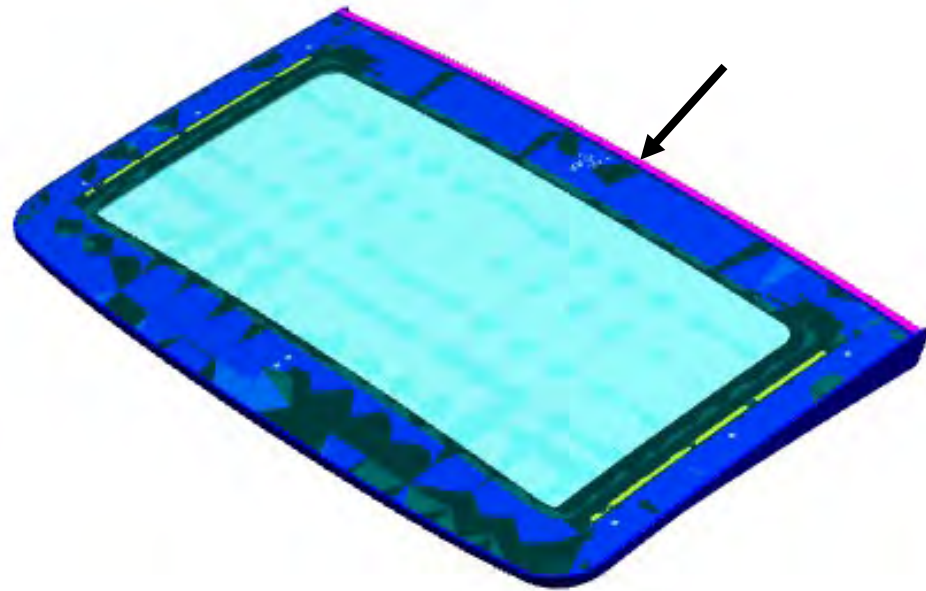
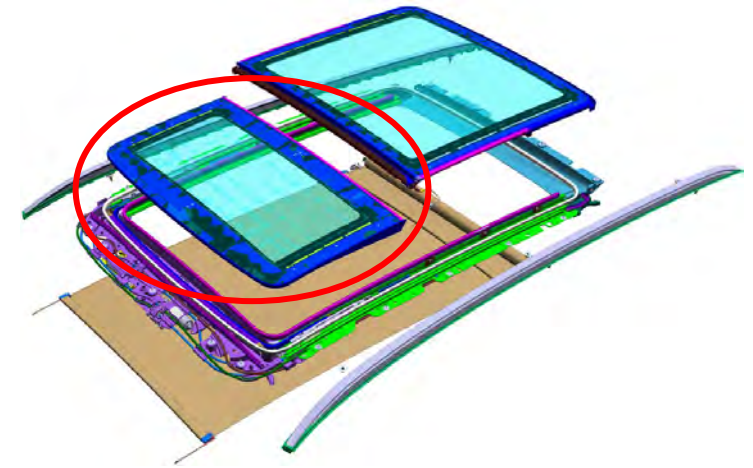
FRONT CENTER SEAL LOOSE/SHRINKING

Defect: separated

Defect: shrunken / gap

Situation: Wind noise heard at speeds of 30 Mph. A gap can be seen near the end of the seal on front glass.

Repair: Replace seal according to ISTA/AIR instructions REP 54 13 052. Refer to B54 04 21.

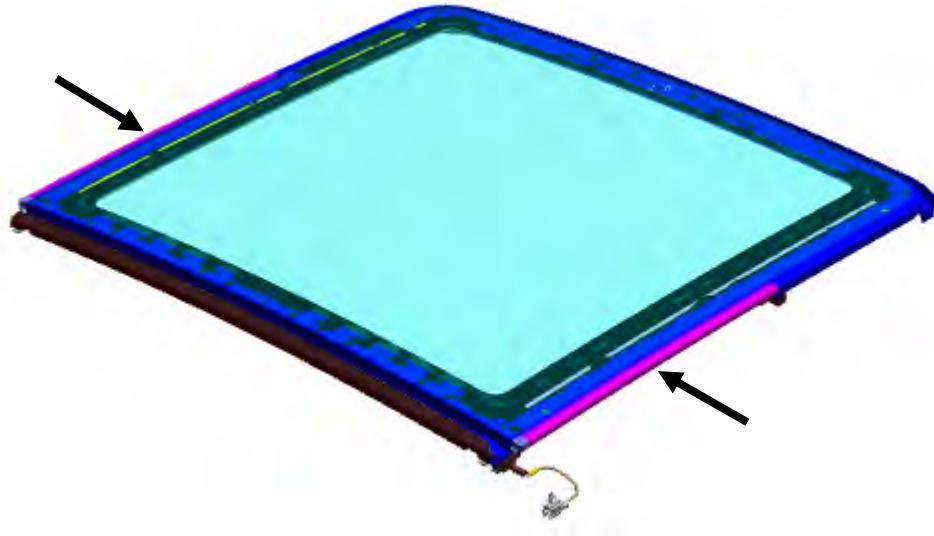
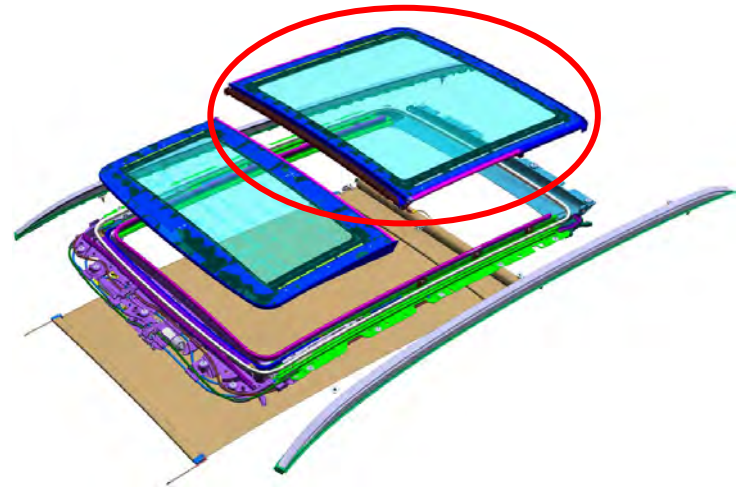
SIDE SEAL LOOSE/SHRINKING

Situation: Wind noise heard at speeds of 30mph.

example: gap

example: twist

example: loose

Repair: Look for gap near ends or twist in seal. If found, replace seal according to ISTA/AIR instructions.
REP 54 13 050

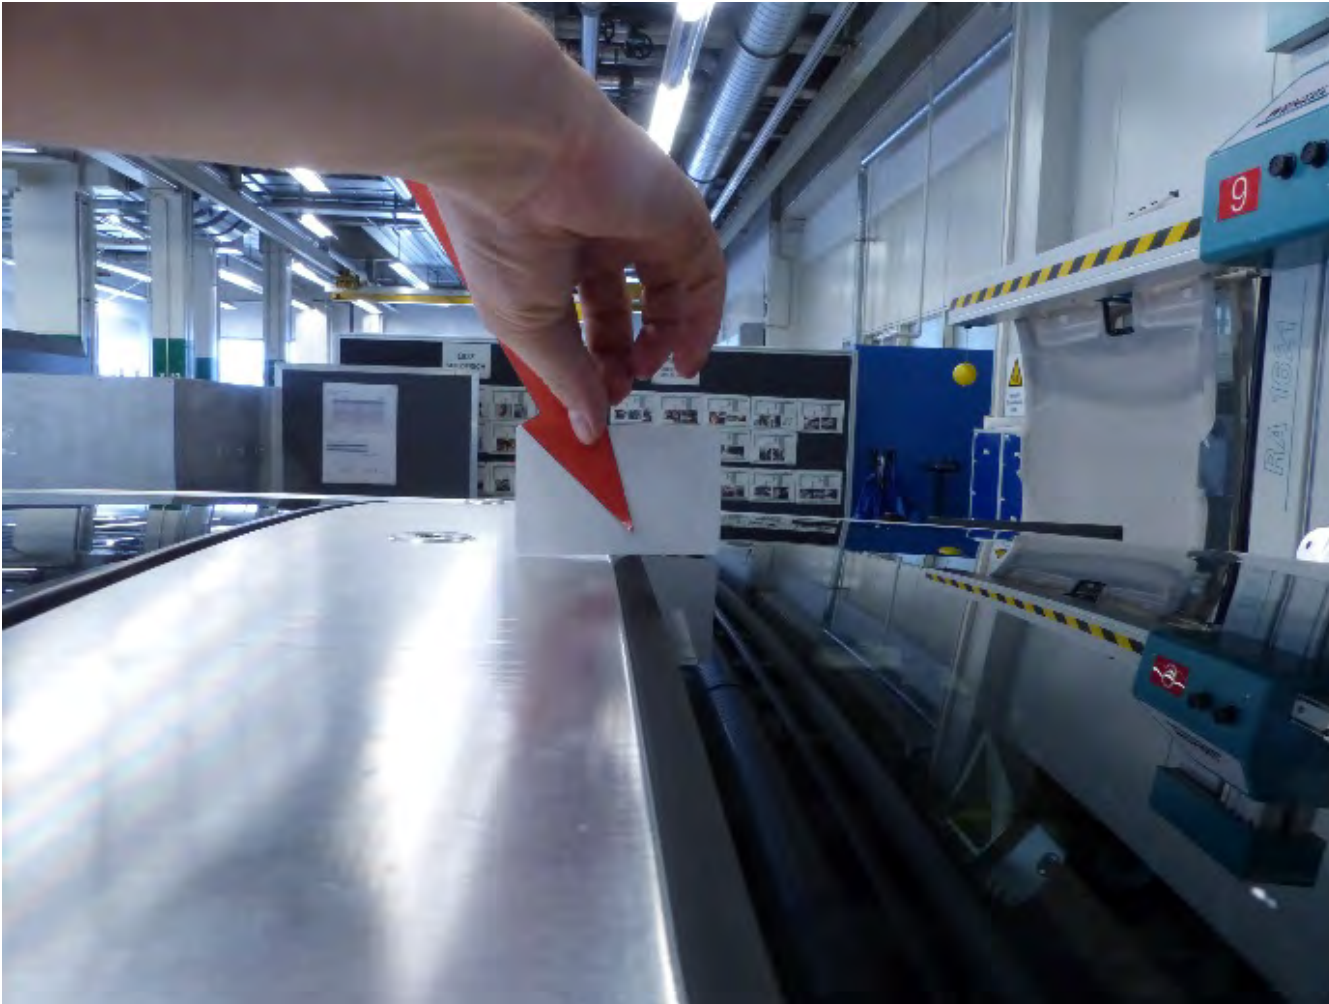
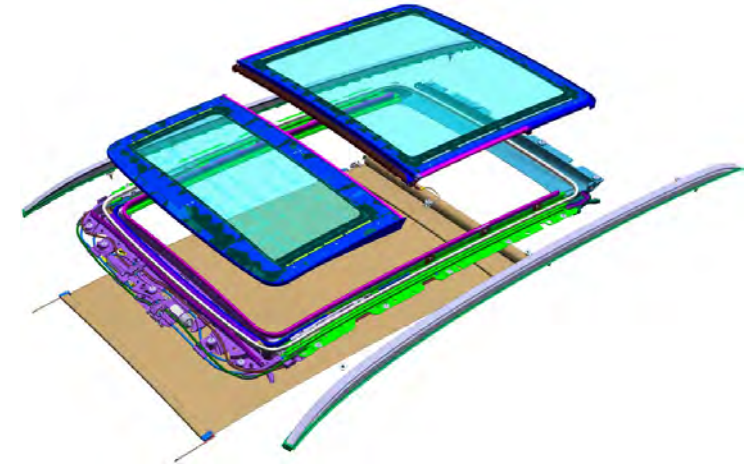
GLASS NOT FLUSH

Situation: Rushing wind noise is heard from center of the glass.

Repair: Tape can be used to isolate noise and find where glass is not flush.

Adjust both sunroof glass panels according to ISTA/AIR instructions REP 54 13 002.

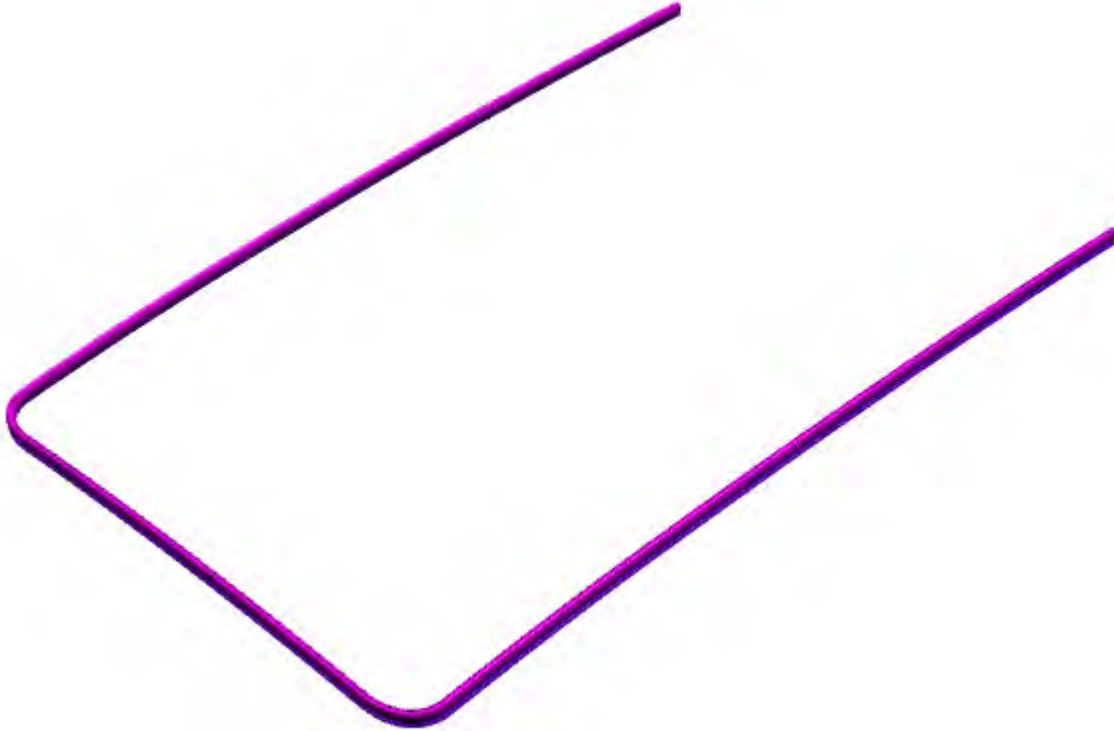
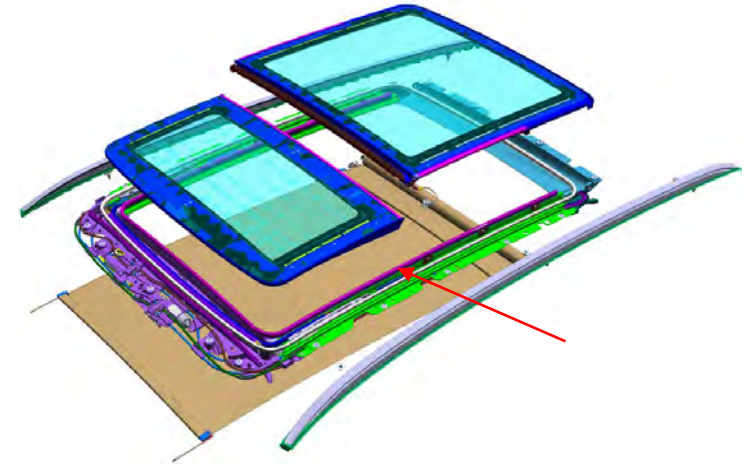
ACOUSTIC SEAL LOOSE

Situation: Rattle or groaning noise heard while driving over rough road surfaces. Upwards pressure on the glass will stop the noise. The cause is interference between the sunroof glass and acoustic seal mounted to the sunroof frame (not the roof perimeter seal).

Repair: Slightly lower glass (within specification) to increase pressure between the glass and the seal.

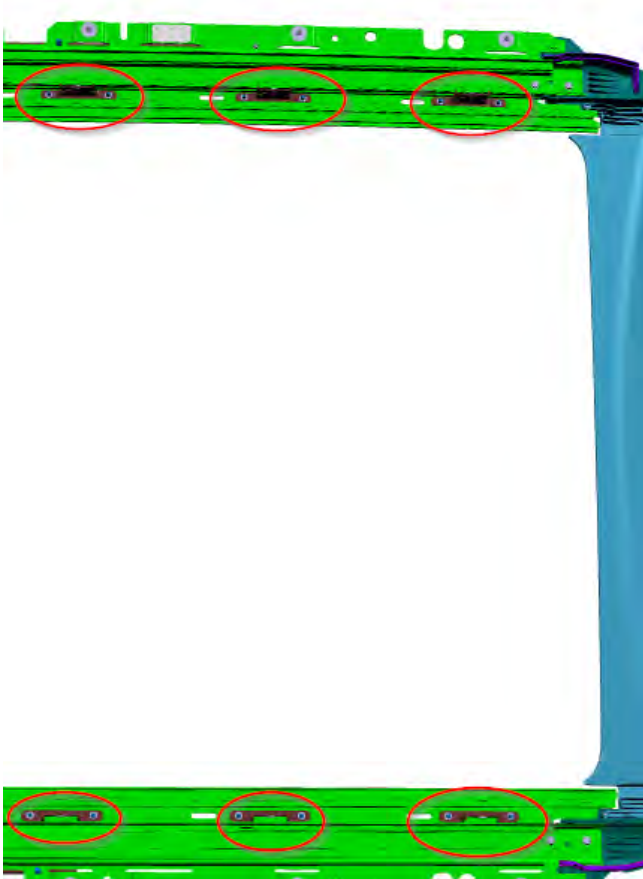
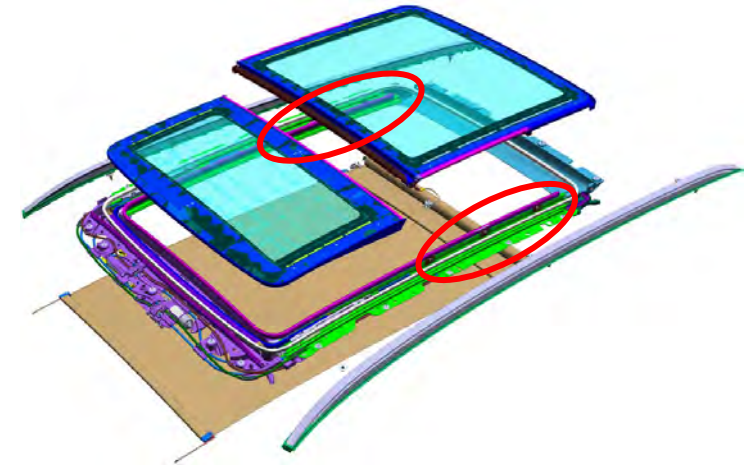
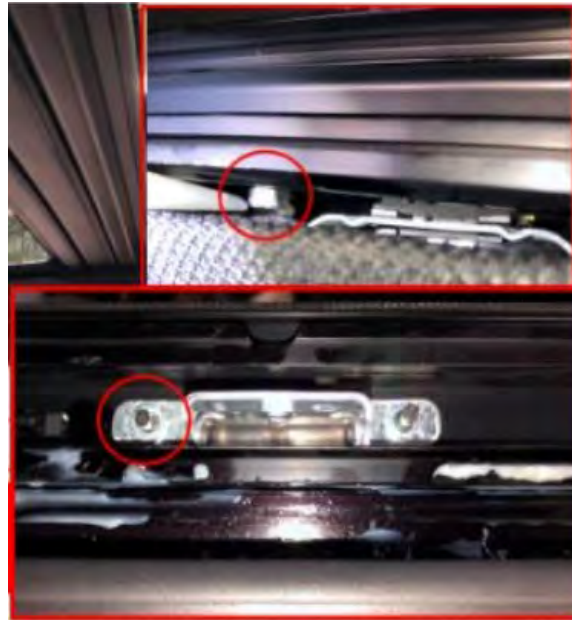
REAR GLASS BRACKET LOOSE

Situation: Metallic noise heard while driving over rough road surfaces.

Repair: Inspect bracket screws (**Bracket to frame**, not glass to bracket). Check for any cross threaded screws. If cross threaded screws are found then replace screws. If screws can't be tightened correctly, the frame would need replacement.

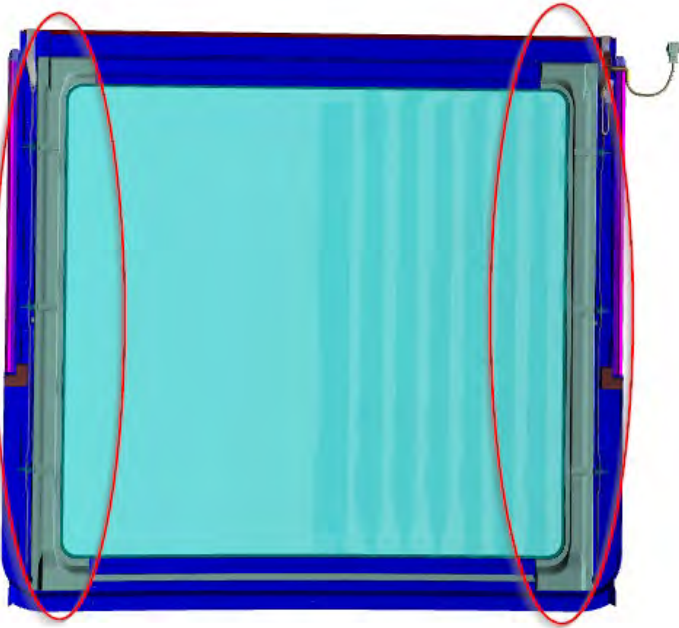
AMBIENT LIGHT COVERS LOOSE

Situation: Rattle is heard from plastic cover tapping on glass panel (front or rear glass) when driving on rough road surfaces.

This situation only affects vehicles with SA407 (Panoramic Sky Lounge LED Roof)

Repair: Attempt to insulate with felt tape is visually appropriate. Replace glass panel according to ISTA/AIR instructions REP 54 13 250 if insulation is not possible.
