PANORAMIC SUNROOF DIAGNOSIS

This Service Information Bulletin (Revision 4) replaces SI B54 11 19 **dated July 2021**.

SUNROOF DIAGNOSIS

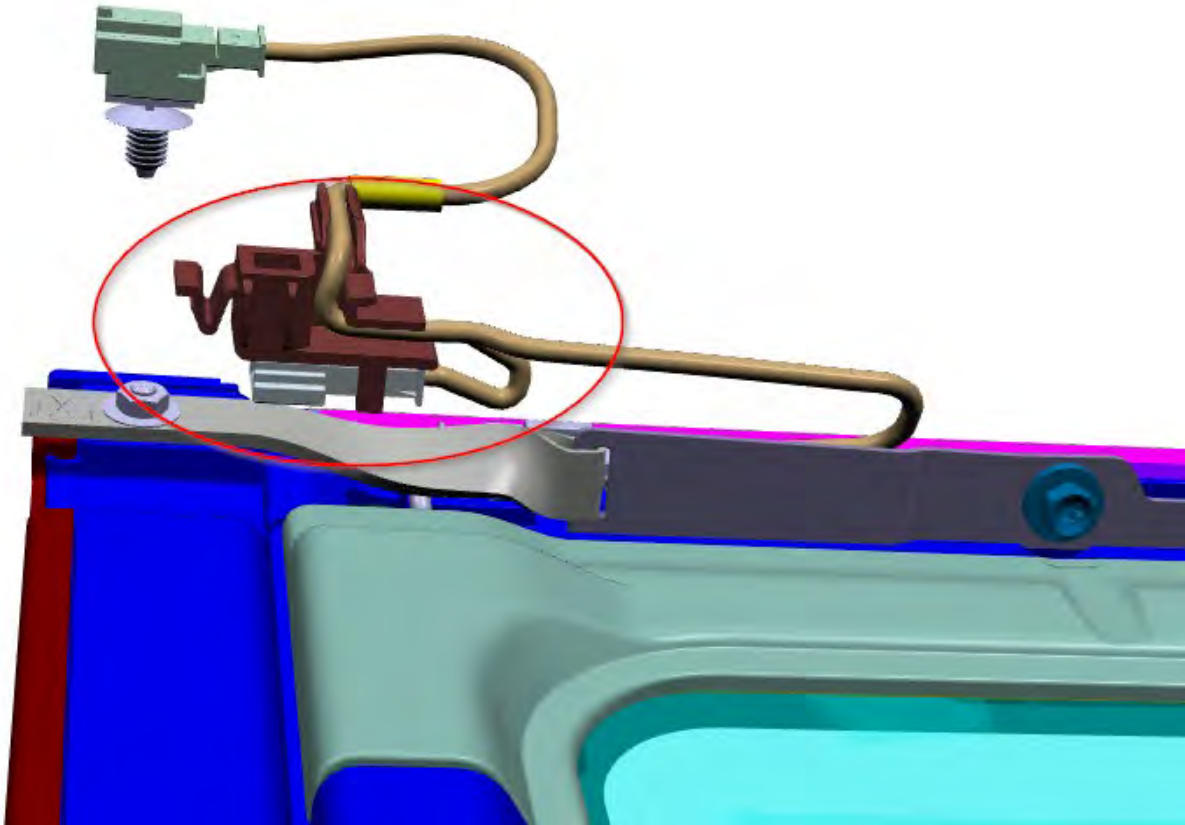
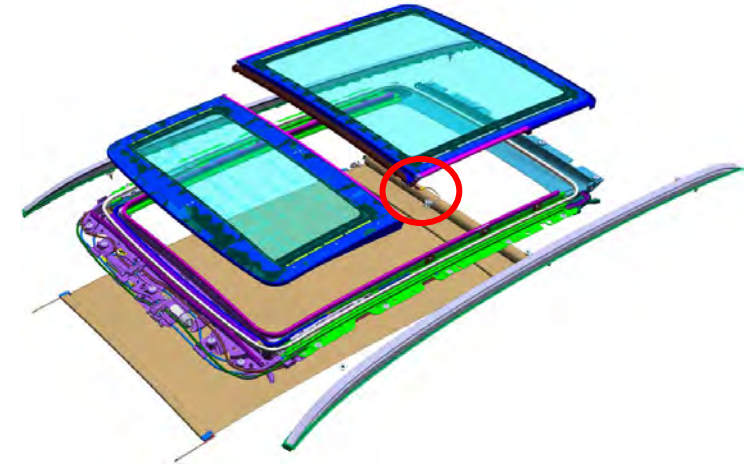
AMBIENT LIGHT CLIP LOOSE/NOT INSTALLED

Situation: A loose clip for the ambient light harness is tapping on the glass or contacting the sunroof mechanism. Only affects vehicle with SA407 (Panoramic Sky Lounge LED Roof).

Repair: Correctly install the harness clip.

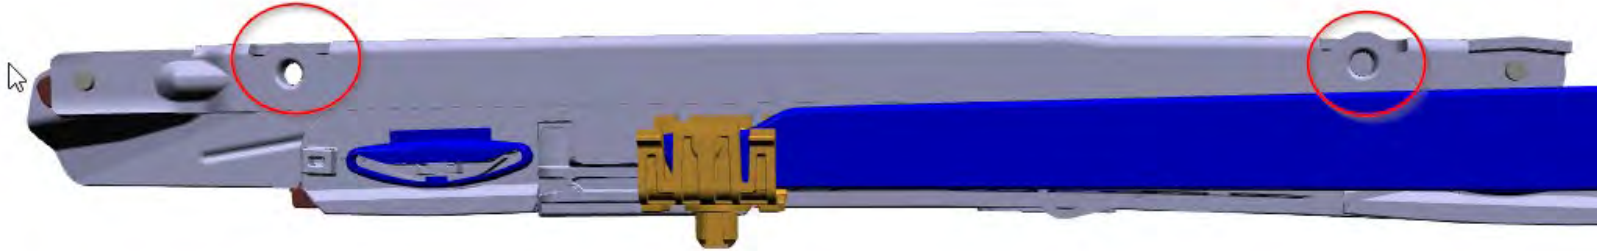
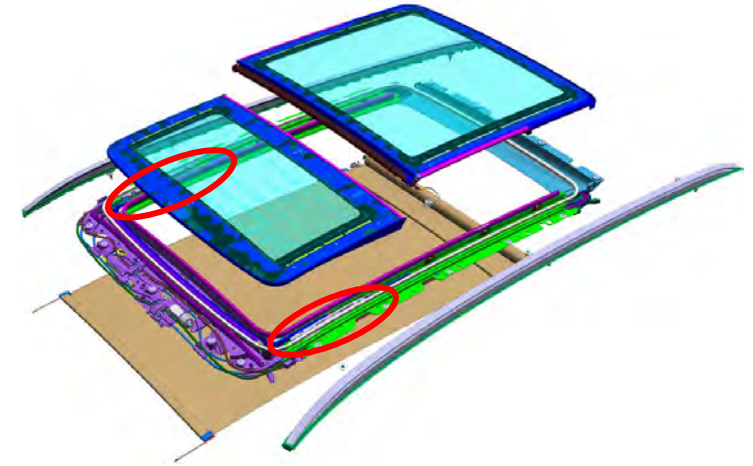
EXTRA SCREW

Situation: A metallic “rolling” noise is heard during acceleration/deceleration. An extra screw may have fallen into the track during production. The screw is not missing from any location.

Repair: Remove the extra screw. Additional repairs are not necessary, all other screws are correctly installed.

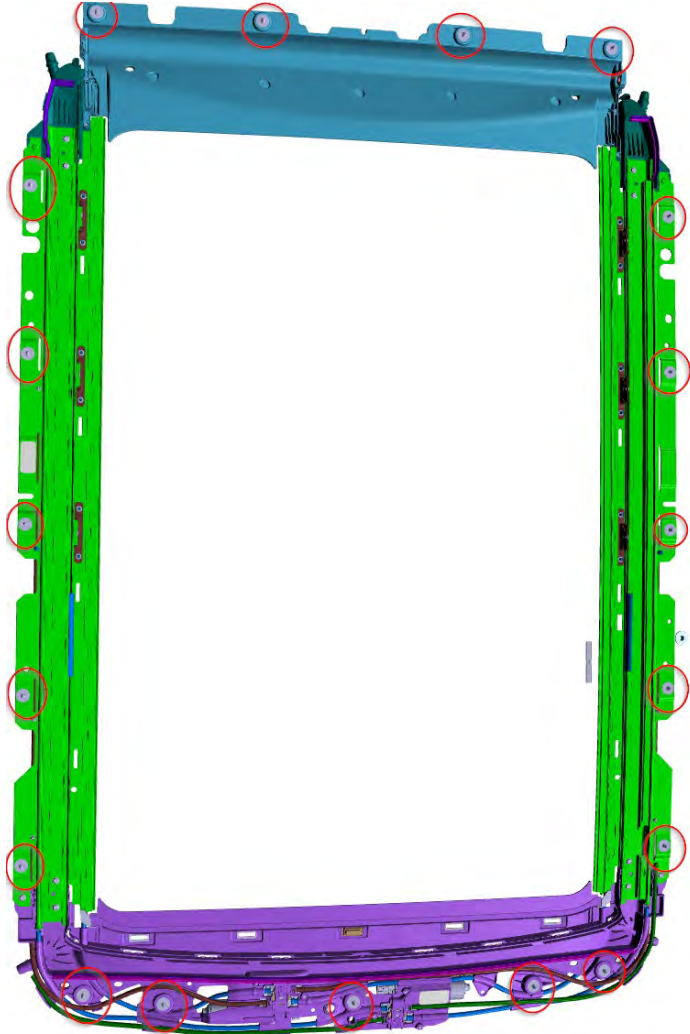
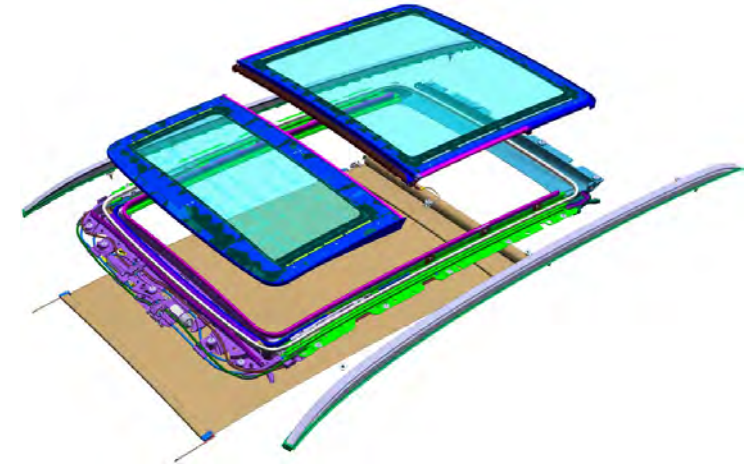
LOOSE SCREW

Situation: Rattling noise is heard from the roof area. One or more sunroof frame screws may be loose.

Note: 1 under torqued screw is unlikely to cause a noise. Fully investigate to ensure loose screws are the only cause. Attempt to measure torque if not correct and provide feedback via INFO case.

Repair: Inspect screws for signs of cross-threading. Replace screws if damaged. Retorque frame screws correctly according to ISTA/AIR repair instructions to 5.4nm. Retorque glass panel screws to 4.5nm.

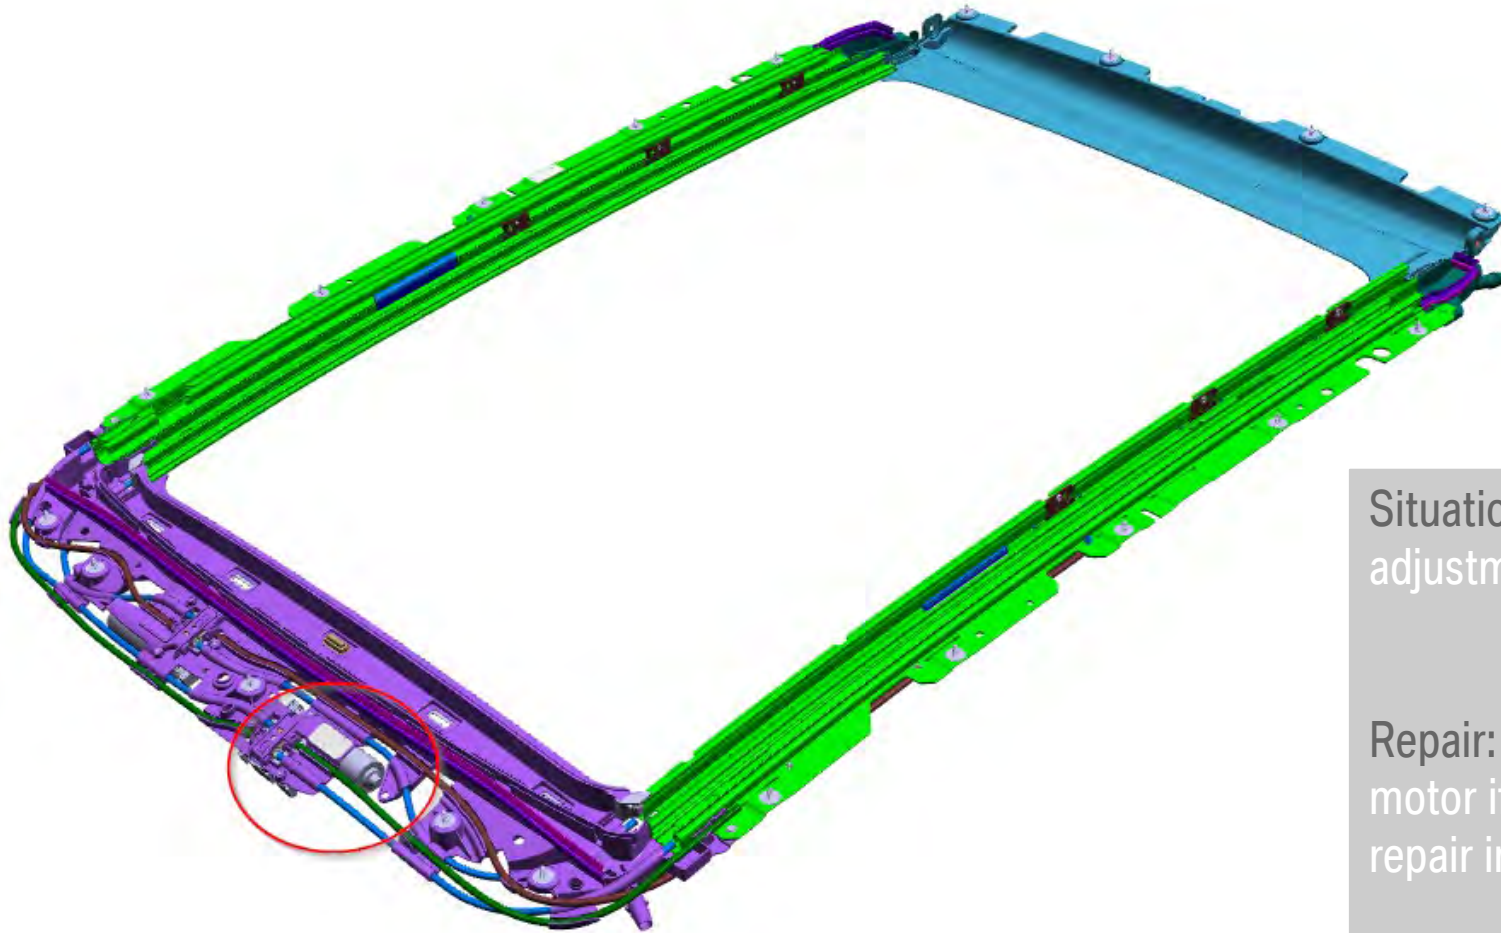
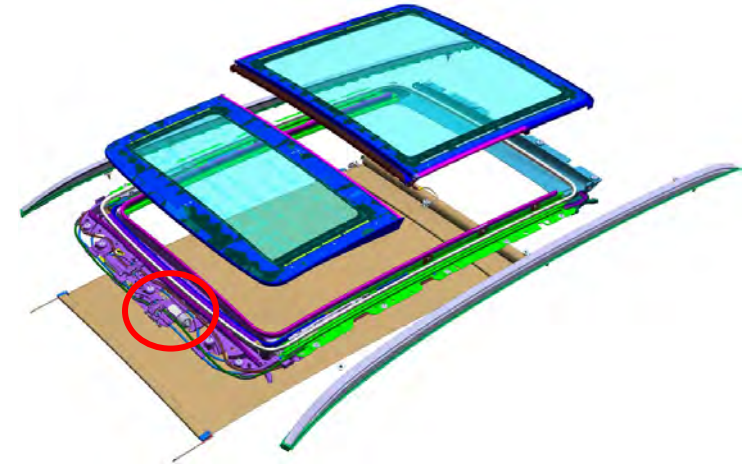
MOTOR NOISE

Situation: An oscillation noise is present from the adjustment motor when the shade or glass is moving.

Repair: Swap/replace the motor and retest. Replace the motor if found to be the cause according to ISTA/AIR repair instruction REP 67 61 580.

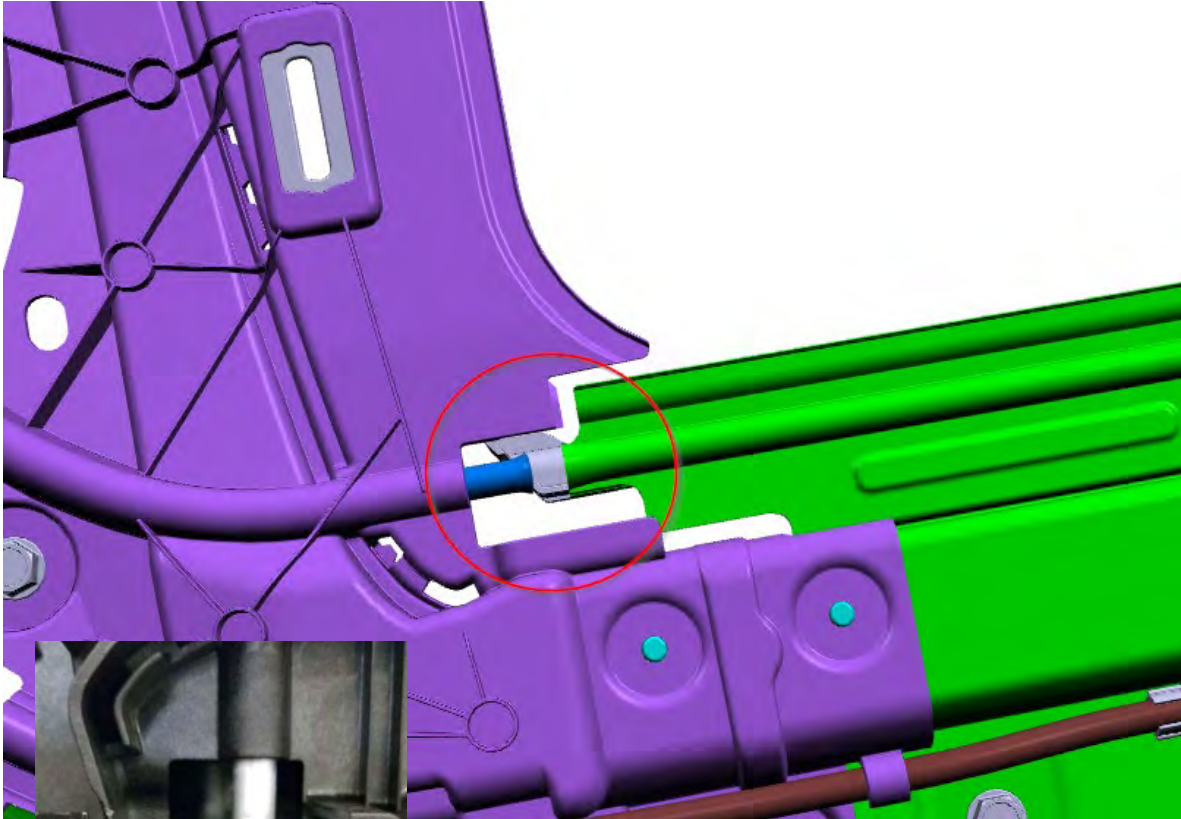
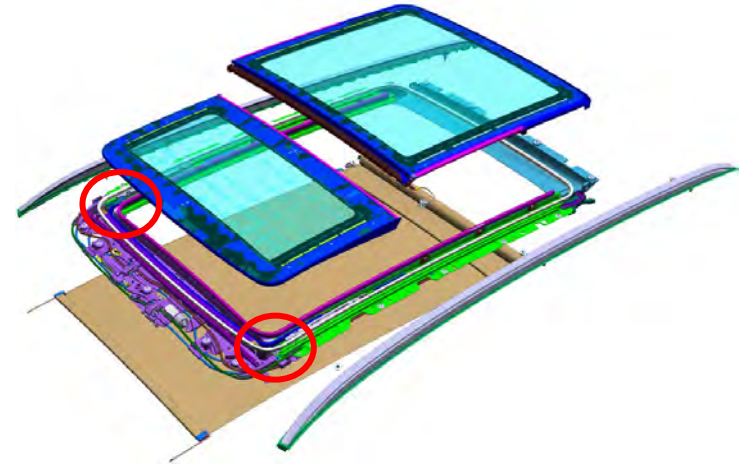
CABLE RATCHETING

Defect: misaligned or burr

Situation: A quiet oscillating/chattering noise is present when moving only the sunshade.

Repair: Inspect the sunroof frame for misalignment or a burr on the cable guide as shown. If damage is found, replace the frame according to ISTA/AIR instructions REP 54 13 261.

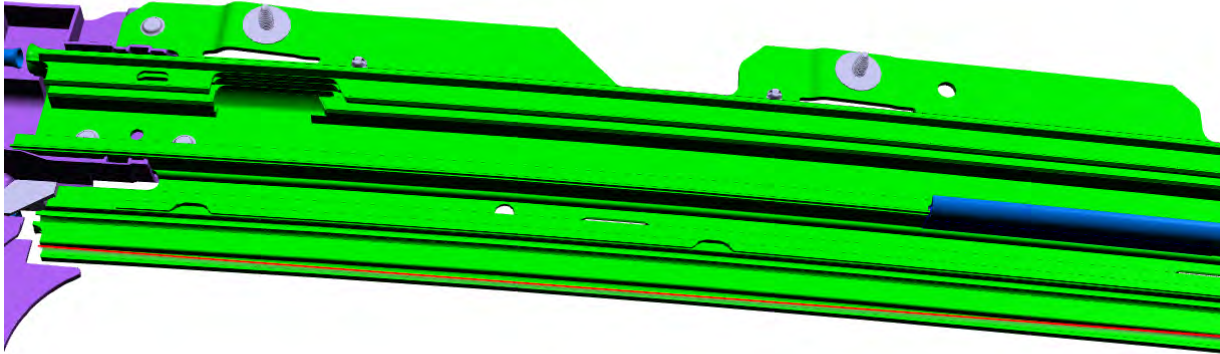
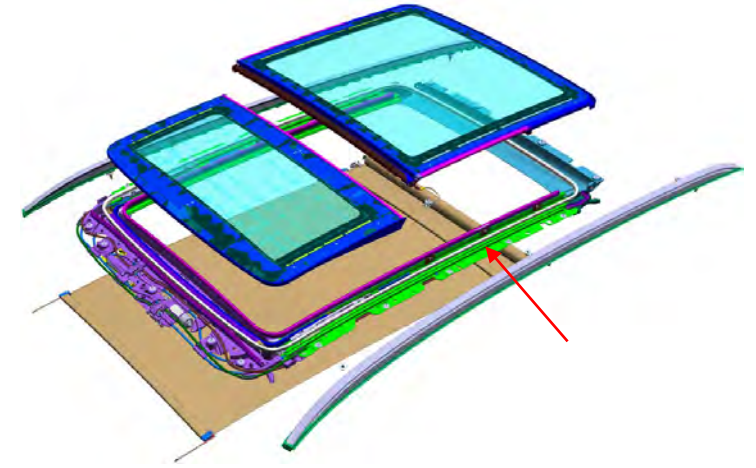
GUIDE RAIL NOT ENOUGH LUBRICATION

Situation: A squealing or chattering noise is heard when moving the sunshade. Typically on Alcantara (suede) equipped vehicles.

Repair: Clean and lubricate the sunroof guides. If noise persists then replace sunshade according to ISTA/AIR instructions REP 54 13 548.

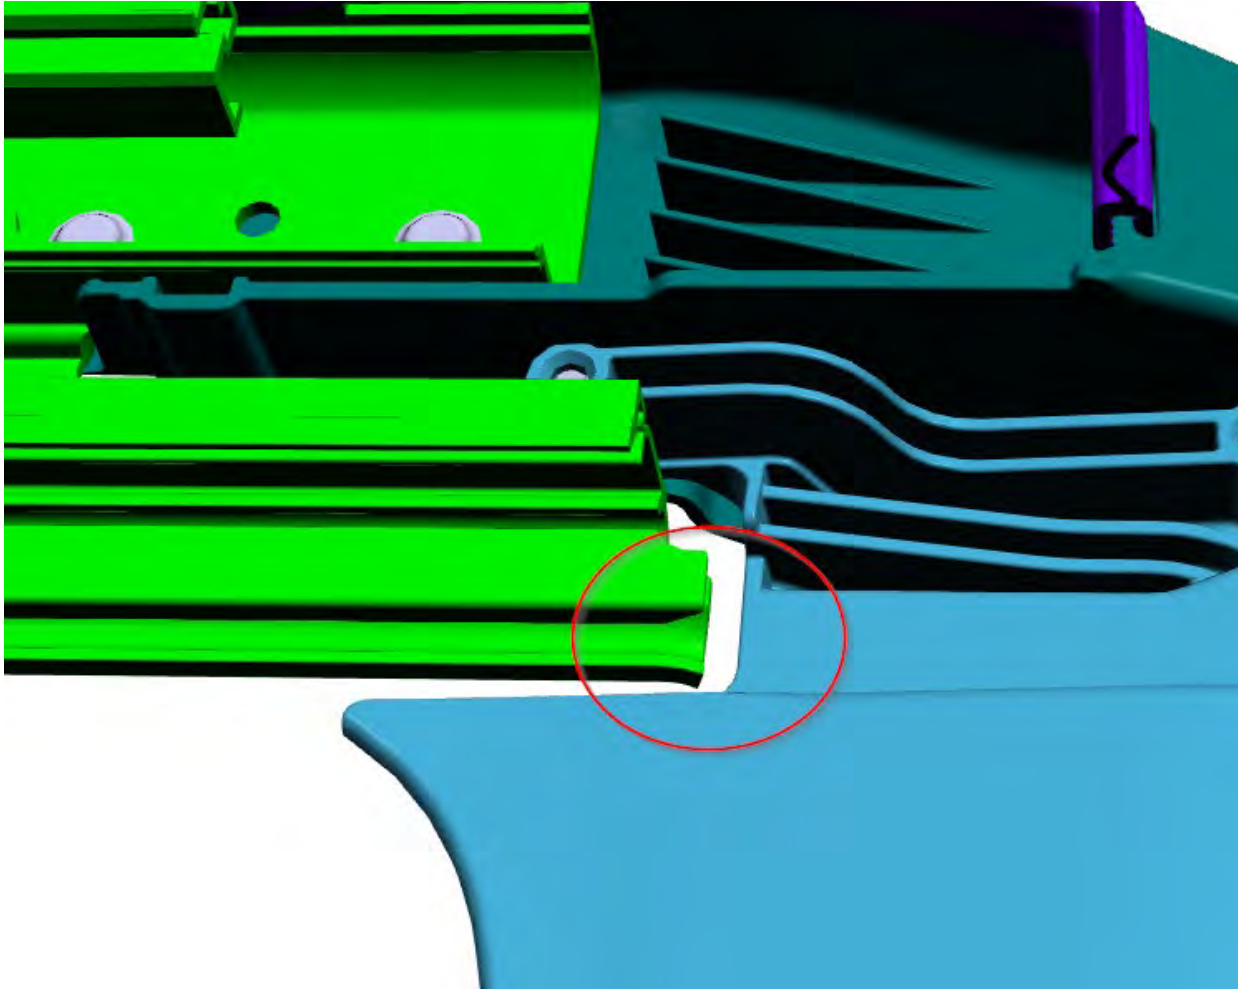
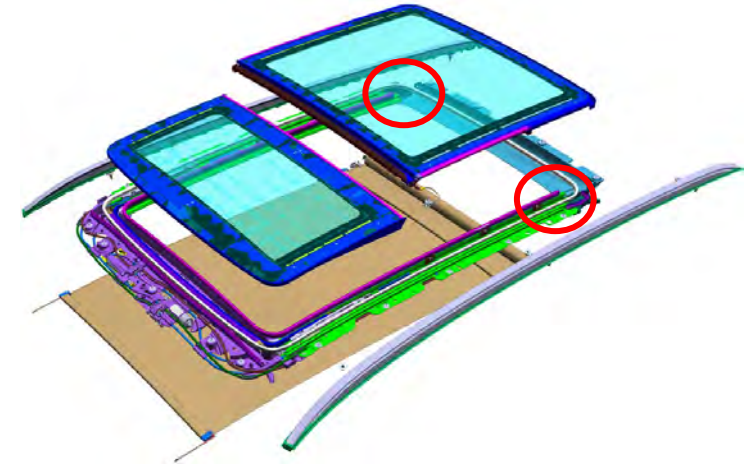
PDF RAIL BURR

Situation: A scratching/catching noise is heard while shade is moving.

Repair: Replace frame according to ISTA/AIR instructions REP 54 13 261.

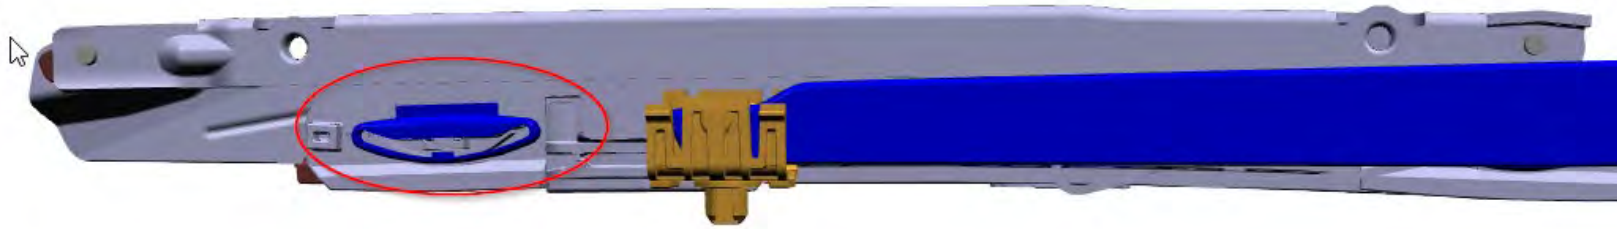
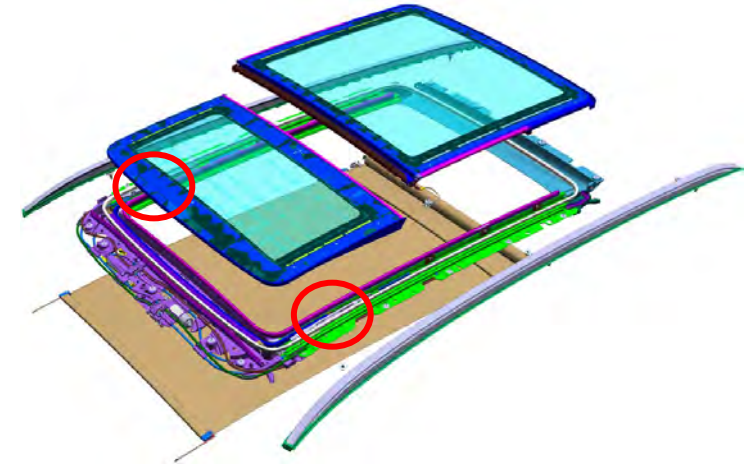
GUIDE SHOE NOT INSTALLED CORRECTLY

Situation: A rubbing/tapping noise heard when glass is moved.

Repair: Replace mechanism according to ISTA/AIR instructions REP 54 13 515.

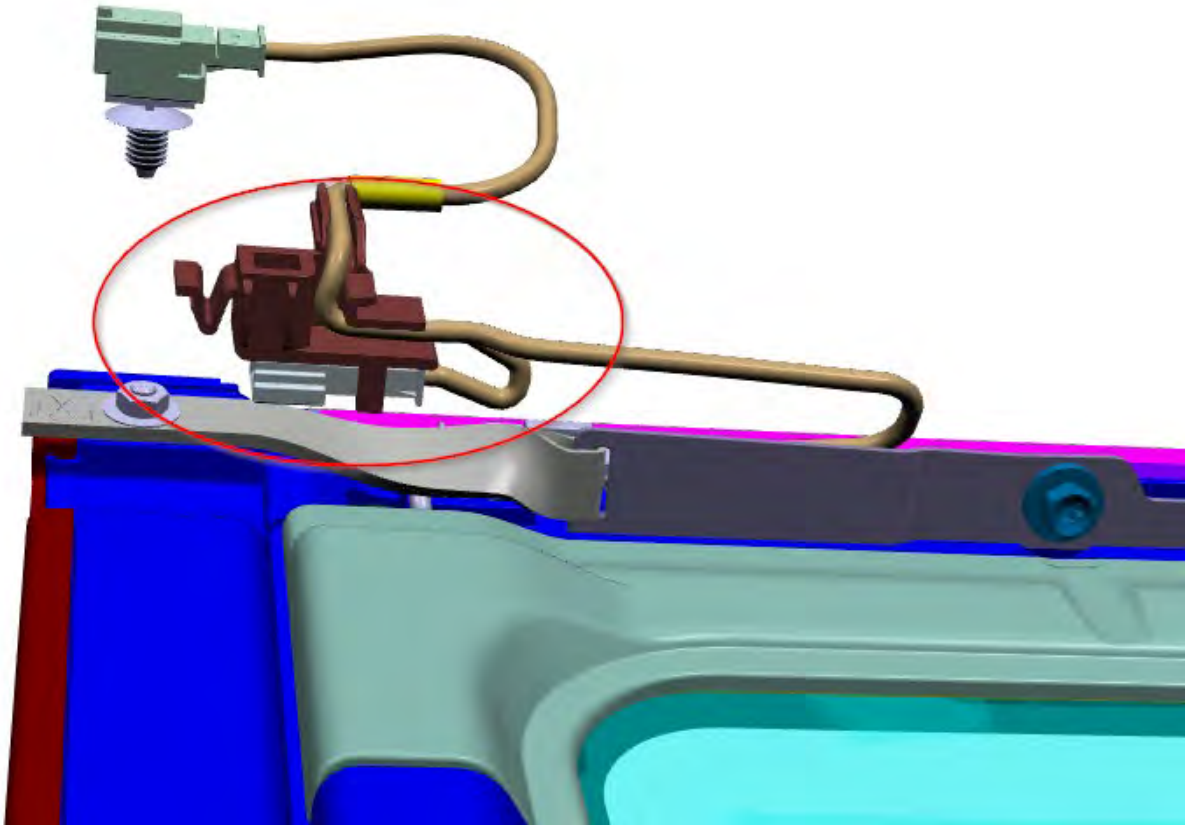
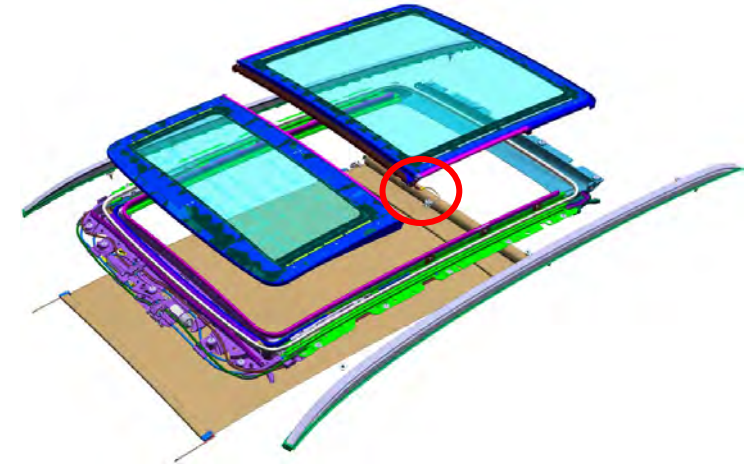
AMBIENT LIGHT CLIP LOOSE/NOT INSTALLED

Situation: A loose clip for the ambient light harness is tapping on the glass or contacting the sunroof mechanism. Only affects vehicle with SA407 (Panoramic Sky Lounge LED Roof).

Repair: Correctly install the harness clip.

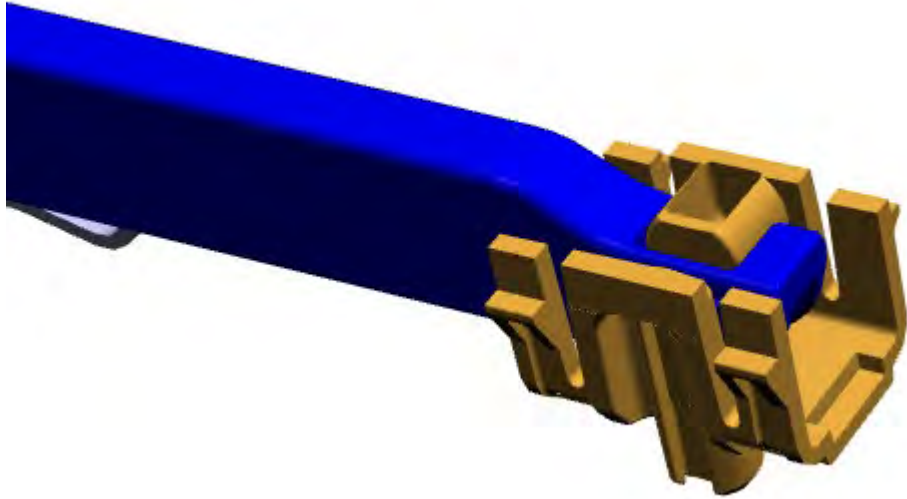
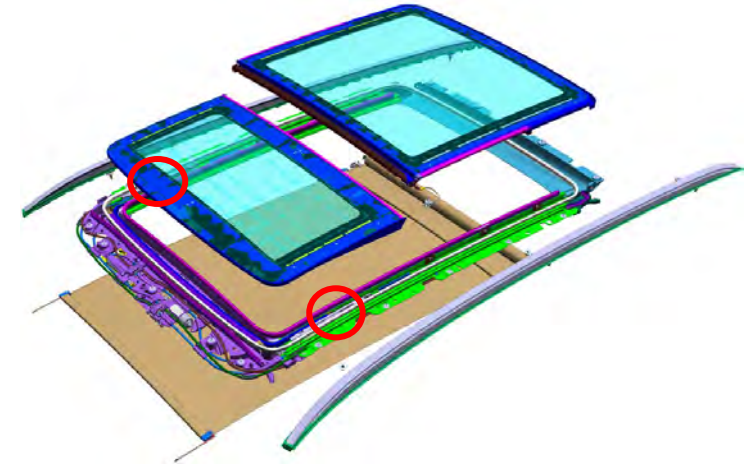
WIND DEFLECTOR PIVOT POINT LOOSE/BROKEN

Situation: A creaking noise is present while the wind deflector raises/lowers. Sunroof may reverse due to anti-trap when closing.

Repair: Replace pivot point and wind deflector according to ISTA/AIR instructions REP 54 13 090

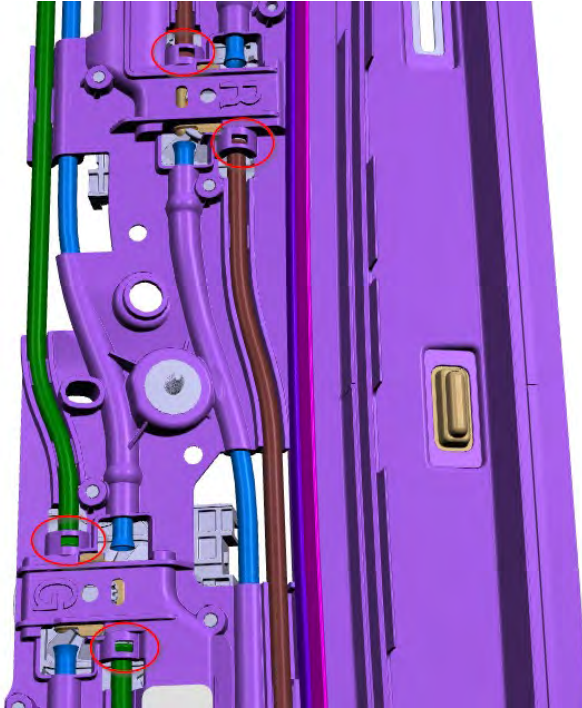
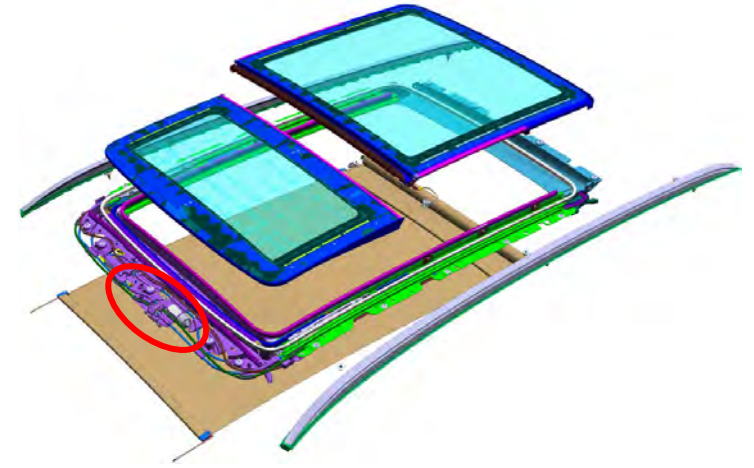
RELIEF CABLE TUBE NOT INSTALLED

Situation: A humming / crackling noise is present when opening the glass or sunshade.

Repair: Replace frame according to ISTA/AIR instructions REP 54 13 261.

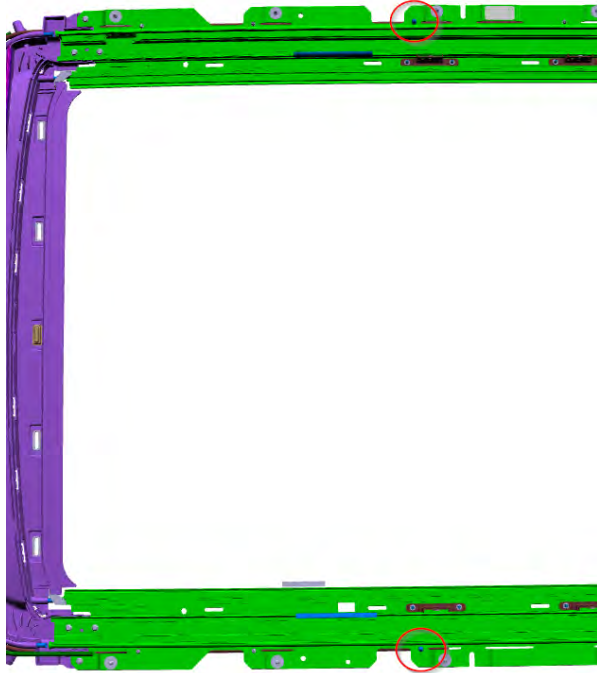
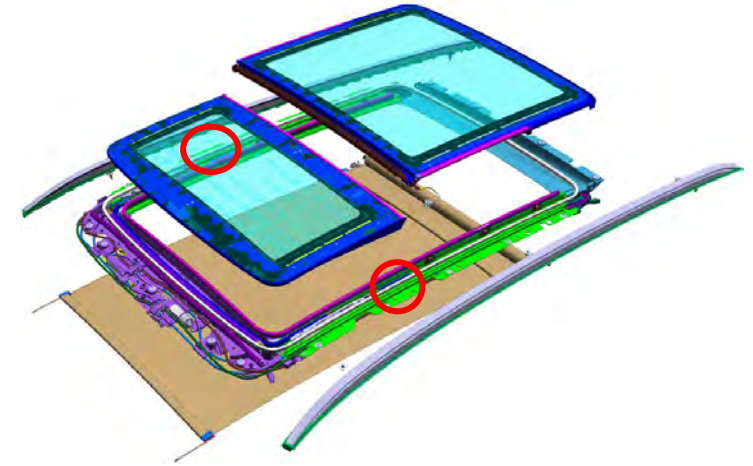
CABLE TUBE CLIP NOT INSTALLED

Situation: A humming / crackling noise is present when opening the sunshade. Or, a plastic rattling noise is heard while driving on rough road surfaces.

Repair: Reinstall the guide tube clip into the frame. If tube is damaged and noise persists then replace the frame according to ISTA/AIR instructions REP 54 13 261.

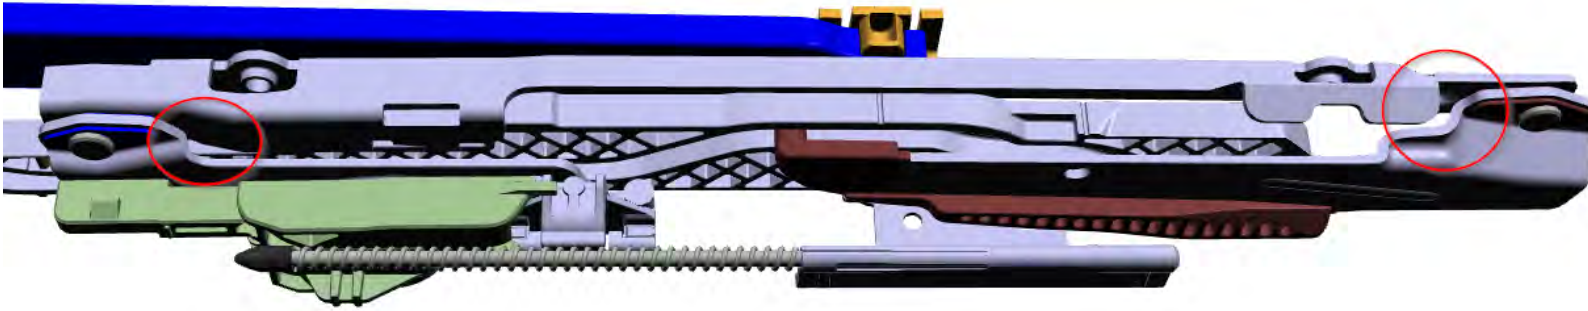
MECHANIC ARM BURR

Situation: A clicking sound is present when the glass is opened to vent.

Repair: Inspect the pivot area for a burr and remove it if found. If burr is not found then replace the sunroof mechanisms according to ISTA/AIR instructions REP 54 13 515.
