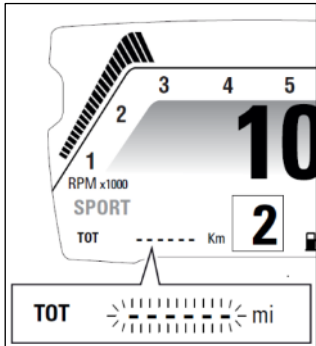
| no. | Symptom | Subject | Photo | Trouble Code<br>(Diagnostic Trouble Code) | Part<br>no. | Notes/indications | Corrective<br>action |
|---|---|---|---|---|---|---|---|
| 1 | Possible display of dashes instead of the odometer value | Instrument panel | | There is no error in the control unit | - | Mismatch between the odometer value displayed on instrument panel and the one stored in the BBS.<br><br>It is necessary to use the DDS to update the instrument panel software to version 11.<br><br>To eliminate the odometer value mismatch, it is necessary to fill in a Youtech Request asking for the DDS password. | |

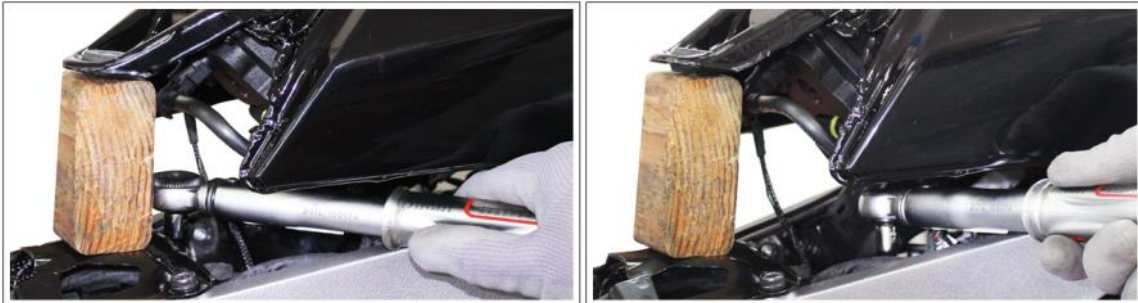
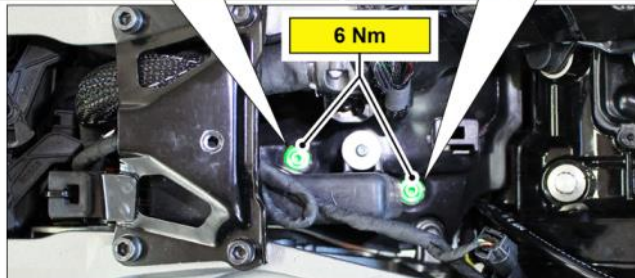
| no. | Symptom | Subject | Photo | Trouble Code<br>(Diagnostic Trouble Code) | Part<br>no. | Notes/indications | Corrective<br>action |
|---|---|---|---|---|---|---|---|
| 2 | Possible vibration of the vertical cylinder exhaust manifold cover | Vertical cylinder exhaust manifold cover part no. 46110401A | <br> | Vibration due to loosening of one of the two retaining screws; check the tightening of the two screws. DMH has added a check based on the VIN ZDMGA00AAGB001001.<br><br>As a precaution, you can check the tightening of these two screws during the pre-delivery operations. Remove the rider seat and fuel tank rear retaining screw; lift up the fuel tank from the rear side by 9 cm while keeping it in position with a block. Use a 4-mm Allen wrench to tighten the two screws to 6 Nm. | | <br> | |

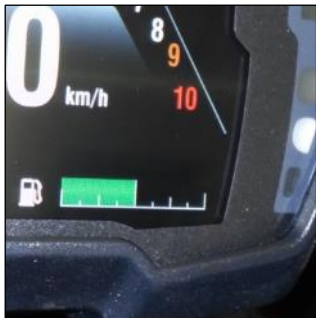
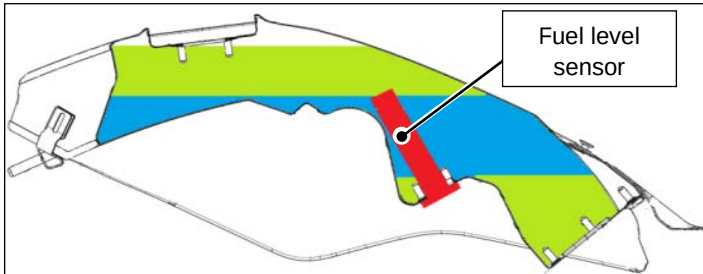
| no. | Symptom | Subject | Photo | Trouble Code<br>(Diagnostic Trouble Code) | Part<br>no. | Notes/indications | Corrective<br>action |
|---|---|---|---|---|---|---|---|
| 5 | <p><u>Only in case of motorcycle just delivered by DMH</u></p> <p>Upon first battery connection, some fuel level marks are displayed on the instrument panel even if the tank is empty</p> | Display of fuel level | | There is no error in the control unit | | <p>This possible mismatch is due to the fuel level management strategy <u>when the fuel is drawn from the tank</u> (at the end of the production line or during a Service operation).</p> <p>The fuel level sensor detects the level in the central part of the tank (blue area); in the upper and lower part of the tank (green areas) the fuel level is therefore calculated by the software.</p> <p>When fuel is drawn, the software could not recognise the level decrease and continue to display on the instrument panel a fuel quantity that is not actually inside the tank.</p> <p>To have a fuel level indication displayed on the instrument panel actually corresponding to the quantity of fuel inside the tank it is <u>necessary to fill in the tank with at least 5 litres of fuel</u> so that the fuel level sensor starts reading the correct level. Turn the motorcycle's key to ON and if the fuel level indication does not change, add some fuel in the tank; in fact, it could happen that the previously poured fuel quantity is not enough to allow a correct fuel level reading by the relevant sensor.</p> | |
