PIC6336A Folding Top Service Tips to Prevent A Broken Rear Glass Assembly

Brand:	Model:	Model Years:	VIN:		Engine:	Transmissions:
			from	to		
Chevrolet	Camaro	2016 - 2022	All	All	All	All

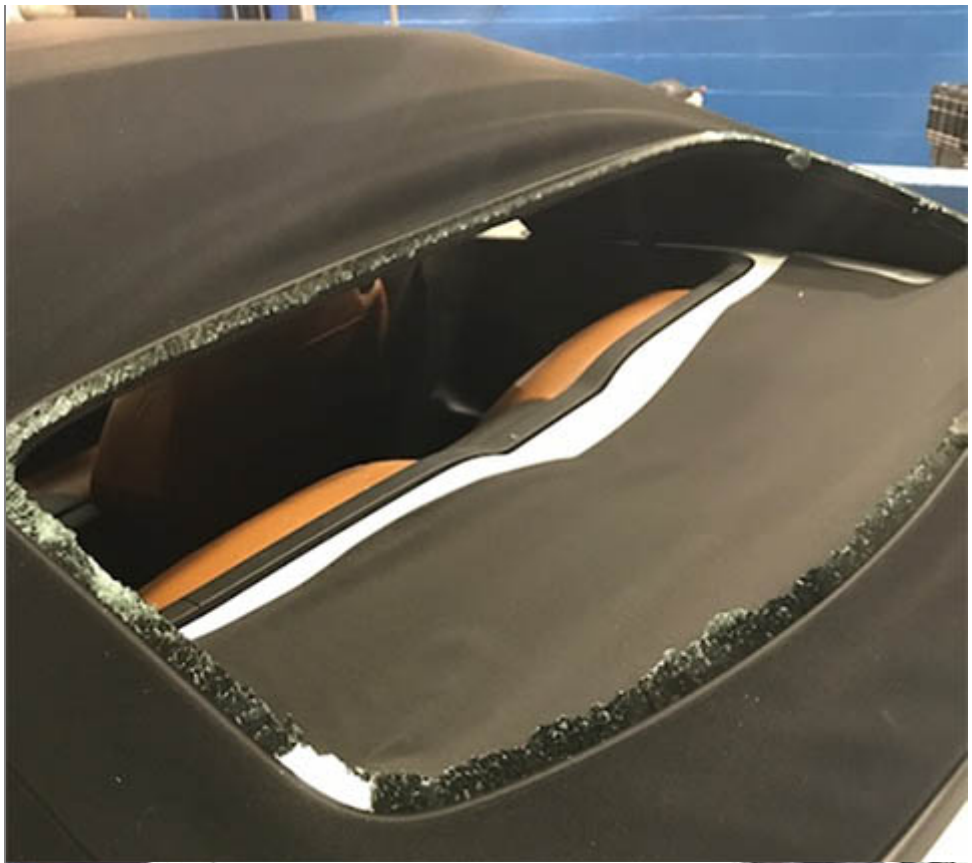
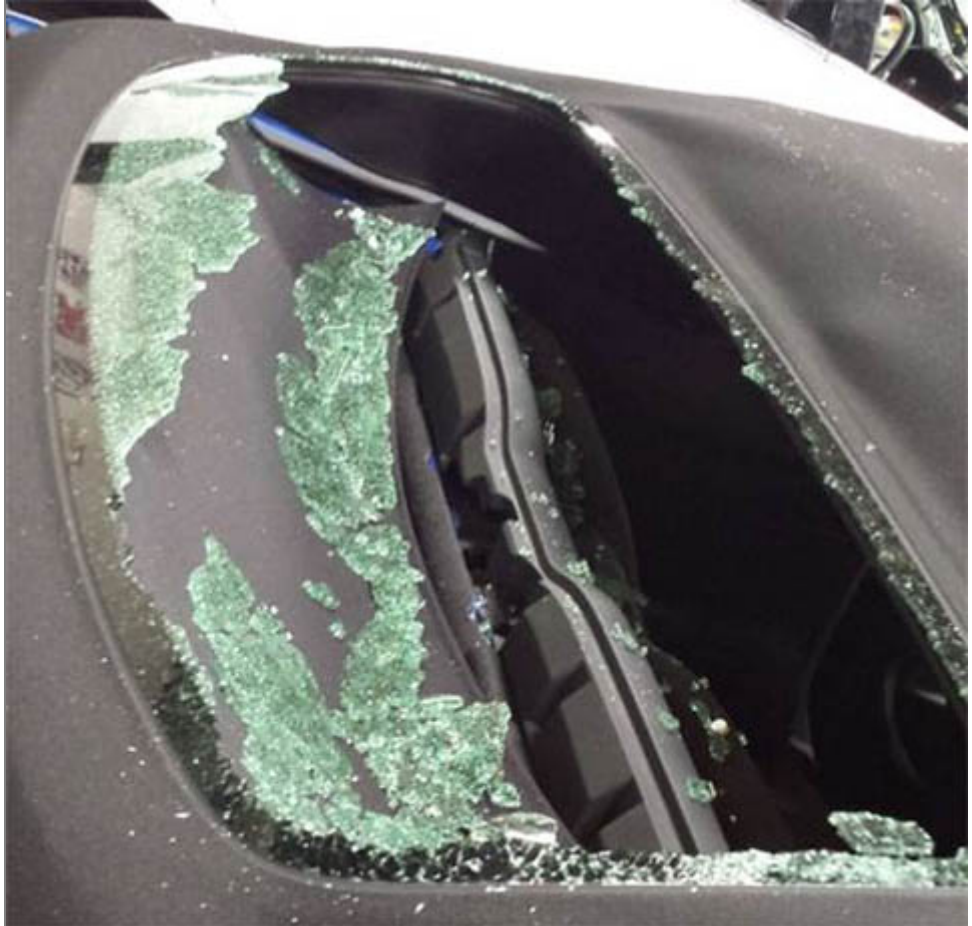
Involved Region or Country	All
Additional Options (RPO)	CM8 - Power Folding Top
Condition	Some technicians may comment that the back glass, which is an integral part of the folding top canvas, had broken after cycling the folding top assembly. This will be noticed very soon after a folding top canvas or a side rail has been replaced for service.

Cause	The cause of this concern may be due to improper reassembly of the folding top linkage where it connects to the back glass.
-------	---

If this concern is encountered, dealership technicians are to first inspect the linkage that connects the folding top frame to the back glass that is attached to the folding top canvas.

The most common issue seen is mistakenly putting the top linkage on the inboard side of the back glass attachment point.

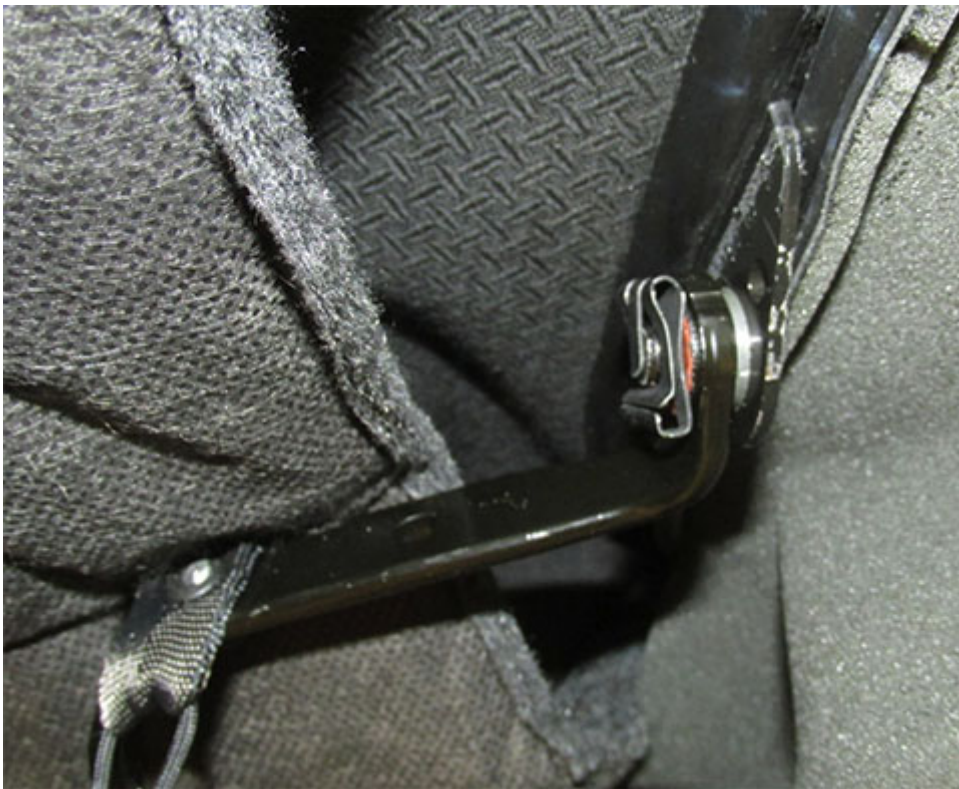
See photo below of a correctly assembled folding top linkage at the rear glass attachment point.

The folding top linkage that attaches to the rear glass **MUST** be located on the outboard side of the back glass bracket.

The pin that holds it together is inserted from the inboard side of the linkage.

It first goes through the back glass bracket, after that it goes through the top frame linkage.

A gray plastic washer **MAY** be found in this assembly. Servicing technicians are to note if this is present during disassembly.

Finally, the spring clip is installed on the outboard side of the top frame linkage.
