# Preliminary Information

**PIT5801B Diagnostic Tip / Vehicle Sits Unlevel / Leans / Sags / Leveling Unavailable Message / Speed Limited Message / Service Air Suspension Message / DTC C1190 C1191 C1192 C1193 C1187 C1188 C1189 C118A C118B C118C C118E C118F**

Models

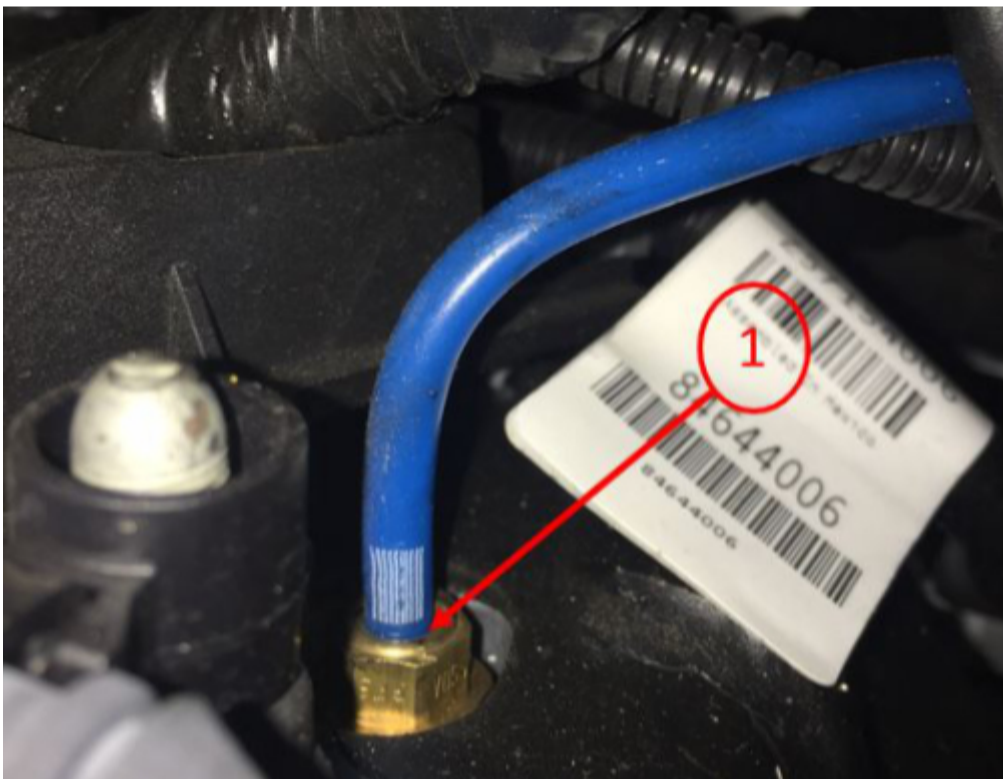
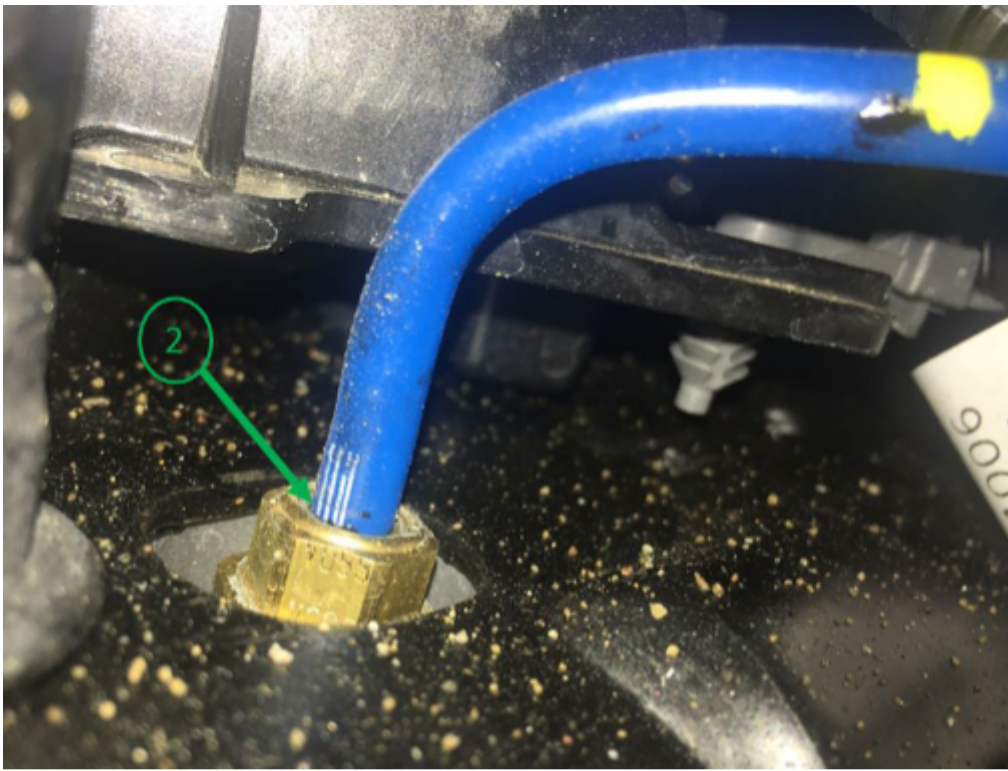
Involved Region or Country	North America
Additional Options (RPO)	F47 - Air Ride Suspension
Condition	<p>Some customers may notice one or more of the following conditions related with the air ride suspension.</p> <ul style="list-style-type: none"> <li>- Vehicle suspension trim height is too high or too low at one or more corners.</li> <li>- DIC Messages "Leveling Unavailable", "Service Air Suspension" and/or "Speed Limited"</li> <li>- DTC's: C1190, C1191, C1192, C1193, C1187, C1188, C1189, C118A, C118B, C118C, C118E, C118F</li> </ul>
Cause	<p>The cause of these concerns could be one or more of the air lines not being fully seated into an air spring or air manifold block assembly. An air line that is not fully seated can cause the air spring to be either over inflated or under inflated.</p> <p>It can be easy to understand and explain why an air line that is not fully seated can cause an air spring to be under inflated, due to the air leaking out, but over inflated air springs will require some additional details. The air springs use a unique air line fitting that contains a one way check valve. This one way check valve was needed for manufacturing purposes to keep a small amount of air inside the air spring before it is installed on the vehicle. Once the air spring is installed in the vehicle and the air line is fully seated into the air spring fitting, the one way check valve is no longer needed and the air line holds the check valve open. If the air line is not fully seated into the fitting, it will not fully open the one way check valve. When this happens, air can be pushed past the one way check valve into the air spring, but air can not be released. This will cause the air spring to inflate but during a deflate it cannot release the air from inside the air spring.</p> <p>Because it is critical for the air lines to be fully seated into the air fittings, there are white marks on each air line to indicate when the air line is fully seated. The air line has to be inserted into the air fitting until it bottoms out AND the white marks are going into the top of the fitting. Below is a picture of an air line, at one of the air springs, which is NOT fully seated (1). This is indicated by the white markings not actually going into the fitting. The second photo below shows the air line after it was fully seated (2). You can see the white marks are now down into the top of the air line fitting (2) and the air line is bottomed out in the fitting.</p>

**NOTE:** It is recommended to push the line into the fitting as far as it will go. At least part of the white marking **MUST** be into the top of the fitting.

Typically, performing a very thorough inspection of each air line at the four shocks and manifold valve block will prove to be the most fruitful way at discovering the root cause within the system. Make sure the white marking on each air line is into the top of the fitting and that the air line is bottomed out in the fitting, as both shown and described above. If an air line is not fully seated, then push the air line into the fitting until it is fully seated and the white marking is into the top of the fitting. In most cases, there is no need to loosen the air line fitting to fully seat the air line.

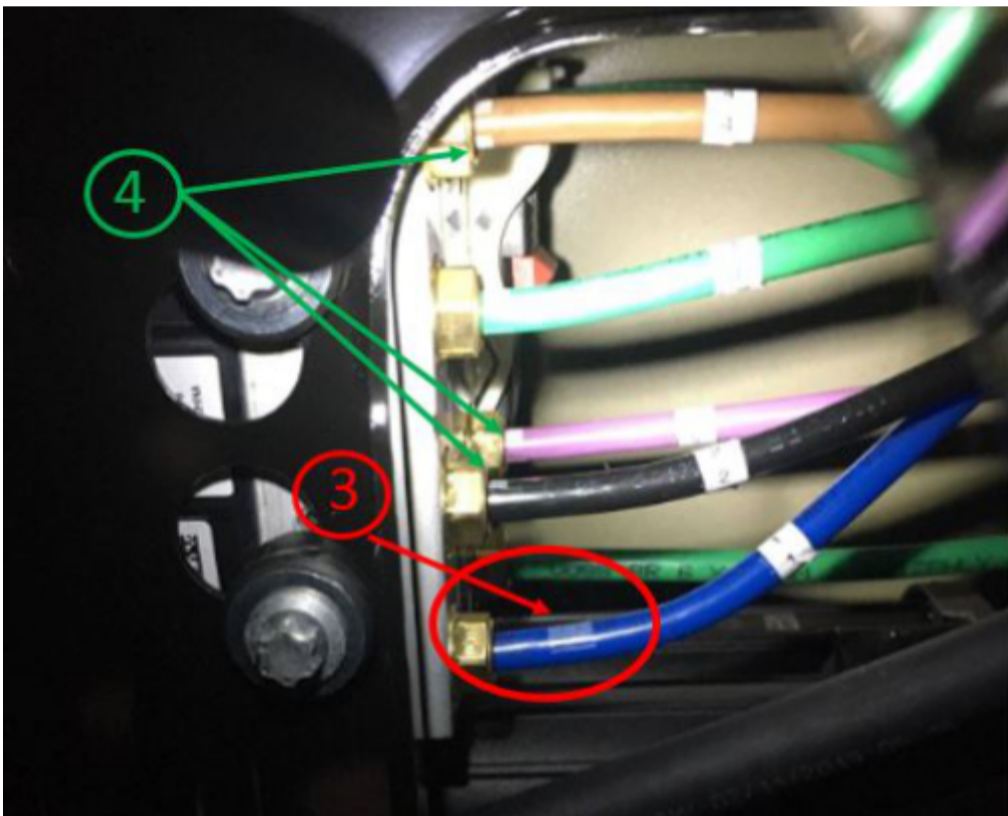
For additional examples see the third photo below. This is a picture of the air lines at the air manifold block. In this example, there are several fully seated lines as shown in call out 4. Each of these lines are fully seated as indicated by the white markings being into the top of the air line fitting. Call out 3 is an example of a line that is not fully seated. In call out 3 you can see the white marking is not into the air line fitting as it should be.
