Preliminary Information

PIT5866B Multiple Radio Inoperable Issues – IOK Radio

Models

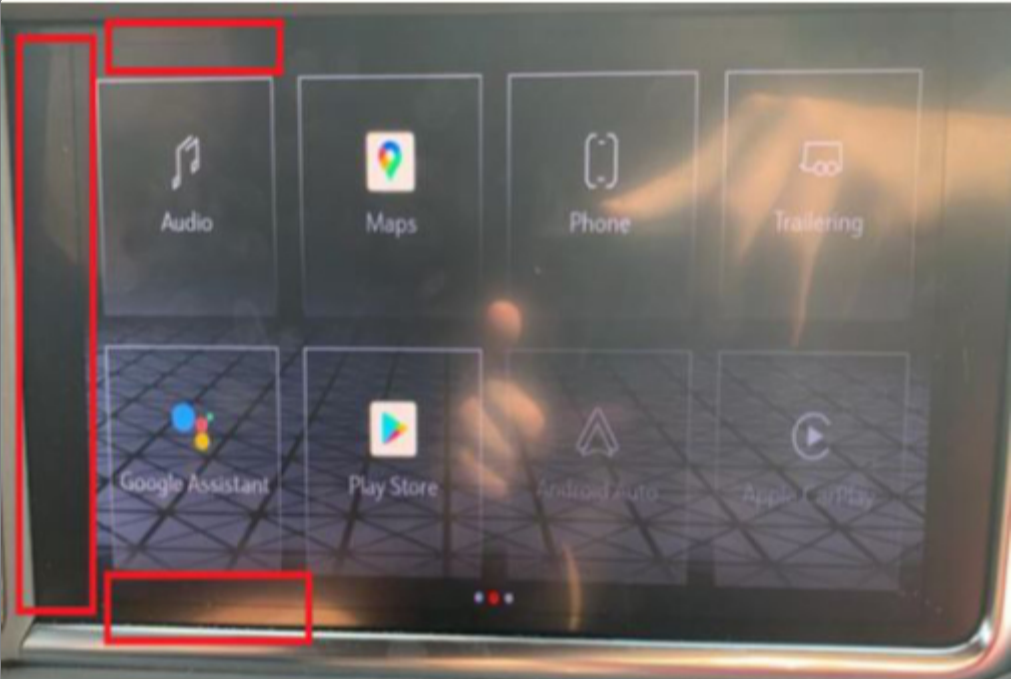
EX. Defect

1. **That the home screen bar is missing on the left side of the display.**

Cause	Condition is occurring in W160.4 software and reason is unknown at this time. Engineering is aware of the issue and is working on a fix.
--------------	---

While engineering is working on a permanent solution, dealers should not replace the radio. Dealers are to use link below to access the data wipe package, which will help to clear the data. Directions for the package are below:
