## Preliminary Information

### PIP5811 Crankshaft Balancer Contacting Timing Cover on Replacement Engine

Involved Region or Country	North America
Condition	Crankshaft Balancer Pulley Contacting Timing Cover After Installation on Replacement Engine Part Numbers 19368174 and 19368176
Cause	Incorrect Crankshaft Timing Gear Installed

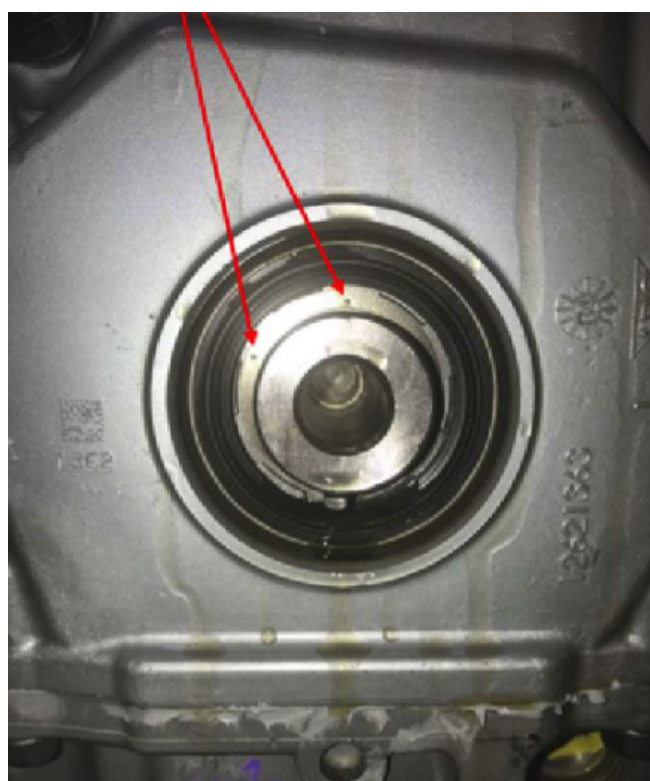
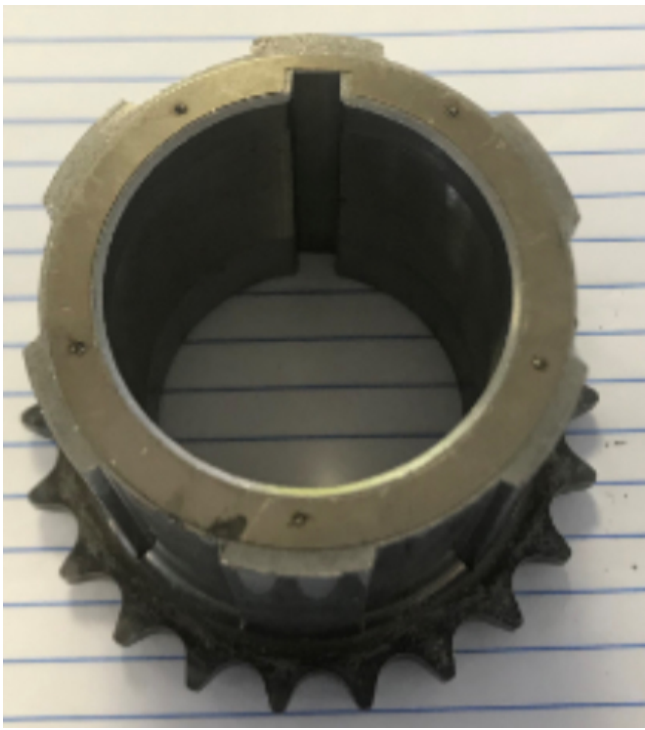
To identify if the engine was assembled with the incorrect crankshaft timing gear inspect for 5 dimples on the crankshaft timing gear (the incorrect gear will NOT have these dimples present), the dimples should be visible with the cover installed and balancer removed (see below):

If it has been confirmed that the lower crankshaft timing gear is incorrect, crankshaft timing gear P/N 12631214 along with a new oil pump will need to be installed.

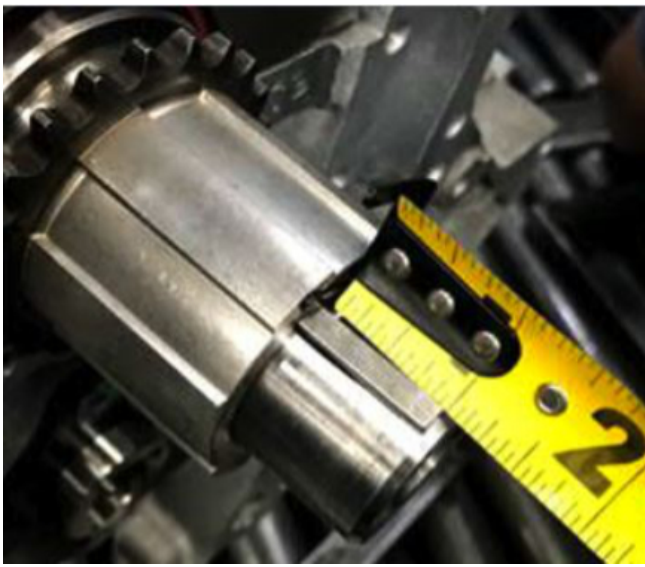
Further confirmation can be made with the timing cover of and measuring from the end of the crankshaft to the end of the gear (see below), this measurement should be approximately 1 1/16" (27.0mm).
