### PIP5819A VT40 Transmission Setting DTC P2714

Product Investigation Review Required

Brand:	Model:	Model Years:	VIN:		Engine:	Transmissions:
			from	to		
Chevrolet	Malibu	2019 - 2022	All	All	All	VT40 CVT Automatic (MRG)
Chevrolet	Trailblazer	2021 - 2022	All	All	All	VT40 CVT Automatic (MRG)
Buick	Encore GX	2020 - 2022	All	All	All	VT40 CVT Automatic (MRG)

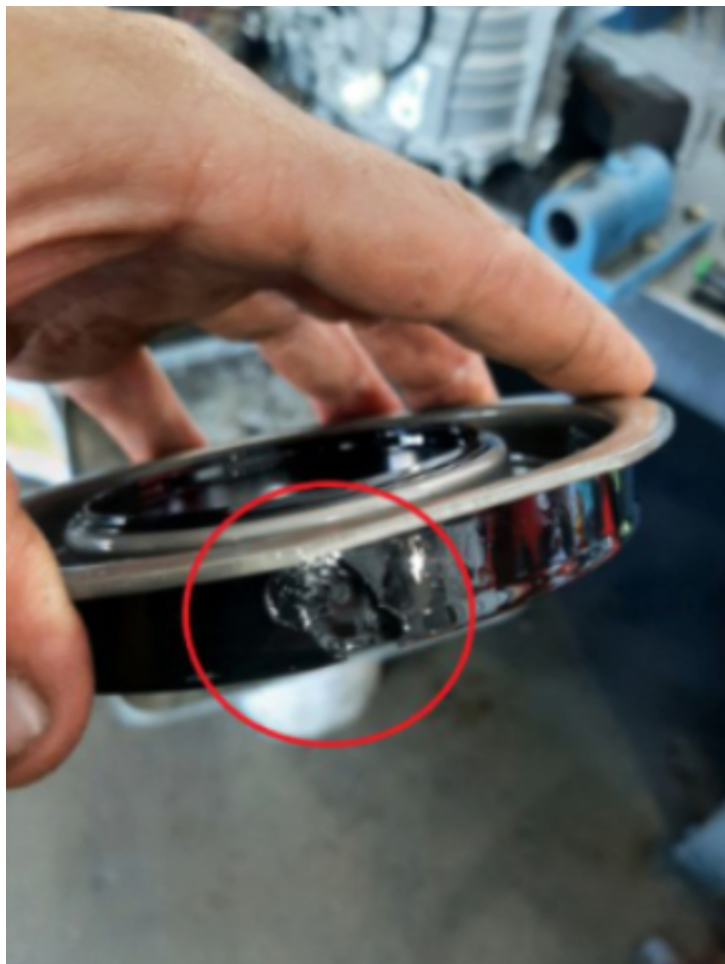
Involved Region or Country	North America and NA exports
Condition	Some customers may comment on a loss of forward gear, slipping, and/or a check engine light on. Technicians may find the following DTC set in the Transmission Control Module (TCM) P2714: Transmission Control Solenoid Valve 4 Stuck Off
Cause	<b>Note: This condition may be intermittent or not reproducible</b> This condition may be caused by the clutch regulator valve sticking in the valve body; Damage to the forward clutch piston and/or wear in the Primary Pulley Bearing Bore causing damage to the case.

With the transmission disassembled, inspect the Forward Clutch Piston for damage along the side as shown.

If the Forward clutches are worn and there is damage seen to the Forward Clutch Piston then replace the Forward Clutch Piston and Housing and the applicable apply components as needed

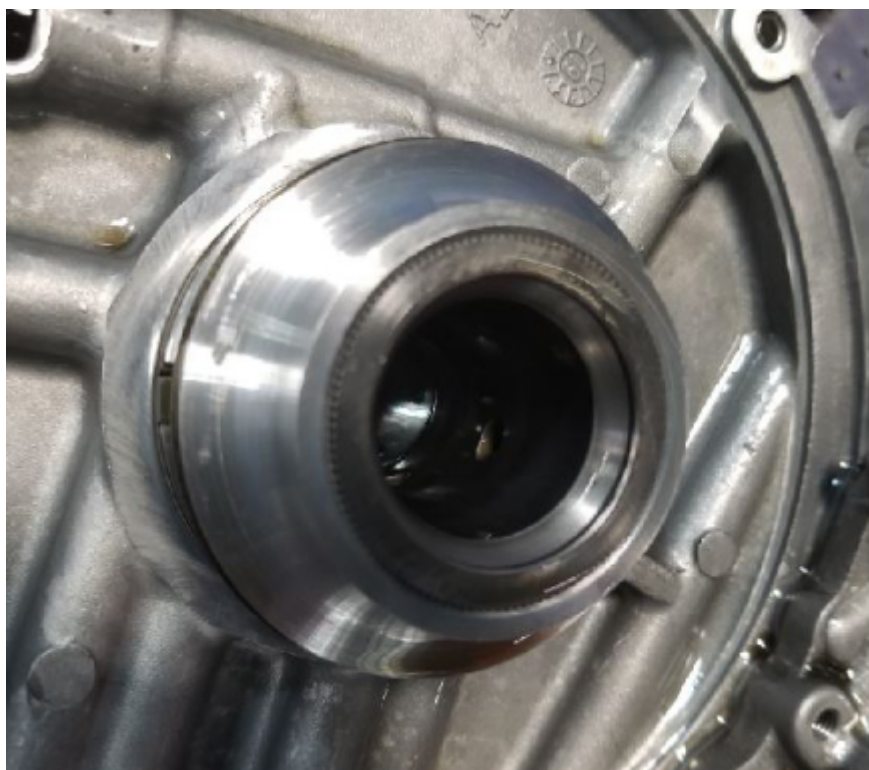
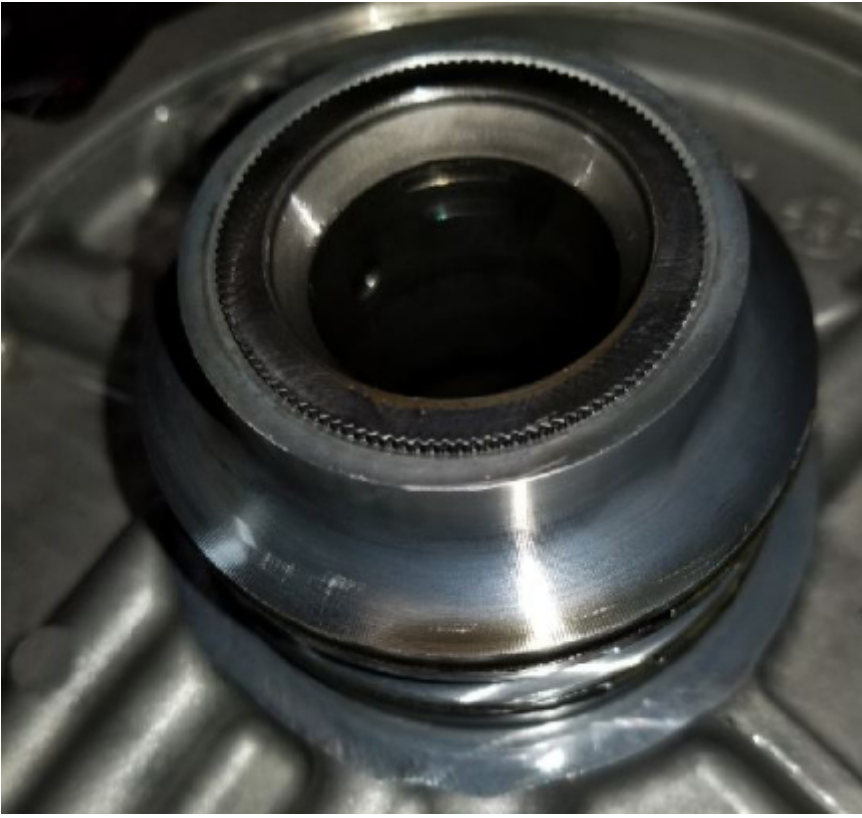
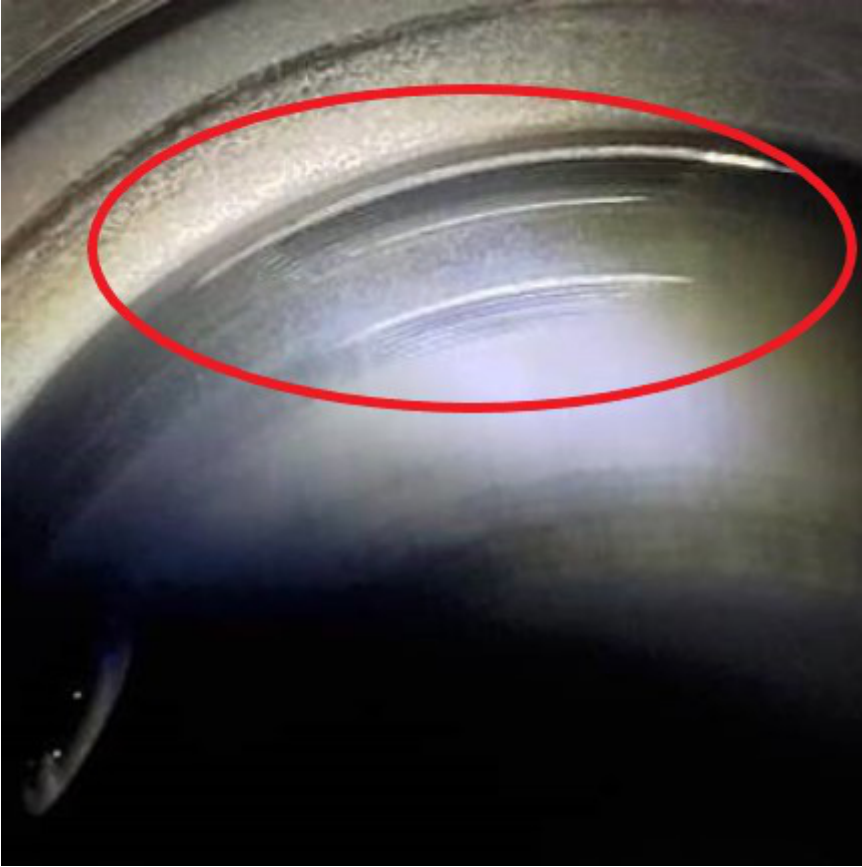
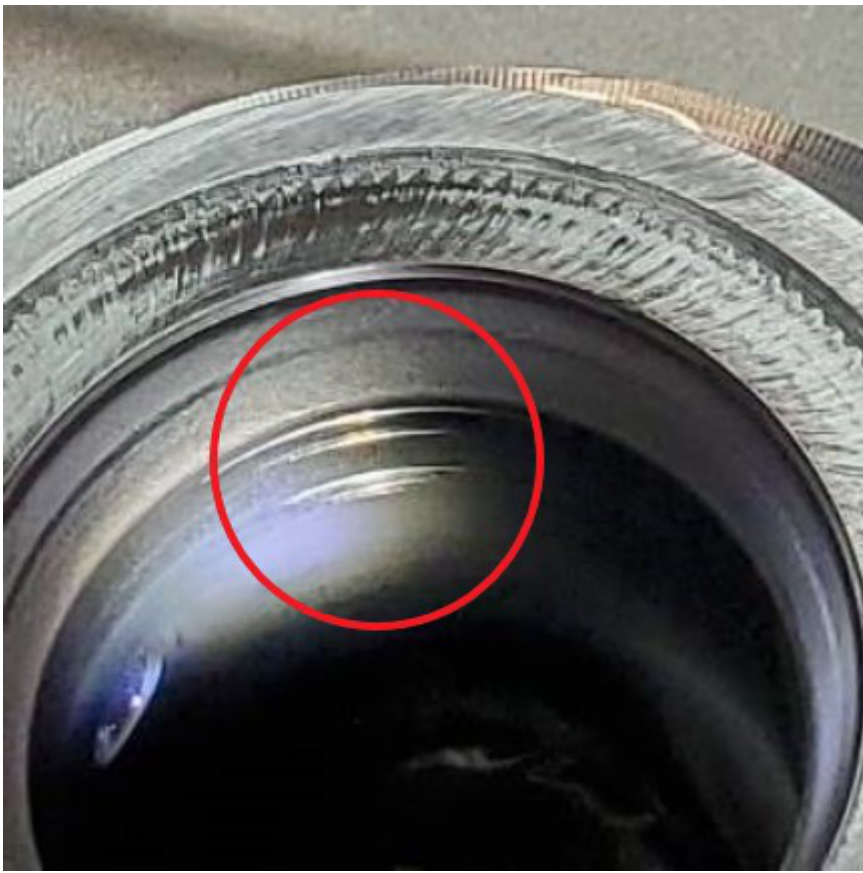
**Note:** The first 2 pictures show the outside of the pump, and the second 2 pictures show the wear that is found internal to the pump when wear to the Primary Pulley Bearing Bore is found .

If signs of wear are seen as shown, this indicates the Primary Pulley Bearing has spun in the bore and is allowing the Turbine Shaft to become off center. When this happens, it causes a pressure leak.

**Note:** The Primary Pulley Bearing is installed on the inside of the case on the primary pulley, this area of the transmission cannot be accessed for inspection, inspection of the pump for DTC P2714 and no concern found with the Forward Clutch Piston is critical.

If this concern is found, the transmission will need to be replaced.
