Preliminary Information

PIP5826B MIL illuminated with DTC P0521

Brand:	Model:	Model Years:	VIN:		Engine:	Transmissions:
			from	to		
Buick	Encore GX	2020 - 2021	All	All	1.2L (LIH)	All
Chevrolet	Trailblazer	2020 - 2021	All	All	1.2L (LIH)	All

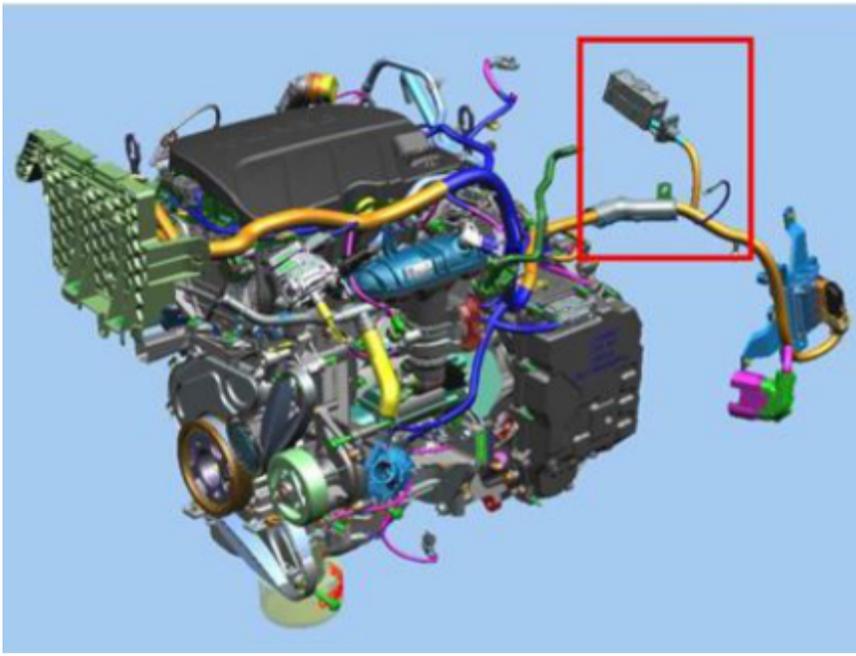
Branch for X50A Fuse Block - Underhood.

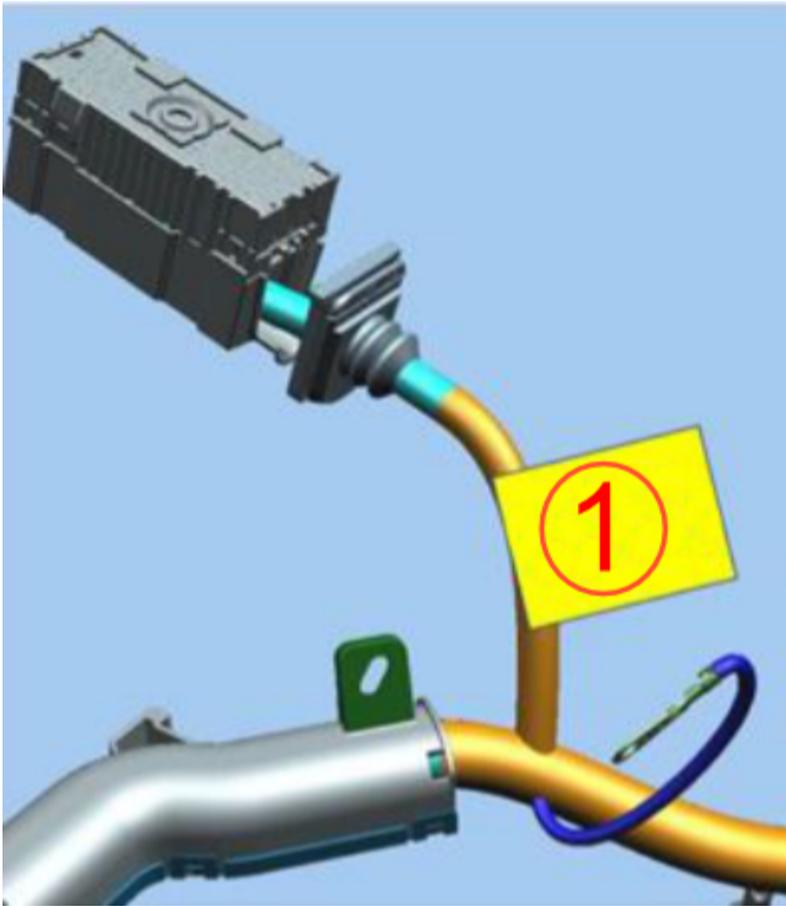
Engine wiring harness part number tag.

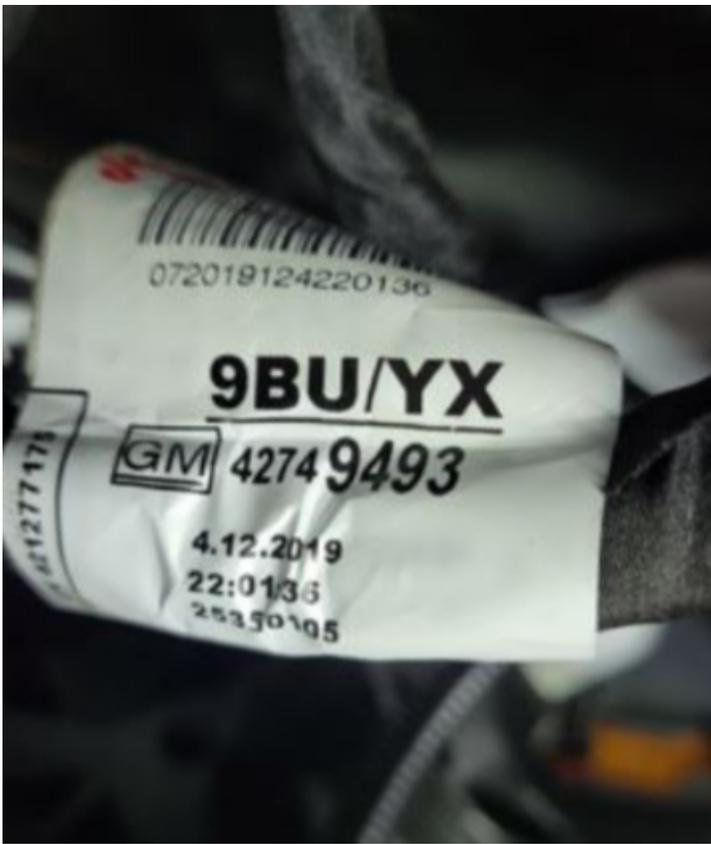
If the part number is one of the following (42737310, 42737311, 42749493, 42749494), inspect the three ECM connectors for proper locking lever and CPA lock positions. (refer to picture below).

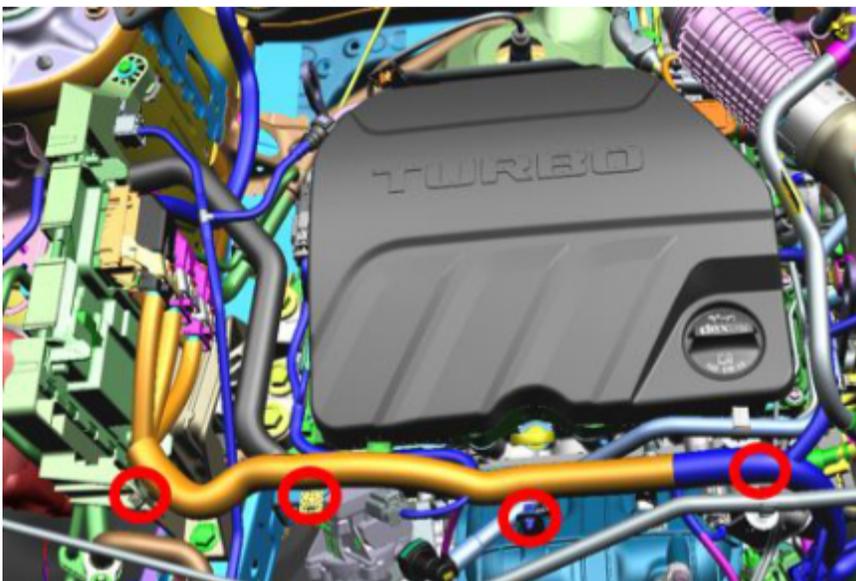
Inspect the 4 clips circled below for broken Tie Straps and proper retention of the main engine wiring harness.

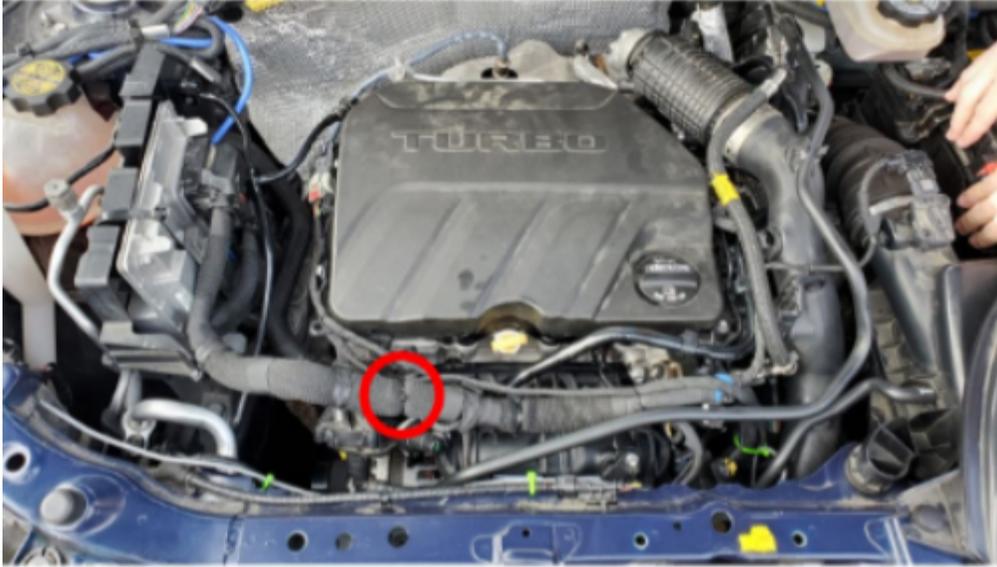
Once duplicated, open the hood and bend the harness back and forth at the circled location shown below while monitoring for the engine oil pressure to change.

A change in the engine oil pressure reading either up or down in PSI, isolates the issue to the Special three wire Splice in this location of the main engine wiring harness.

Open the engine wiring harness in the location circled above to access the three wire special splice for Low Reference circuit 548 BK/GN.

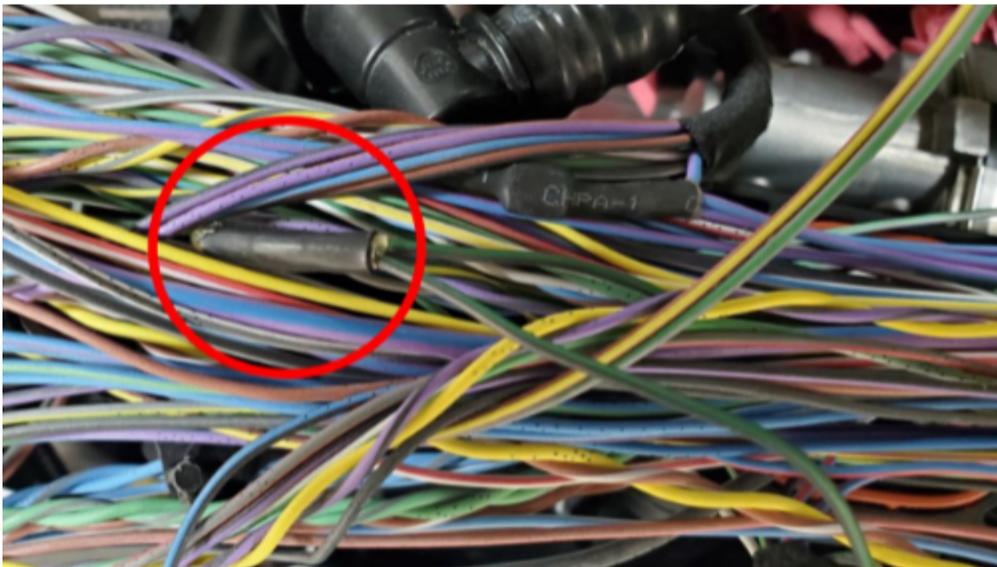
Remove the Heat Shrink and splice clip to expose all three legs of the special splice.

Inspect each leg for broken wire strands and correct any issues.

Slide the appropriate size heat shrink tube on one branch of the circuit.

Install a new splice clip, solder the three legs, and seal with the heat shrink.
