Aftersales Bulletin

00 34 61 02 00 – Service Action Rear Carrier Fixings

This service action affects Dawn (RR6) models produced from 10/20/2020 to 3/19/2021.

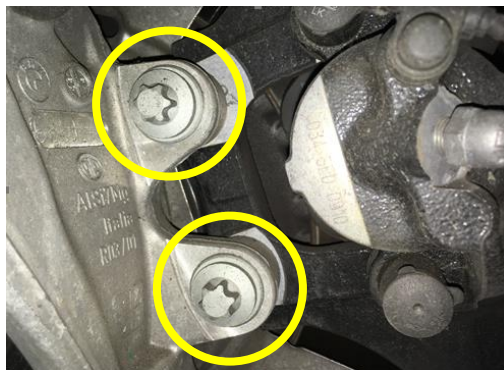
Step 1. Locate rear brake caliper carrier fixings (2 fixings on the right side and 2 on the left)

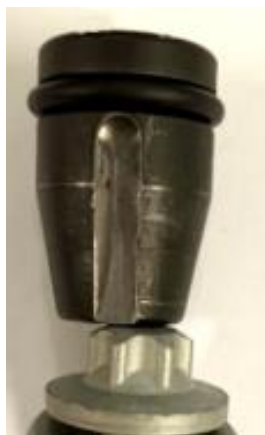
Step 2. Attempt to fit a Torx E14 socket on each of the four fixing fixings.

Torx E14 does not fit, the screw head is too big (E16).

The screw is OK. No action is needed.

Torx E14 fits.

Incorrect screw is fitted. The screw needs to be replaced with the correct one following the procedure below.

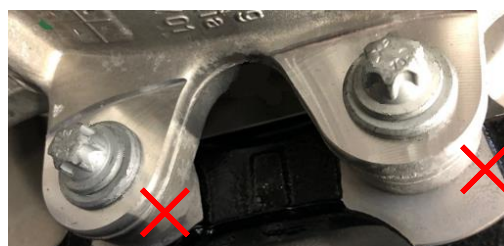
Example Not OK (Torx E14)

The affected vehicles have been identified as having a potential issue concerning the rear brake carrier fixings. It could be possible that during the rear axle assembly, the rear brake carriers were fitted with incorrect fixing (Torx E14 instead of the correct E16).

Summary: Torx E14 head on screw – Not OK, replace screw and torque tighten.
Torx E16 head on screw – OK, no further action.

Required torque:

Type	Thread	Dimension
2AZ Brake anchor plate to wheel carrier	RR5 / RR6	M12x1.5	110Nm

Description	Part Number	Quantity
Torx screw with washer	34 10 6 864 424	up to 4
