# Service Bulletin

## P89 Plus Wheel End Inspection for Water Ingress

October 2021

The bulletin is for use when the wheel end is suspected of water ingress, for example a submerged axle.

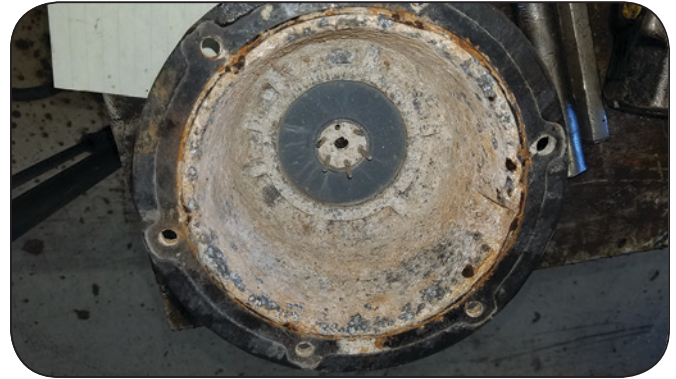
**Figure 1**

1. Remove the hubcap and inspect for evidence of water intrusion (i.e. water, rust or corrosion).
2. If no water, rust or corrosion is present, parts are able to be re-used. Continue to step 9.
3. If evidence of water intrusion is found inside the hubcap area, the wheel end must be disassembled to inspect for additional damages. Refer to **Figures 1, 2, and 3**.

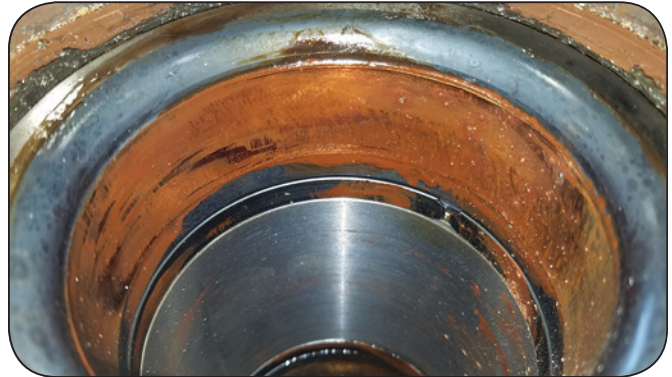
**Figure 4**

4. Upon disassembly, inspect wheel bearings (**Figure 4**) and Spindle (**Figure 5**) for evidence of rust and/or corrosion.
5. If there is no rust along the spindle and the inside of the bearings, the wheel end can be reassembled as per XL-SA20024UM-en-US and returned to service. Continue to step 8.
6. If there is rust present along the spindle and the inside of the bearings, the sealed bearings are likely compromised. Therefore the hub unit should be considered out of service and be replaced with a new hub unit.
  - a. Clean any residual rust/corrosion off the spindle with emery cloth.
  - b. Hub assembly should be replaced with a new unit.

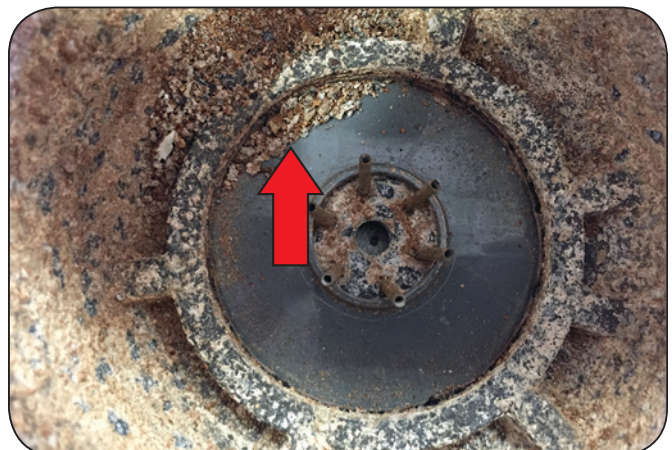
**Figure 6**

7. If rust flakes are present inside the hubcap (**Figure 6**), the hubcap, spindle nut and tire-inflation components should be replaced with new. If light rust is present, but no flakes, the corrosion can be removed with a wire brush.

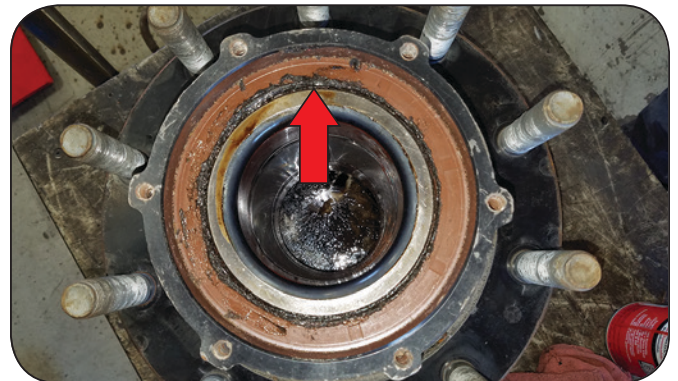
**Figure 8**

**NOTE:** Using a rust inhibitor may compromise the ability to assess grease leakage from the P89 Plus sealed bearing unit, which could lead to bearing failure. Refer to **Figure 8**.
