# Service Update

## N212330830 Navigation System Displays Incorrect GPS Location

Release Date: June 2021

<b>Condition</b>	Certain 2021 model year Cadillac CT4 and CT5 vehicles may have had incorrect parameters set in the One Time Programmable (OTP) Chip area to initialize GPS Navigation System correctly once installed or assembled into the vehicle during manufacturing of the center stack module (CSM).
<b>Correction</b>	Dealers will reprogram the radio.

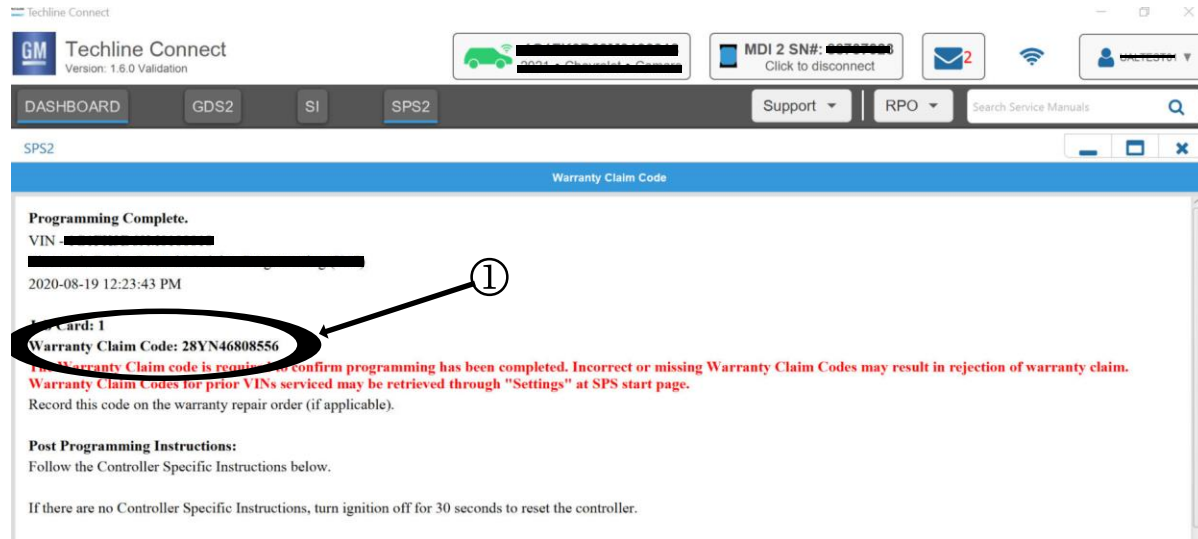
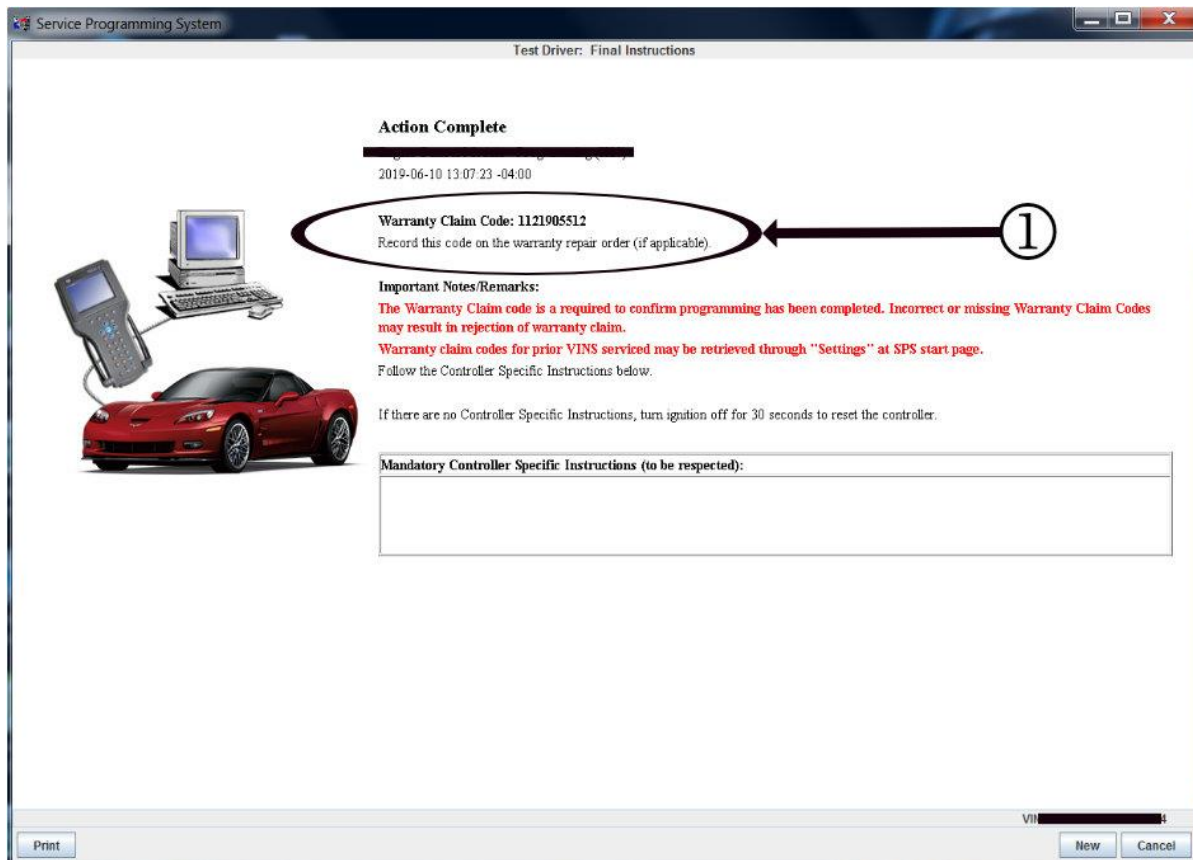
**Note:** The screenshots above are an example of module programming and may not be indicative of the specific module that is being programmed. Module selection and VIN information have been blacked out.

**Important:** To avoid warranty transaction rejections, you **MUST** record the warranty claim code provided on the Warranty Claim Code (WCC) screen shown above on the job card. Refer to callout 1 above for the location of the WCC on the screen.

- Record SPS Warranty Claim Code on job card for warranty transaction submission.
