GLOBAL SAFETY FIELD INVESTIGATIONS
DCS5969
URGENT - DISTRIBUTE IMMEDIATELY

Subject: N212344390 - Emission Recall
Incorrect ECM Calibration

Models: 2021 Chevrolet Colorado
2021 GMC Canyon
Equipped with 2.8L Diesel Engine (RPO LWN)

N212344390 Incorrect ECM Calibration

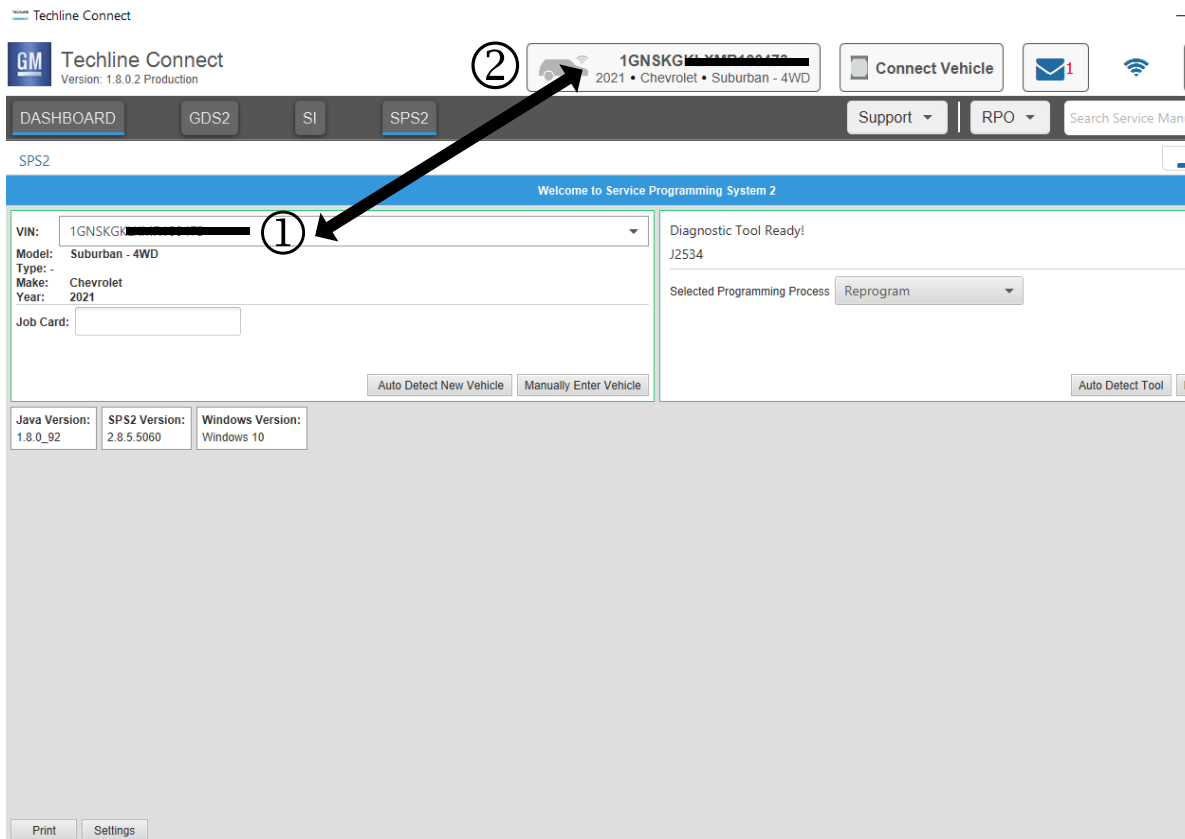
5743643

Caution: Be sure the VIN selected in the drop down menu (1) is the same as the vehicle connected (2) before beginning programming.

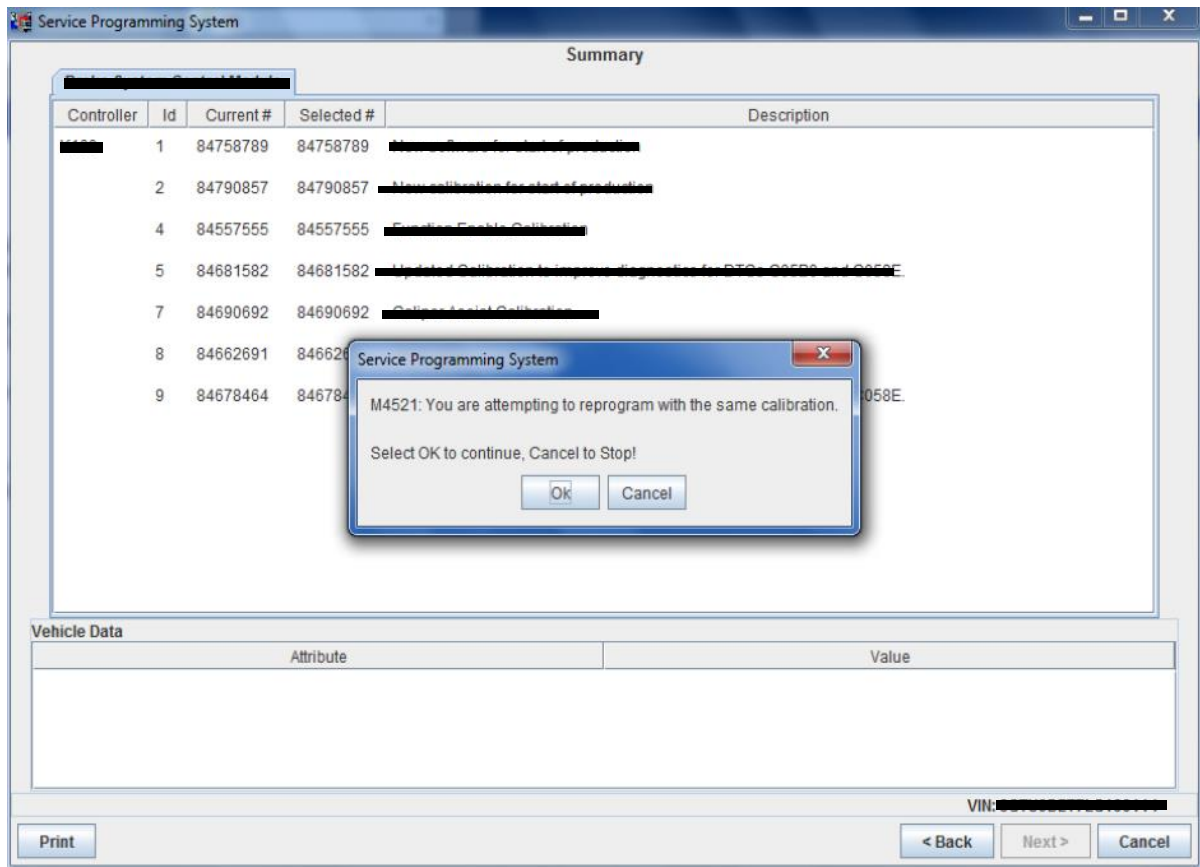
5431207

Important: Techline Connect and TIS2WEB screens shown above.

Important: If the same calibration/software warning is noted on the TLC or SPS Summary screen, select OK and follow screen instructions. After a successful programming event, the WCC is located in the Service Programming System dialogue box of the SPS Summary screen. No further action is required. Refer to the Warranty section of the bulletin.

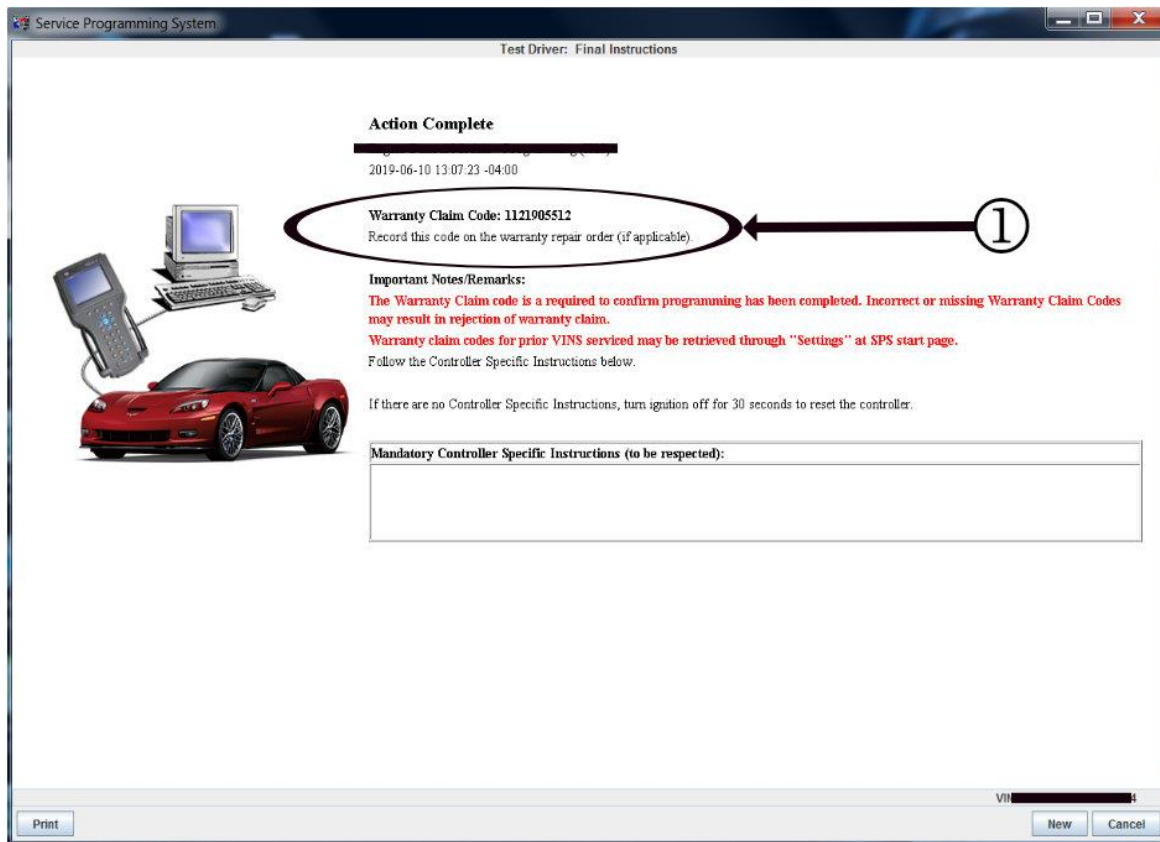
5431209

Note: The screenshots above are an example of module programming and may not be indicative of the specific module that is being programmed. Module selection and VIN information have been blacked out.

Important: To avoid warranty transaction rejections, you **MUST** record the warranty claim code provided on the Warranty Claim Code (WCC) screen shown above on the job card. Refer to callout 1 above for the location of the WCC on the screen.

- Record SPS Warranty Claim Code on job card for warranty transaction submission.
