Campaign Service

BULLETIN NUMBER:
CB21-N-001

E-98/E-97 GROUND INSPECTION (V2104)

- 2012 - 2017MY Isuzu N-Series Vehicles
Equipped with 6.0L Gasoline Engines

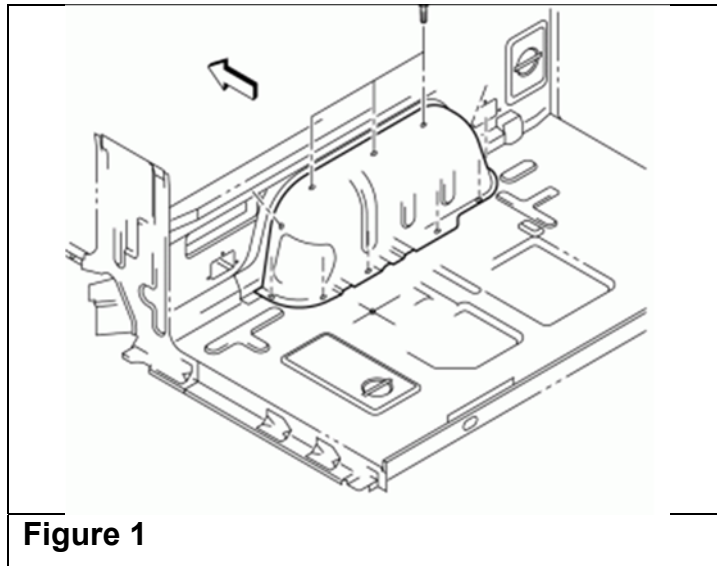
1. Place the vehicle in park, apply the parking brake, and remove the key from the ignition switch.
2. Disconnect the negative battery cable.
3. For non-crew cab models, safely tilt the cab and insert the safety pin per the instructions in the applicable Workshop Manual (WSM). If the vehicle is a crew cab model, remove the in-cab rear engine cover. (See Figure 1.)

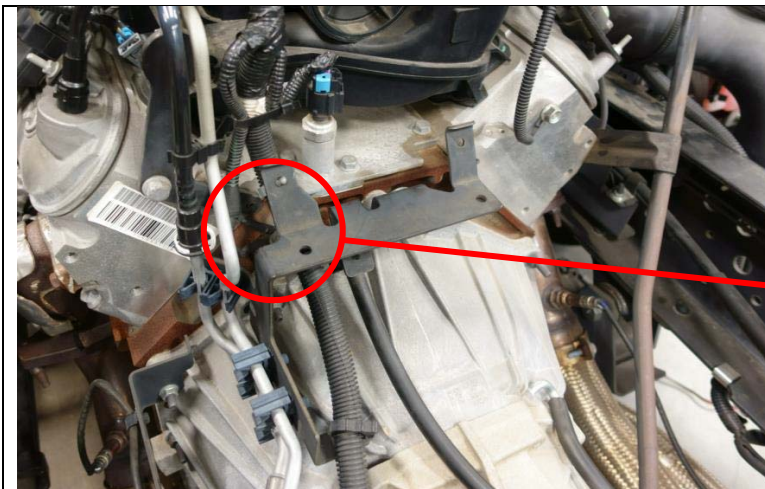
Figure 2

4. Remove the bolt attaching the E-97 and E-98 ground terminals located at the rear of the engine block on the driver side. (See Figures 2 and 3.)

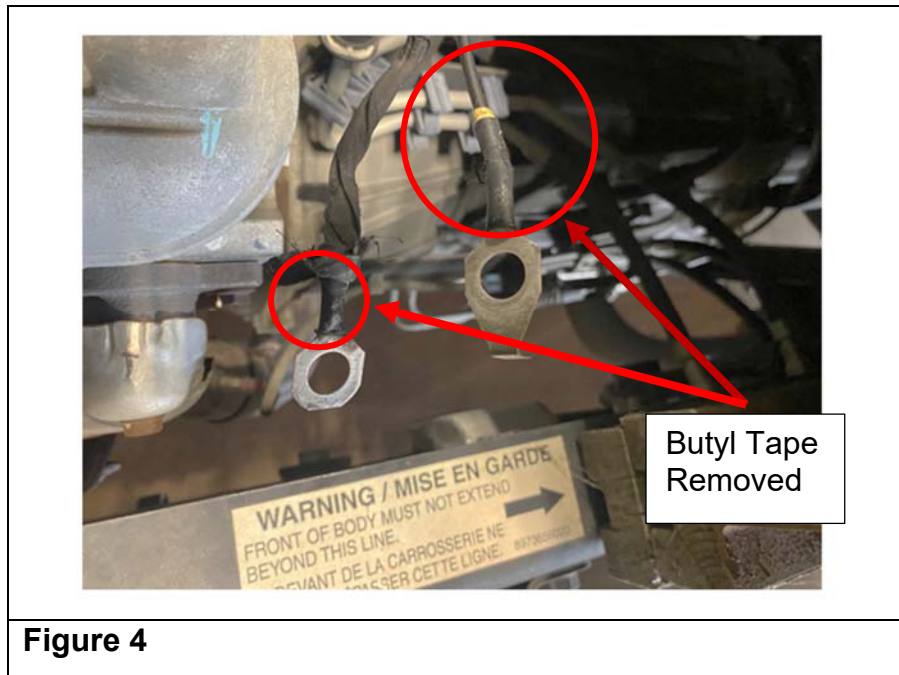
5. Remove enough of the outer layer of the butyl tape from the E-97 and E-98 terminals to fully expose each terminal loop. (See Figure 4.)

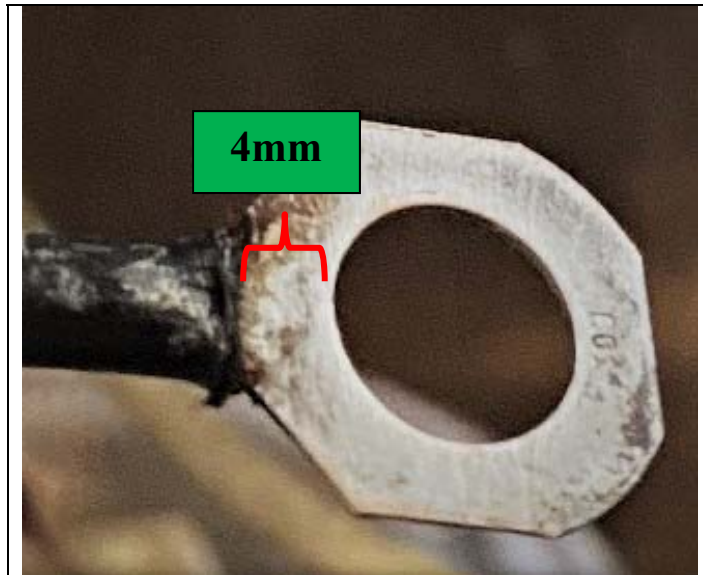
Figure 5

- b. If there is minimal or no corrosion on either ground terminal **and** no damage to the wiring, proceed to Step 7.
7. Inspect the E-97 and E-98 ground terminals for evidence of sealant or tape where each metal terminal makes contact with the engine block. Use a scale to measure that there is 4mm of clear metal clearance between the center of each terminal and where the tape begins. (See Figure 5.) Refer to Figure 6 for an example of interfering tape.

8. Use an emery cloth to remove any surface corrosion on the engine block ground mounting location.
9. Reapply any butyl tape that was removed in Step 5 to terminals E-97 and E-98. Ensure that the tape does not encroach onto the 4mm area shown in Figure 5.
10. Install and hand tighten the bolt for the E-97 and E-98 ground terminals on the engine block mounting location. Ensure that the E-97 terminal is installed directly on the block and that the E-98 ground terminal (has the anti-rotation tab) is installed on top of the E-97 ground terminal. (See Figures 8 and 9.)
