Service Bulletin

Bulletin No.: 21-NA-218

Subject: Diagnostic Tip on Reduced Propulsion (EREV), Malfunction Indicator Lamp (MIL) Illuminated - DTC P0C17, P1B03 and/or P0C01 Set (Drive Motor 1 Only)

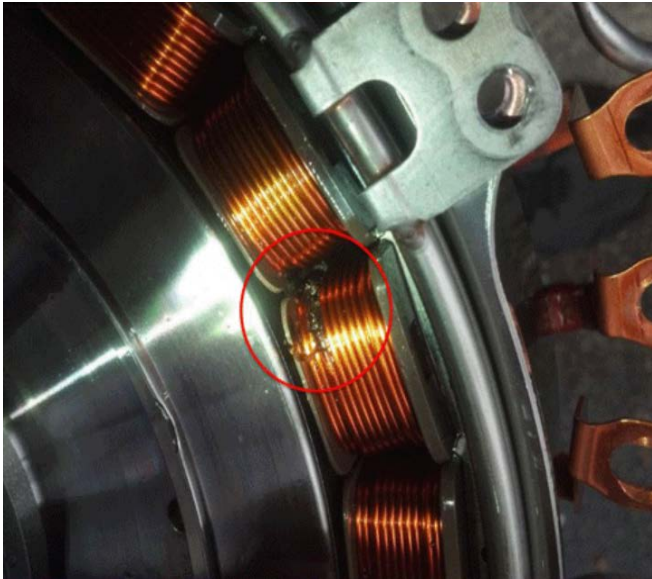
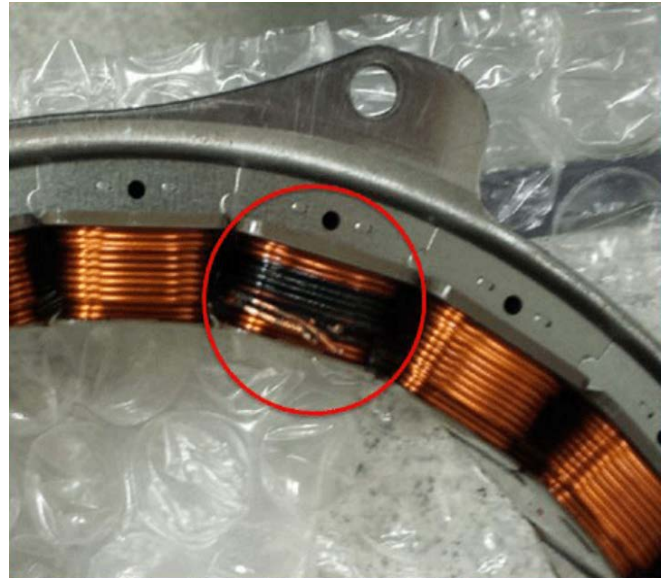
Some SI diagnostic procedures may not comprehend the possibility of the Motor 1 Stator as the cause of these DTCs. If one or more of these diagnostics are set, especially on a vehicle with a lifetime fuel economy less than 50 mpg (greater than 4.7 L/100 KM) and above average annual mileage, inspect the Motor 1 Stator for damage as shown in the pictures below.

If no damage is found, replace all of the following parts: Motor 1 Position Sensor, Transmission Internal Harness, and Motor 1 Stator (damage may be on windings below the top layer). Replacing the Drive Motor Generator Control Module should only be ordered if the condition persists after replacing these parts.
