Service Bulletin

Bulletin No.: 21-NA-285

Subject: Windshield Wipers Only Operate on One Speed

Brand:	Model:	Model Year:		Build Date:		Engine:	Transmission:
		from	to	from	to		
Buick	Envision	2021	2022	SOP	November 20, 2021

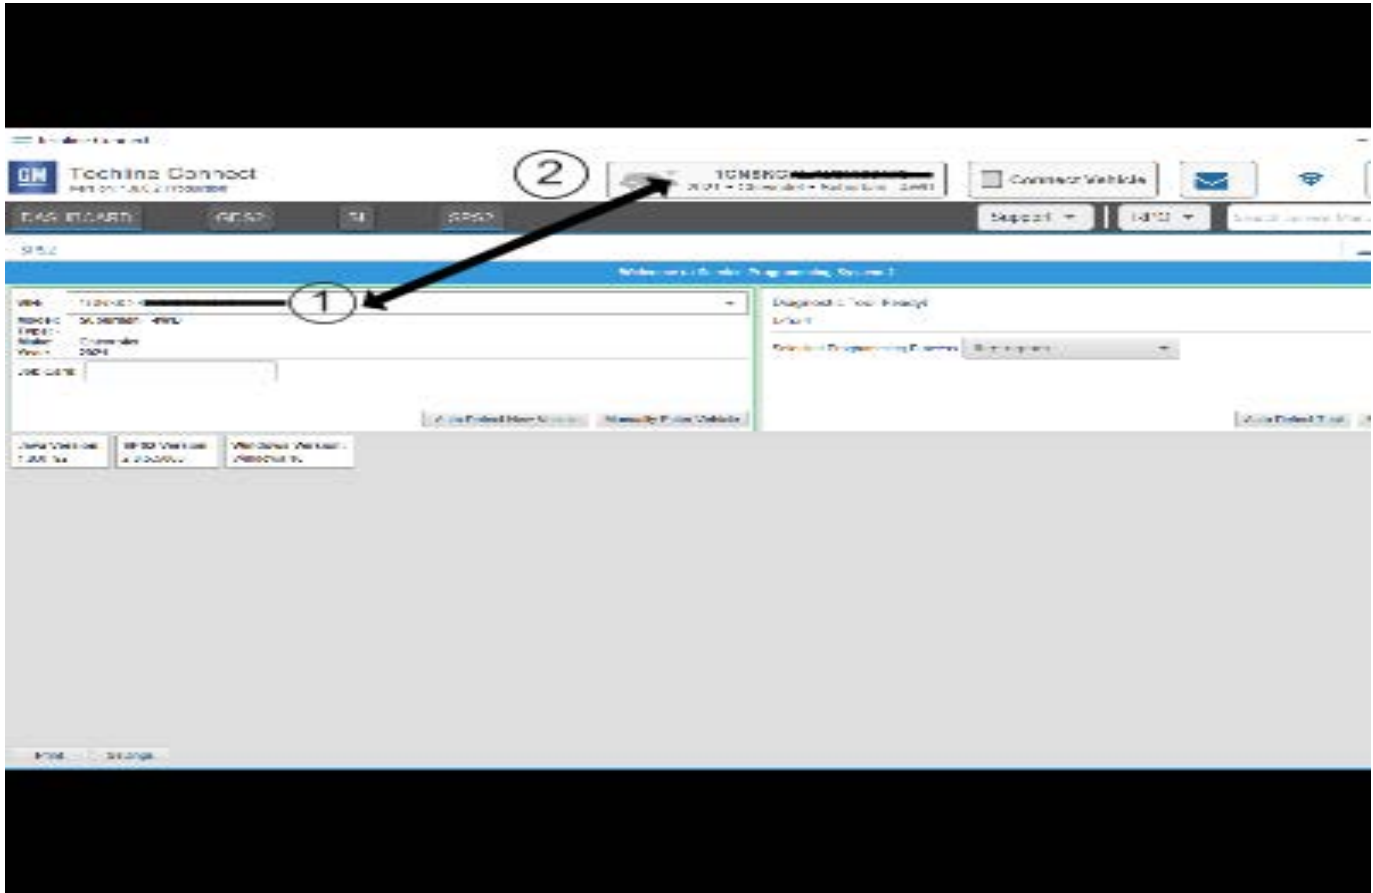
5743643

Caution: Be sure the VIN selected in the drop down menu (1) is the same as the vehicle connected (2) before beginning programming.

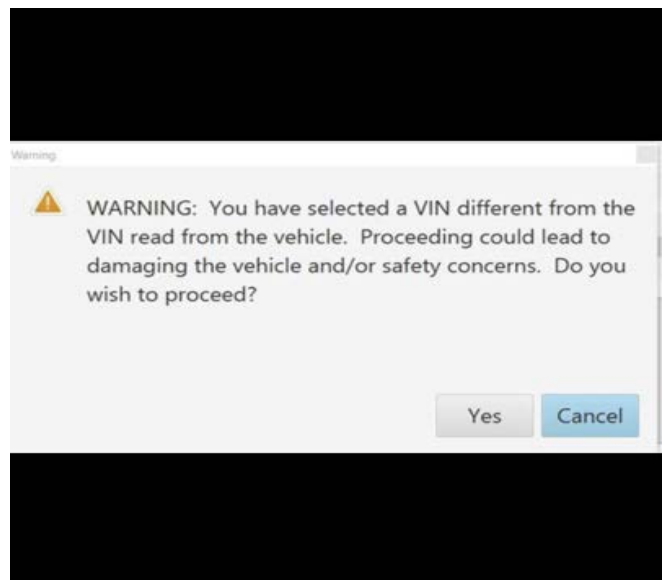
5877000

Important: If the vehicle VIN DOES NOT match, the message below will be shown

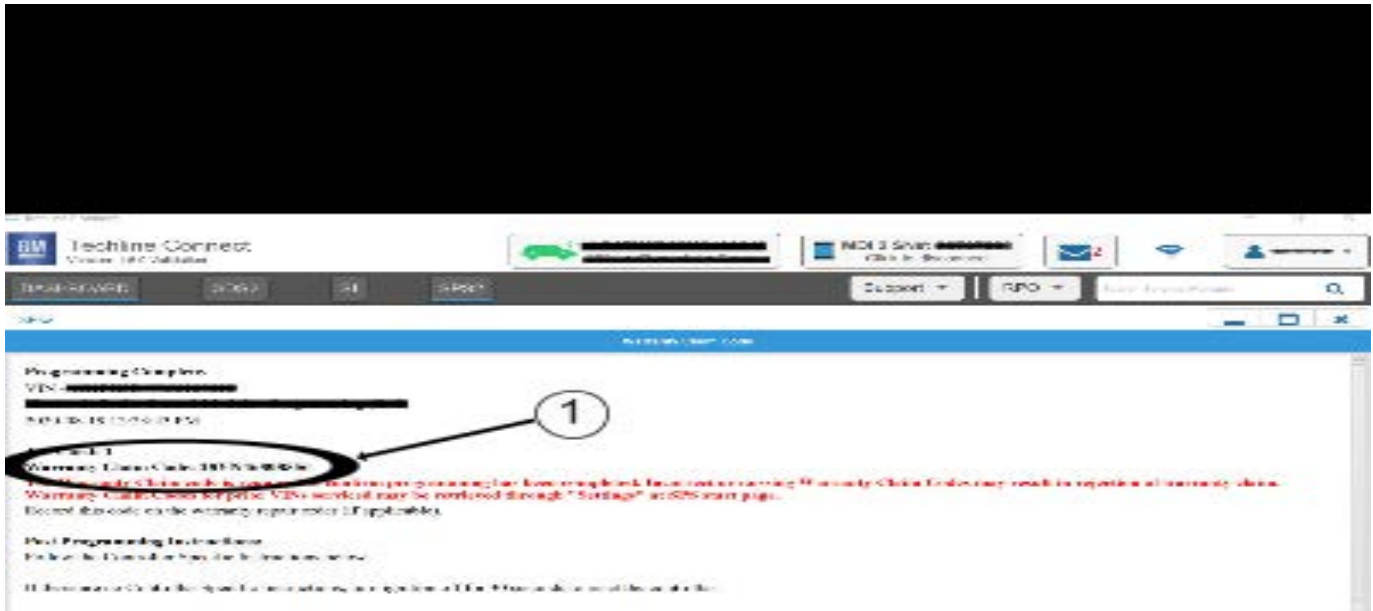
5431209

Important: To avoid warranty transaction rejections, you **MUST** record the warranty claim code provided on the SPS Warranty Claim Code (WCC) screen shown above on the job card. Refer to callout 1 above for the location of the WCC on the SPS screen

2. Record SPS Warranty Claim Code on job card for warranty transaction submission.
