Info request, door sealing strip coming loose

REF NO: TJ 34071.3.0	ISSUING DEPARTMENT: Technical Service	CAR MARKET: United States and Canada	
PARTNER: 3 US 7510 Volvo Car USA		ISSUE DATE: 2021-11-24	STATUS DATE: 2021-11-30
FUNC GROUP: 8451	FUNC DESC: Sealing moulding for side door	Page 1 of 3

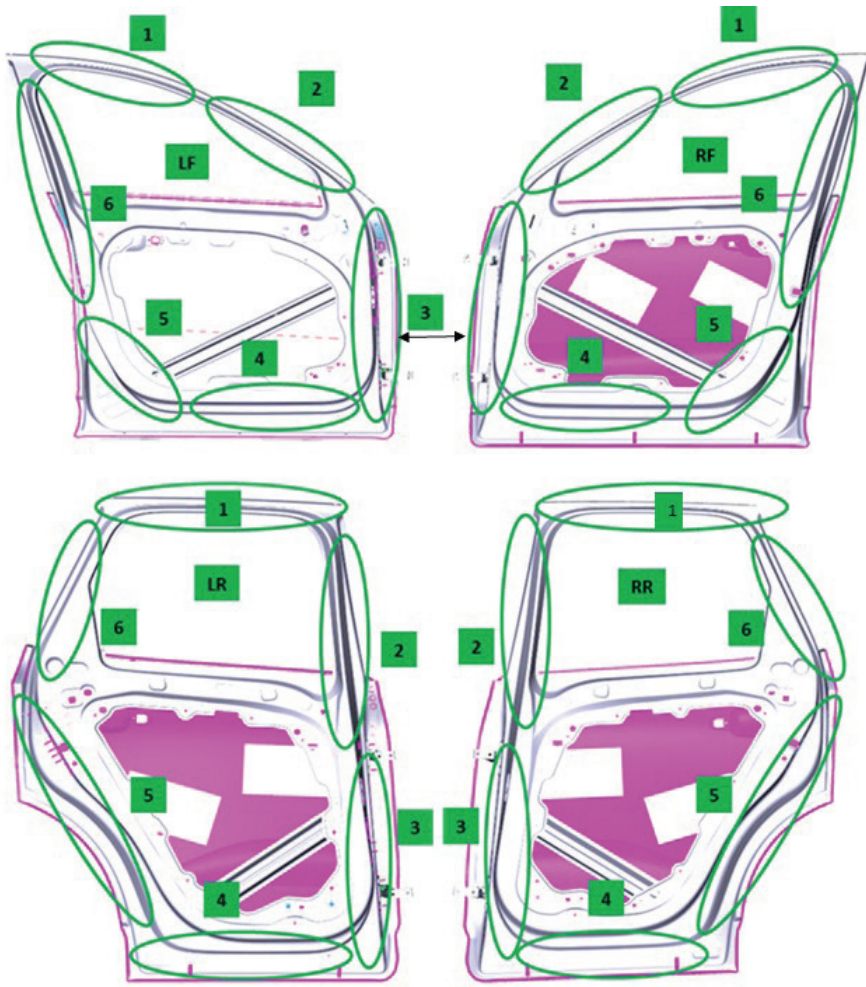
TJ 34071

If front or rear door mounted sealing strip coming loose, please submit a Vehicle Report for information with detailed photos showing the failure (overview + close-up). Include which door that is affected and the failure area, see attachment.

Yes, please submit a Vehicle Report with detailed photos showing the failure. Add the nr of the failure area and what door that is affected according to attachment. Use concern area "Vehicle Report" and sub concern area "Support not needed", use function group 8451.
