| Topic | Under bonnet trim - engine cover (SC16/01) |
| Brand | Bentley |
| Campaign number | EA39 |
| Type | Service campaign |

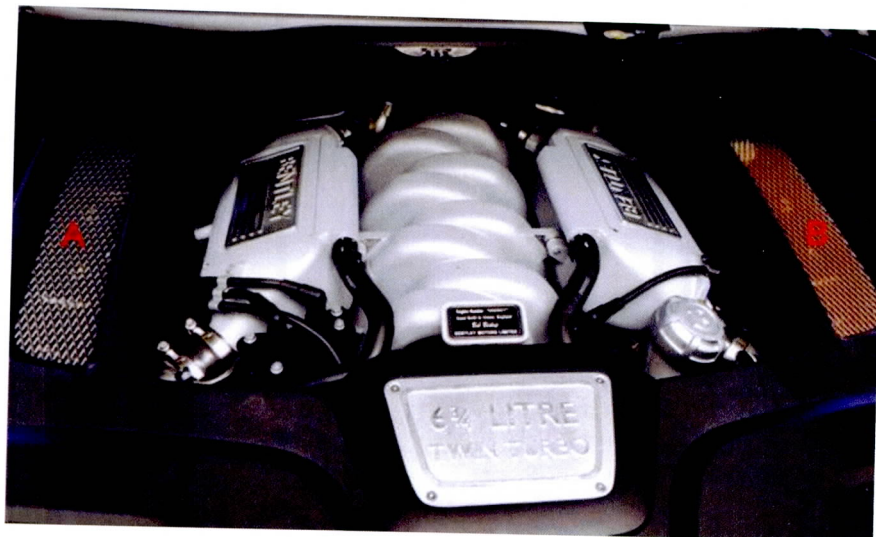
Figure 1

A number of under bonnet trim parts, engine covers, may have been assembled using incorrect material. The suspect material is mild steel mesh and may be prone to oxidation

The metallic grills A and B need to be checked using a magnet, if either grill is found to be magnetic then replace the engine cover assembly (see Figure 1)

Reference workshop manual, Rep. Gr.10 Engine Cover – To Remove and Fit
