EA39

Under bonnet trim - engine cover (SC16/01)

Transaction No.: 2041887/2

Release date: Feb 4, 2016

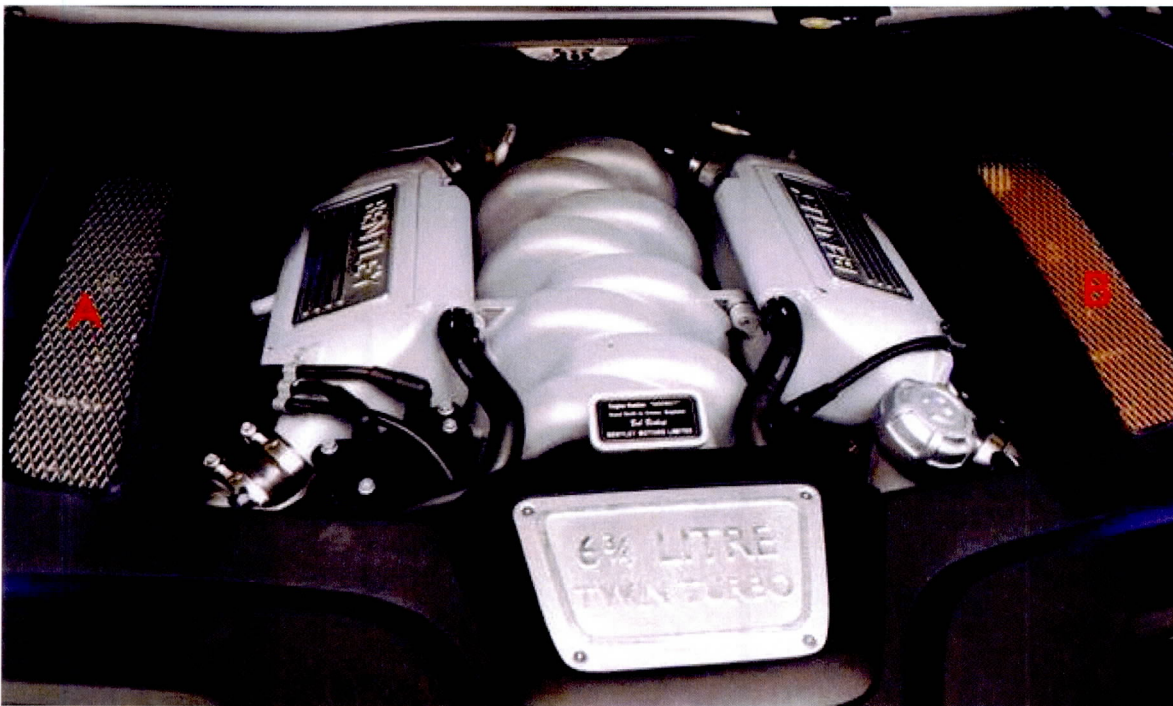
Figure 1

A number of under bonnet trim parts, engine covers, may have been assembled using incorrect material. The suspect material is mild steel mesh and may be prone to oxidation

The metallic grills A and B need to be checked using a magnet, if either grill is found to be magnetic then replace the engine cover assembly (see Figure 1)

Reference workshop manual, Rep. Gr.10 Engine Cover – To Remove and Fit
