STAR ONLINE PUBLICATION

Case Number: S2108000156

Symptom/Vehicle Issue: CEL (Check Engine Lamp) On, DTC Turbocharger Wastegate Control Circuit Low

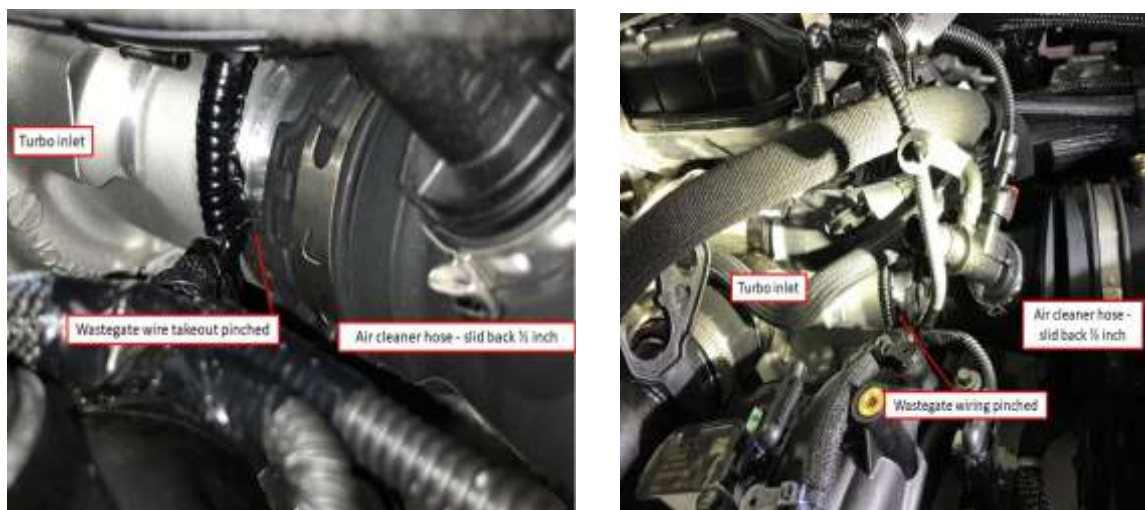
Fig 1

Customer Complaint/Technician Observation: Owner complains the check engine lamp is on and that the vehicle lacks power. Technician observation, PCM is setting P2045 Turbocharger Wastegate Control Circuit Low and can be stored or active.

Repair Procedure: Inspect the harness routing at the Turbo inlet tube for any signs of a pinched harness or harness chaffing damage that may have occurred; isolate and repair as needed. If no suspect damage to the harness, check the terminals at the waste gate solenoid connector and secure or repair any D2932A connector terminals that are loose, spread or damaged; repair kit (full) 68364260AA. Fig 1, 2.
