STAR ONLINE PUBLICATION

Case Number: S2108000148

Symptom/Vehicle Issue: CAN C Bus Intermittently Loses Communication. Power Steering Becomes Stiff

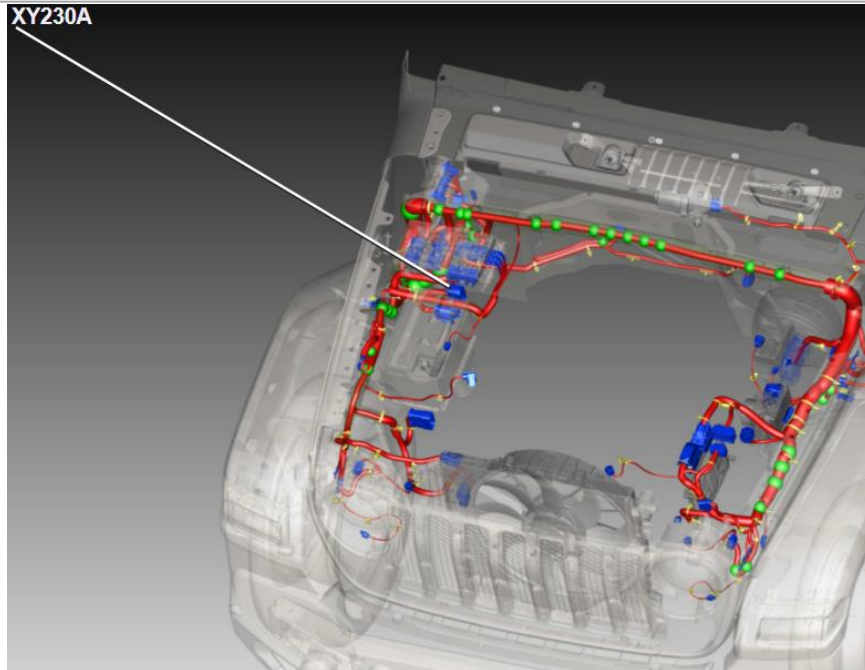
Inspect The Area Near Connector XY230A

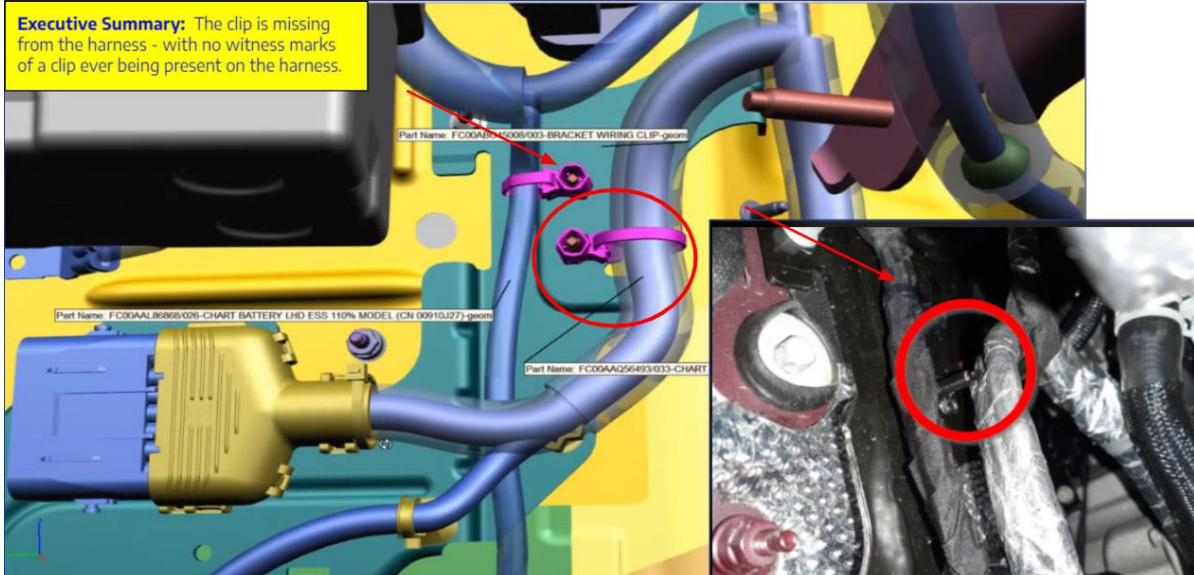
Discussion: The customer may indicate that they lost power steering assist and that multiple warning lights came on. Multiple CAN C communication DTC's are found when scanning the vehicle for DTC's. This issue may be caused by a loss of CAN C communication. This concern may be caused by a missing transmission wiring harness retaining clip which allows the CAN C wiring harness to contact the retaining clip mounting stud.

Location of Missing Trans Harness Retaining Clip. Wiring Harness Contacting Mounting Stud

Repair: Repair any damaged circuits using standard wiring repair methods. Secure the harness to the 6mm stud using an appropriately sized stud mount zip tie or similar. Ensure the harness is routed in such a way that it can no longer make contact with the stud and cause future damage.

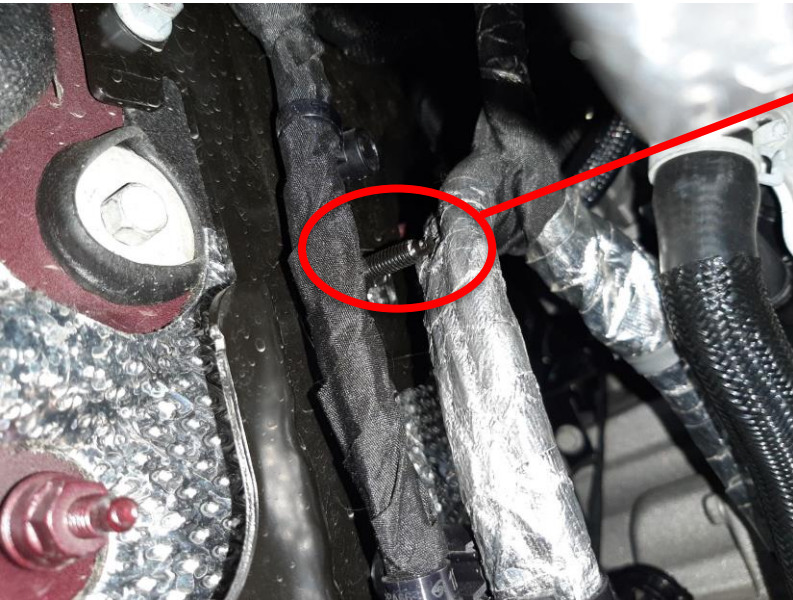
Mounting Stud Contacting Trans Harness

Hole Is Harness Thermal Sleeving From Stud

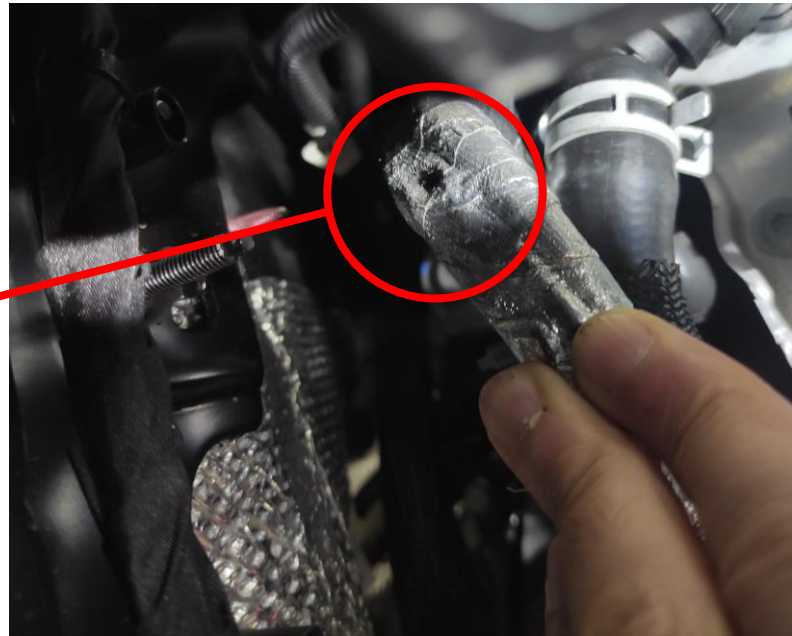
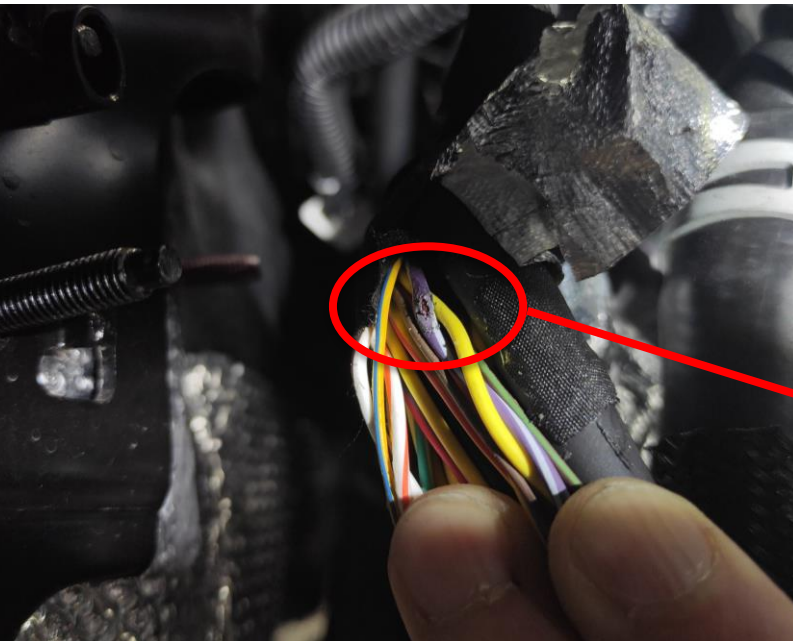
Perforation of CAN C Circuit Insulator
