**NUMBER:** 08-099-21

**GROUP:** 08 - Electrical

UAQ and UCQ Radio Enhancements

This bulletin involves inspecting and if required, updating the radio software level to 39.5

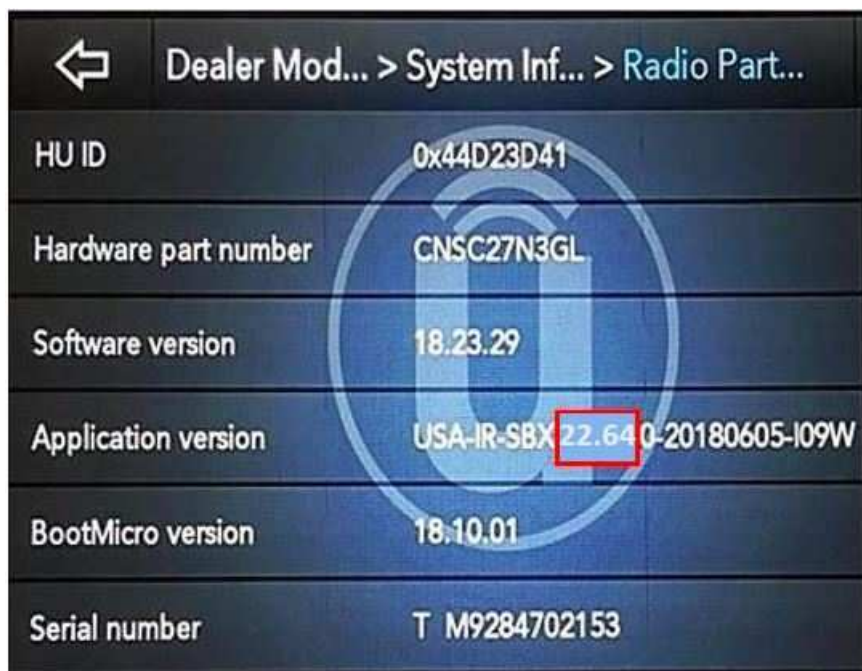
Fig. 1  
Radio Software Level Screen

1. Verify the radio software version. Radio must be in Dealer Mode to verify by following these steps:
  - a. Press and hold both lower corners of the display screen, until the Dealer Mode screen appears (approximately seven seconds). Release screen.
  - b. Select "Radio Part Information". The software version will be listed next to "Application Version" (Fig. 1) .

2. What is the radio software level (Application Version) at?
  - 39.5 or higher >>> The radio software is already up to date. Normal diagnostics should be performed.
  - At or above 22.64 and under 39.5 >>> Proceed to [Step 1](#) of the Repair Procedure.
