NUMBER: 09-008-21

GROUP: 09 - Engine

DATE: June 2, 2021

6.2L Engine Oil Temperature Sensor Leak

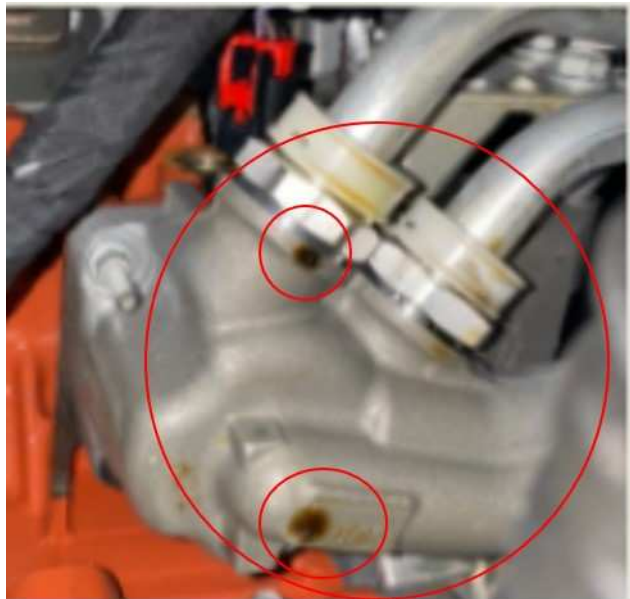
Fig. 1

Customers may notice a slight oil leak from under the vehicle near the oil temperature sensor location (Fig. 1) .

Oil Leaking/Dripping Location

3. Position the generator aside to gain access to the oil temperature sensor.
4. Disconnect the oil temperature sensor wire harness connector.
5. Torque the oil temperature sensor to 50 N·m (38 ft.lbs).
