NUMBER: 11-001-21

GROUP: 11 - Exhaust System

Exhaust Tips Are Loose And Off Center

2021 (DT) RAM 1500 Pickup

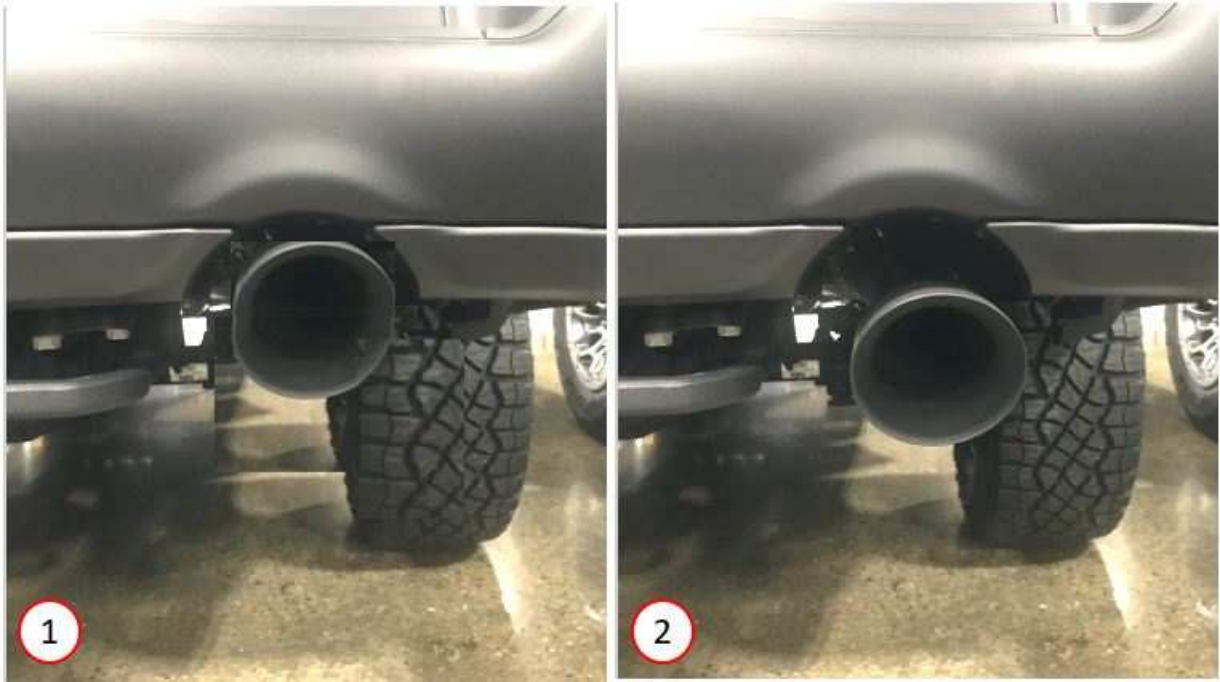
Fig. 1
Exhaust Tip Examples

Customers may notice the exhaust tips are not centered in the bumper opening and loose.

1. Inspect the exhaust tips to see if they are properly centered in the bumper opening and/or loose (Fig. 1) or move by pushing the exhaust tip up and down using hand apply moderate force (approx. 40 lbs) .
2. Are any of the exhaust tips off center and/or loose and/or move (Fig. 1) ?
 - YES>>> Proceed to [Step 1](#) of the Repair Procedure.
 - NO>>> This bulletin has been completed. Use inspection LOP (11-40-05-91) to close the active RRT.

- 1 - Correct - Properly Centered
2 - Incorrect - Need Adjustment
-
