Service Bulletin

Bulletin No.: 17-NA-221

Subject: Poor Engine Performance in Extremely Cold Weather Conditions for LE2 Engines, Charge Air Cooler Icing - Malfunction Indicator Lamp (MIL) Illuminated, DTC P0299, P0234, P0236, P2227, P00C7 Set

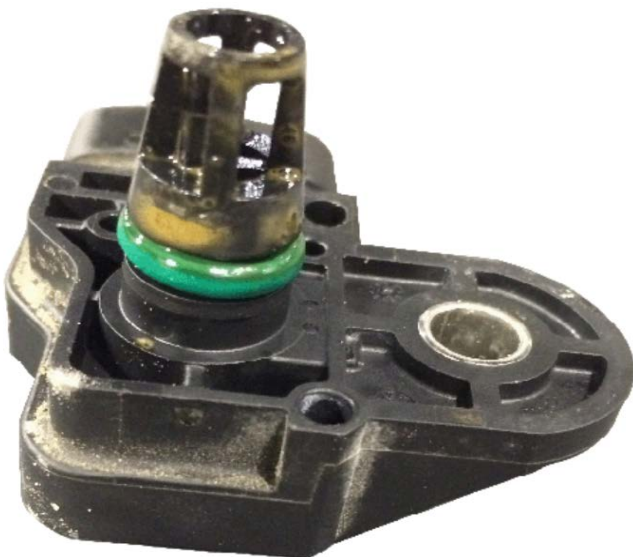
4910683

2. Inspect the sensor for any contaminants.

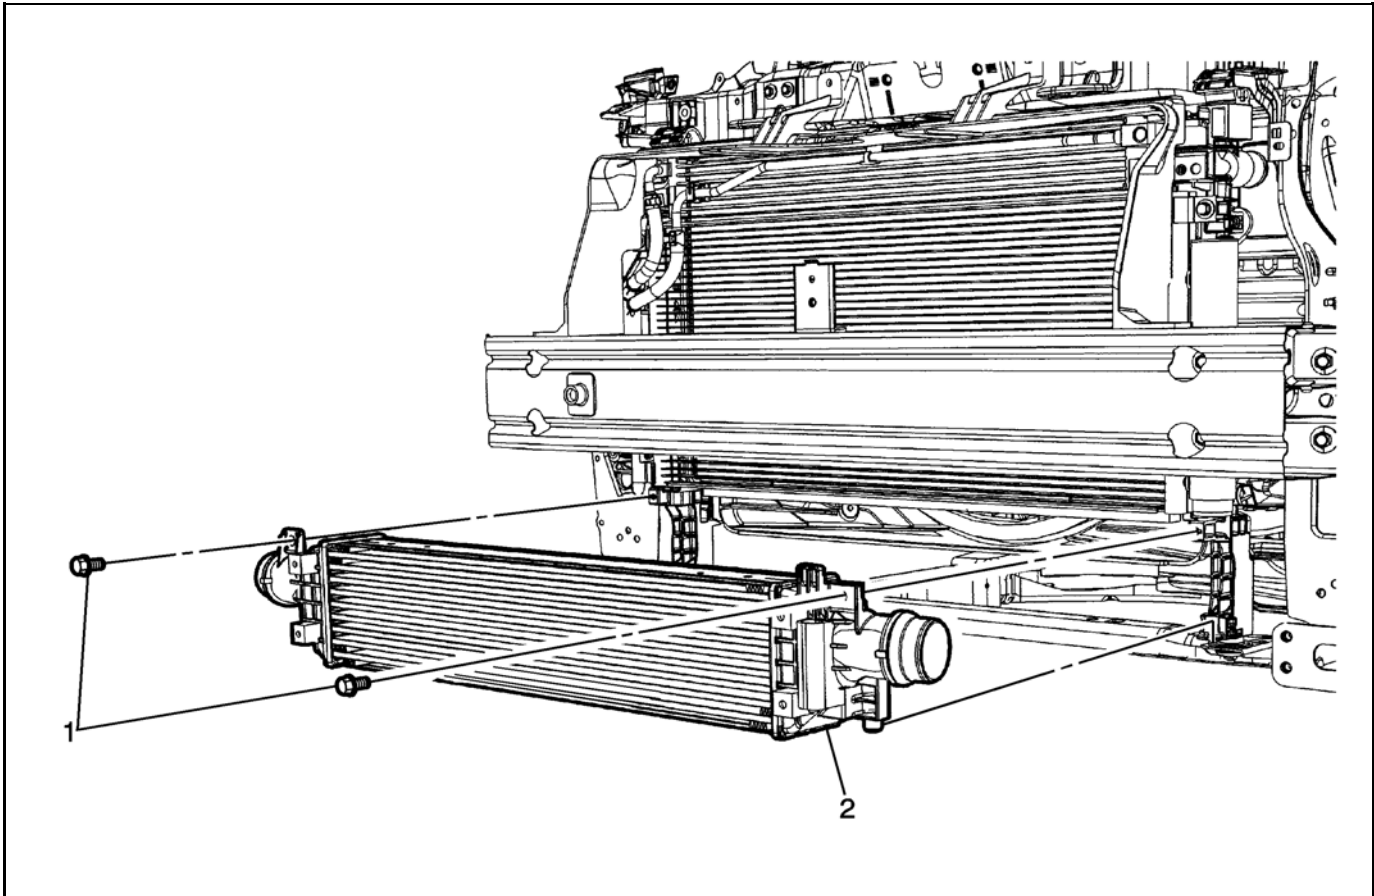
2851444

Cause	This condition may be caused by ice accumulation in the charge air cooler (CAC), restricting air flow to the throttle body.

1. Install the CAC (2). Refer to *Charge Air Cooler Replacement* in SI.
