# Service Bulletin

Bulletin No.: 19-NA-013

**Subject:** Ticking or Popping Noise at Roof Rail Assist Handle(s)

| Brand: | Model: | Model Year: | | VIN: | | Engine: | Transmission: |
|---|---|---|---|---|---|---|---|
| Chevrolet | Equinox | 2018 | 2022 | | | All | All |

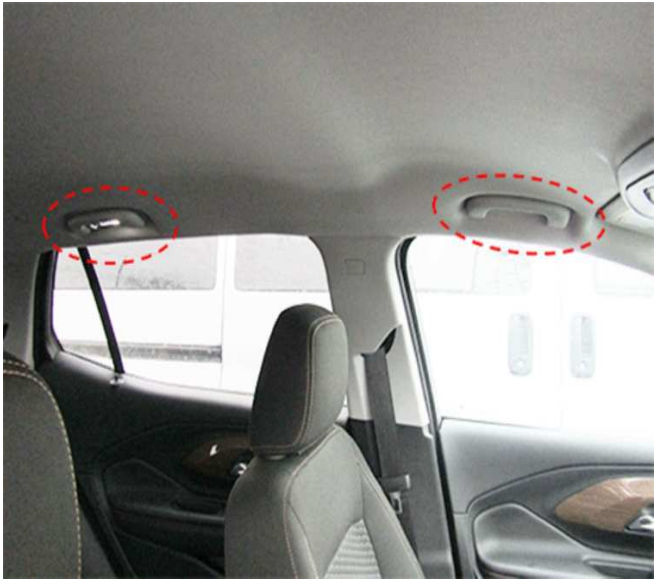
| <b>Condition</b> | <p style="text-align: right;">5222300</p> <p>Customer may comment on hearing a ticking or popping noise at the area of the roof rail assist handle(s). The noise is usually most noticeable on the driver's side.</p> |
| <b>Cause</b> | The cause of the condition may be movement between the assist handle mounting bracket and the inner roof rail structure. |

| <b>Correction</b> | Verify the condition and location(s), then lower the headliner and install a rivet into the assist handle mounting bracket and inner roof rail, at the affected area(s). Follow the steps in the Service Procedure below. |
