# Service Bulletin

Bulletin No.: 19-NA-111

**Subject:** Ticking/Rattle Noise from B-Pillar Area

| Brand: | Model: | Model Year: | | Date Breakpoint: | | Engine: | Transmission: |
|---|---|---|---|---|---|---|---|
| Chevrolet | Blazer | 2019 | 2021 | | | All | All |

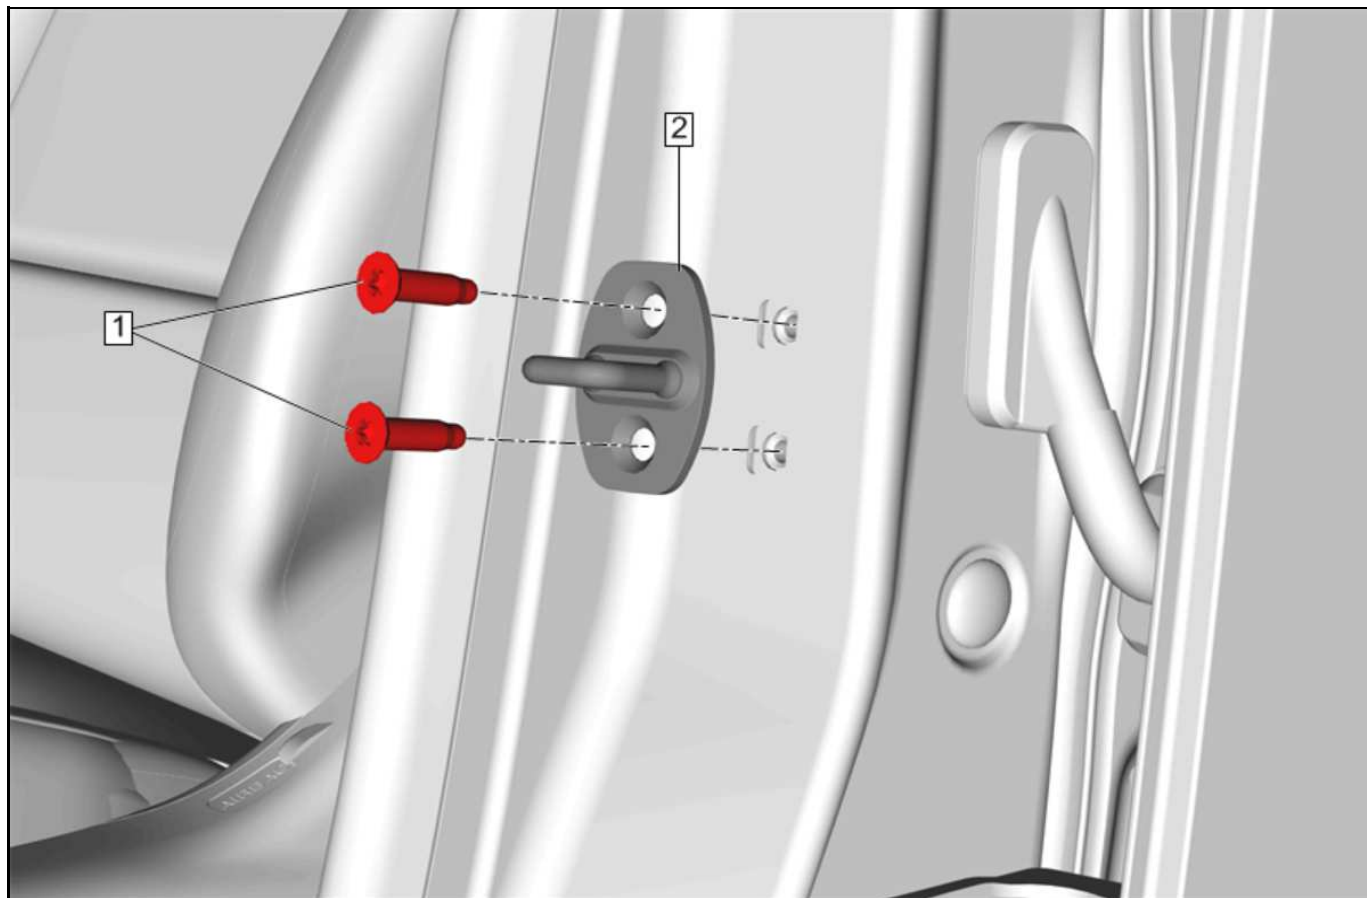
| <b>Cause 1</b> | This condition may be caused by the fasteners on any of the four side door lock strikers NOT being torqued to proper specification. |

1. Verify proper torque specification on the fasteners of ALL FOUR side door lock strikers.

Tighten the screws to 22 N•m(16 lb ft).

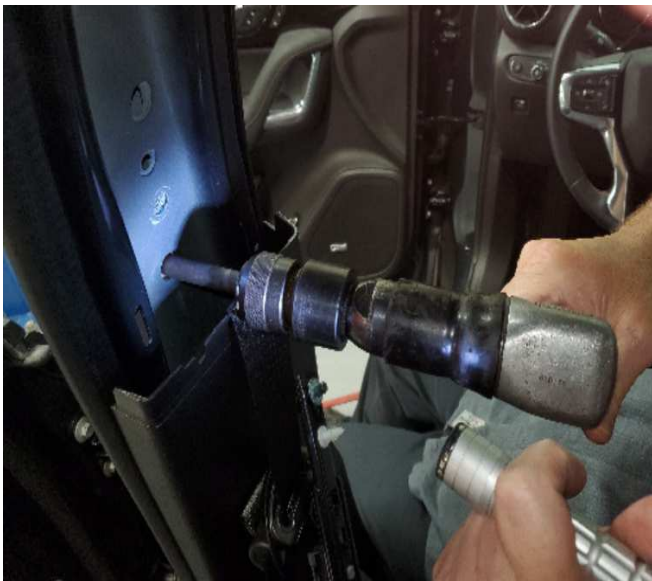
5389872

3. Locate the 2 holes in the center pillar. Note that at each hole, an inner sheet metal shear plate is visible.

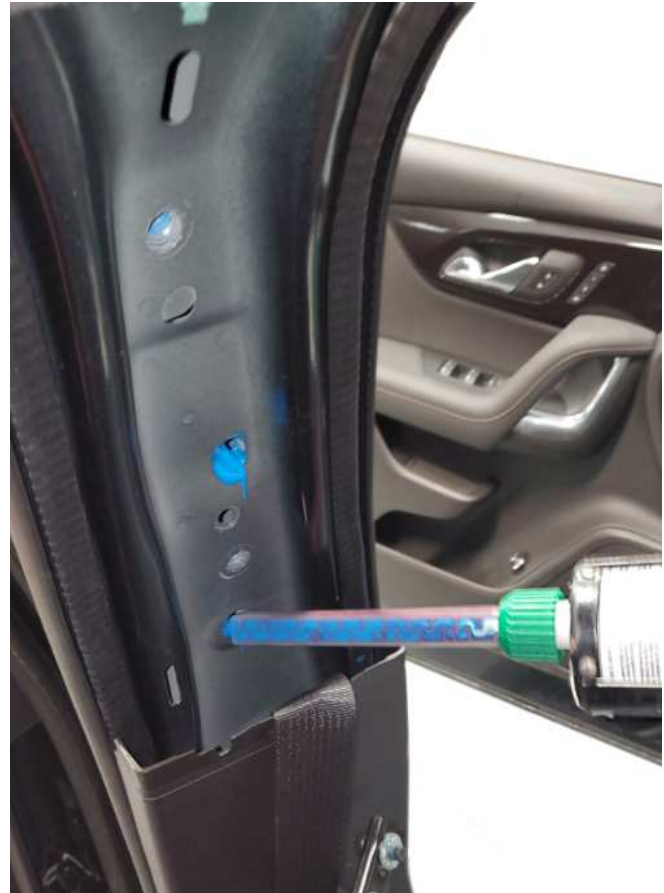
5389899

**Note:** The intent on using the punch is to increase clearance between the inner shear plate and inner sheet metal, to avoid the rub condition.

4. Using an air hammer with a blunt punch, tap the inner shear plate away from the outer panel to increase clearance. Repeat at the second hole location.
