# Service Bulletin

Bulletin No.: 19-NA-181

**Subject:** Multiple Electrical Concerns, Intermittent Multiple Instrument Panel Cluster (IPC) Warning Lamps Illuminated, Intermittent Multiple Message on Drivers Information Center (DIC) and Malfunction Indicator Lamp (MIL) Illuminated - DTC P057D, P057E, P0658, P0700, P073D P07E4, P16F4, P175F, P1778, P1789, P2760, U0073, U0101 and/or U0121

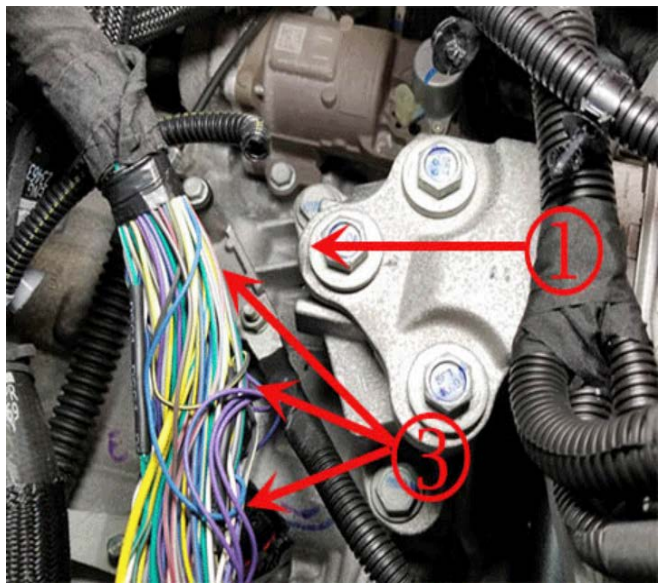
5023193

1. Inspect engine harness for proper routing and circuit 6387 for damaged wiring.
  - Wrap removed, point of contact (1) and chafed wire.

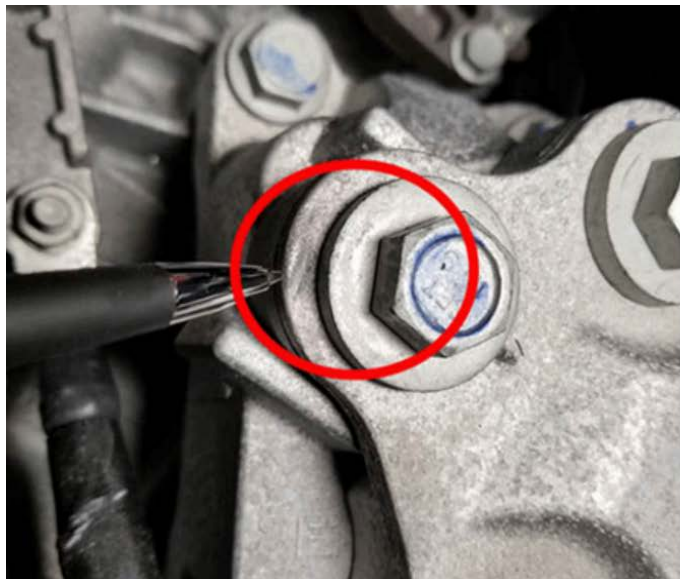
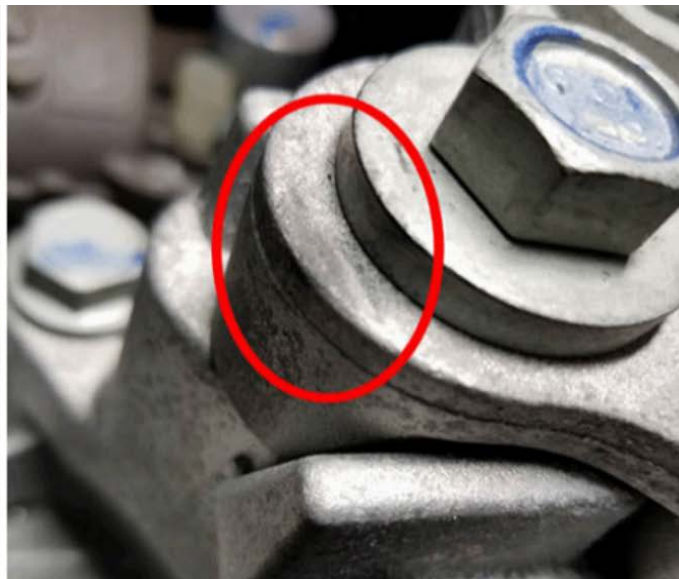
5394518

- Witness mark from point of harness contact.

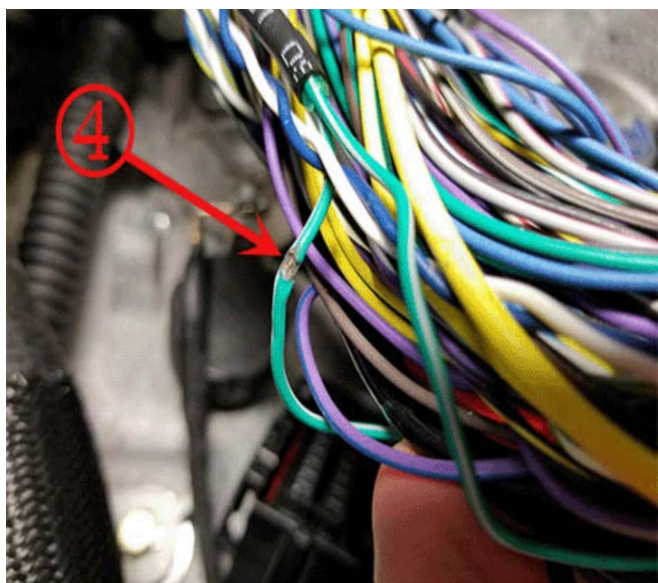
5023199

- Damaged wire (4) at circuit 6387 TCM high side driver.

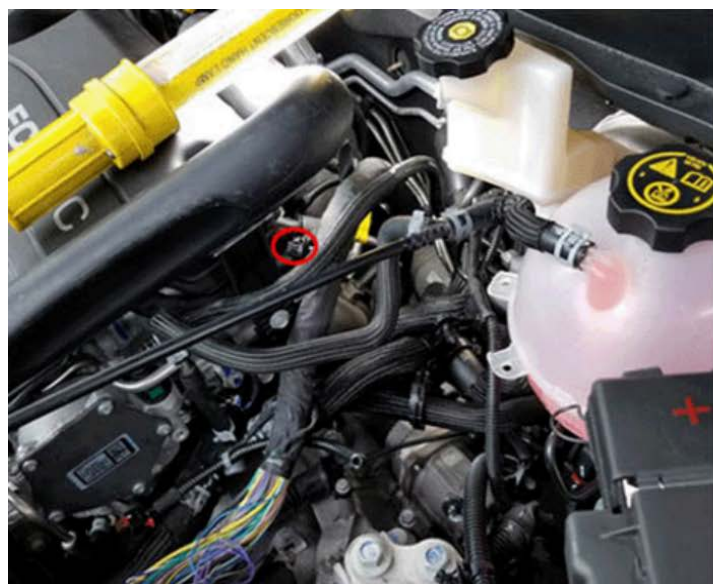
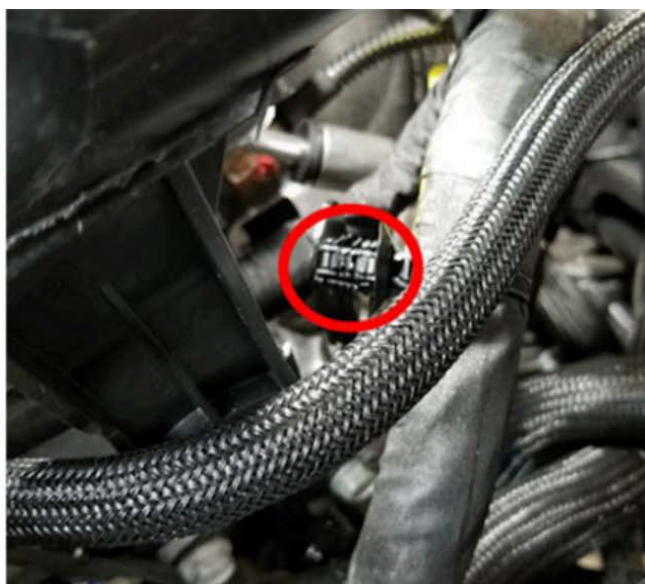
5394519

- Wire harness retainer not installed into bracket.

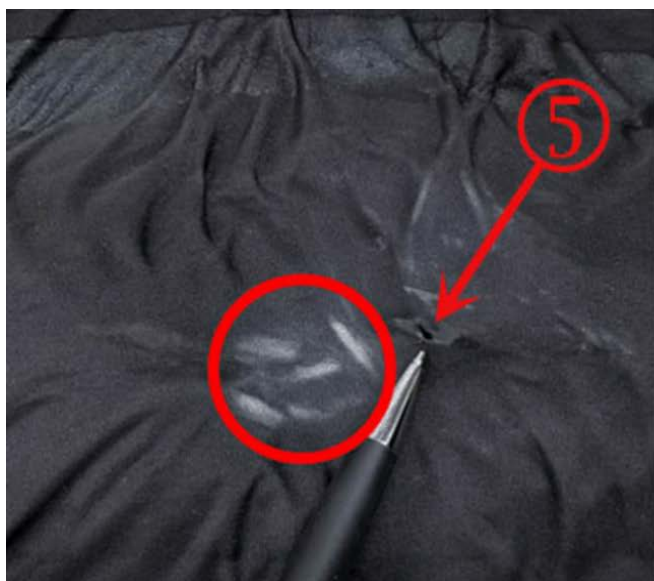
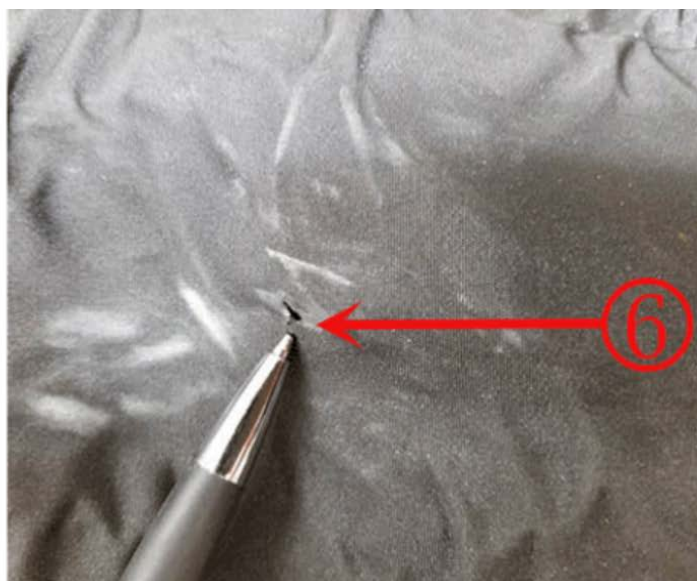
5394520

- Witness mark (hole) from removed wrap (5, 6).
2. Repair the wires per the *Wiring Repairs* procedure in SI.
  3. Using Woven Polyester Electrical Tape (PET), tape all the contact points of the engine harness ensuring that the tape is applied in a double layer extending along the harness past the splice sleeves.
  4. Verify all straps are secured and retainers are installed.

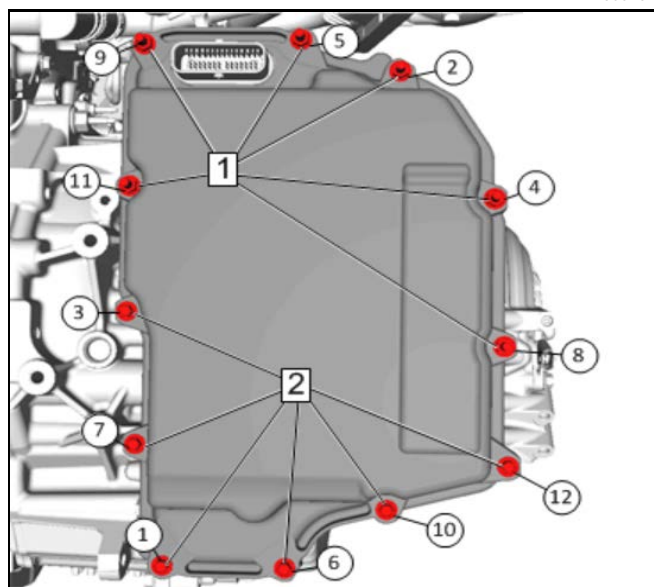
4489055

1. Inspect the engine wiring harness conduit and wires for chaffing around the #2, 5, and/or 9 stud of the transmission control valve body cover.
