# Service Bulletin

Bulletin No.: 19-NA-235

**Subject:** Rattle or Ticking Noise from B-Pillar Area.

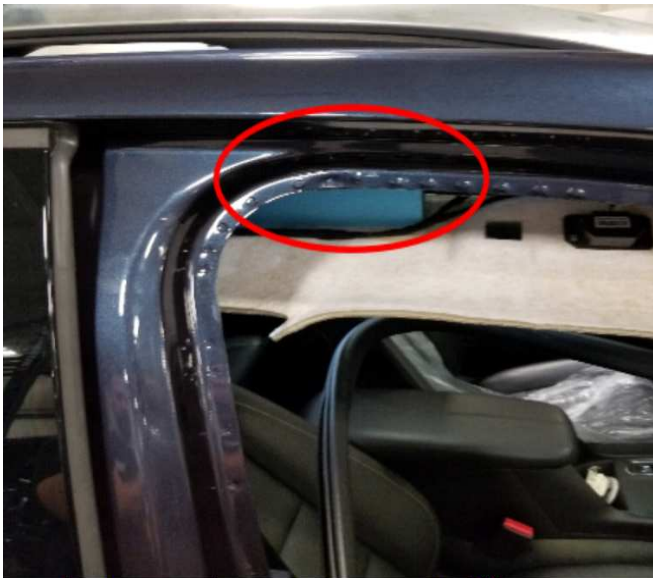
5422100

3. Locate the sheet metal area at the rear radius, shown in the graphic above.

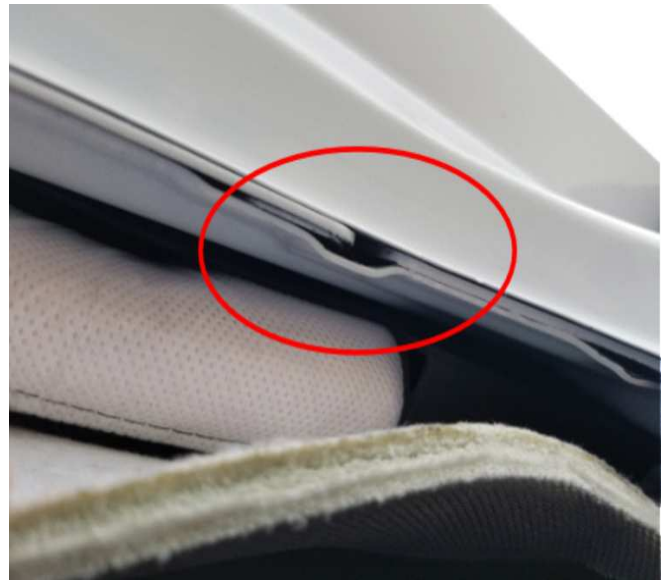
5422104

4. Locate the crease/gap in the sheet metal.
