Service Bulletin

Bulletin No.: 21-NA-013

Subject: Rattle or Ticking Noise Heard Coming from B-Pillar Area

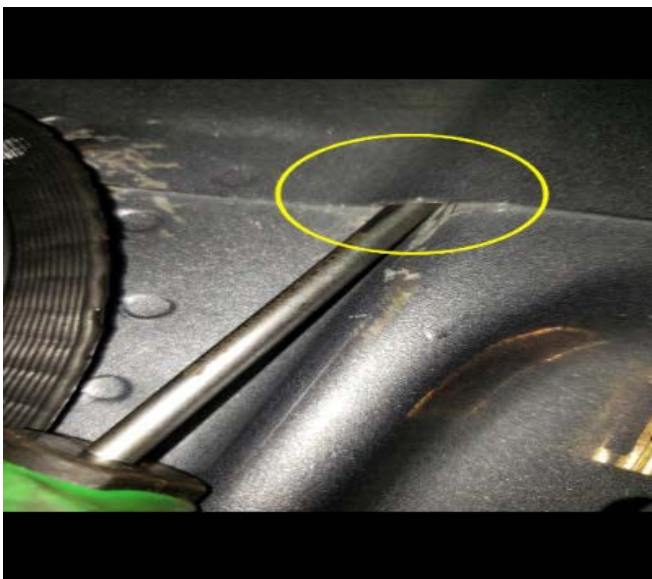
5710823

2. Locate the sheet metal area at the top of the B-Pillar, shown in the graphic above
3. Locate the gaps in the sheet metal, #3 and #4.
