2015 CX-5

CONNECTOR C-04 AND C-08 SERVICE CAUTION

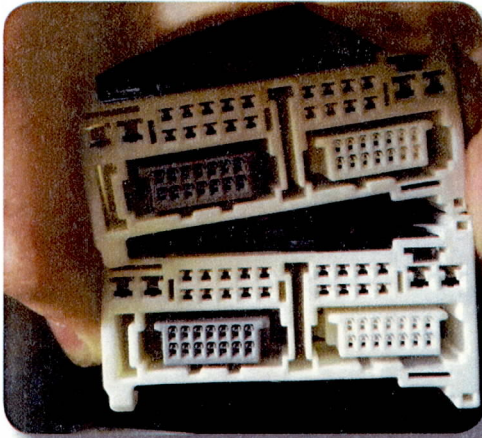
This image shows both C-04 and C-08 connectors side by side

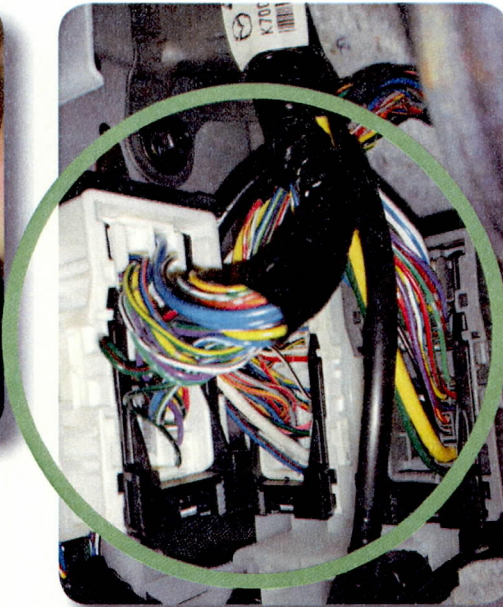
This image shows both C-04 and C-08 connectors installed **correctly**

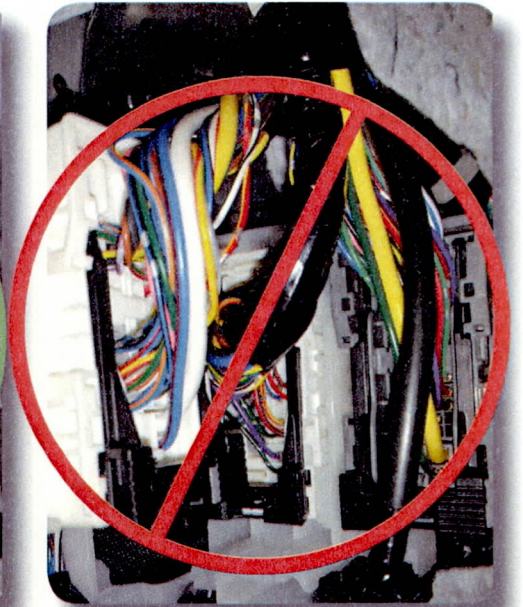
This image shows both C-04 and C-08 connectors installed **incorrectly**
