2016 CX-3

MANUAL DRIVER'S SEAT MOVES DOWN BY ITSELF

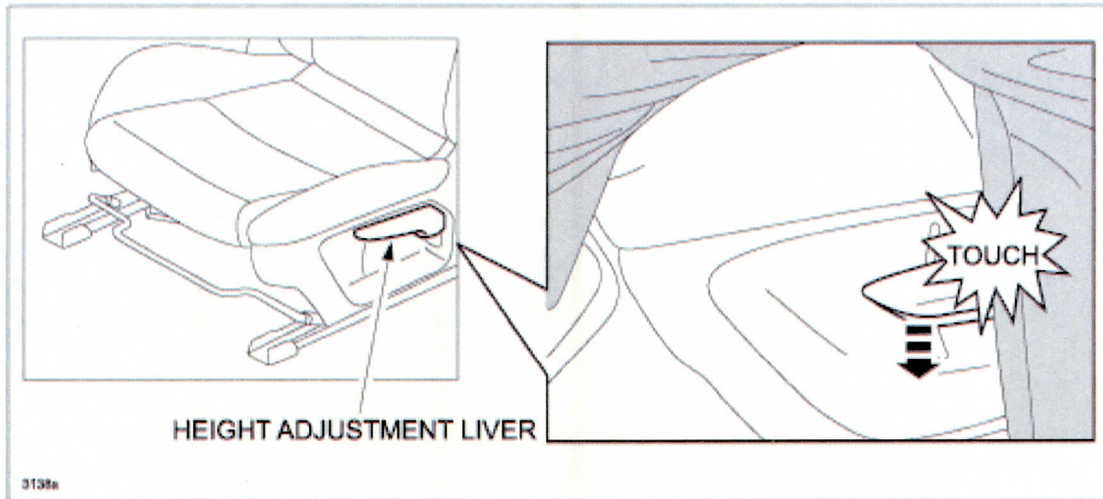
Some customers may complain that the manual driver's seat gradually moves down and needs re-adjustment of the height position. This concern may be caused by the customer's thigh touching and pushing down the height adjustment lever when getting in or out of the vehicle.

When you receive a customer complaint for this concern, explain that the seat may move down by leg touching the seat adjustment lever when getting in or out of the vehicle. Confirm that the seat position is appropriate before driving.

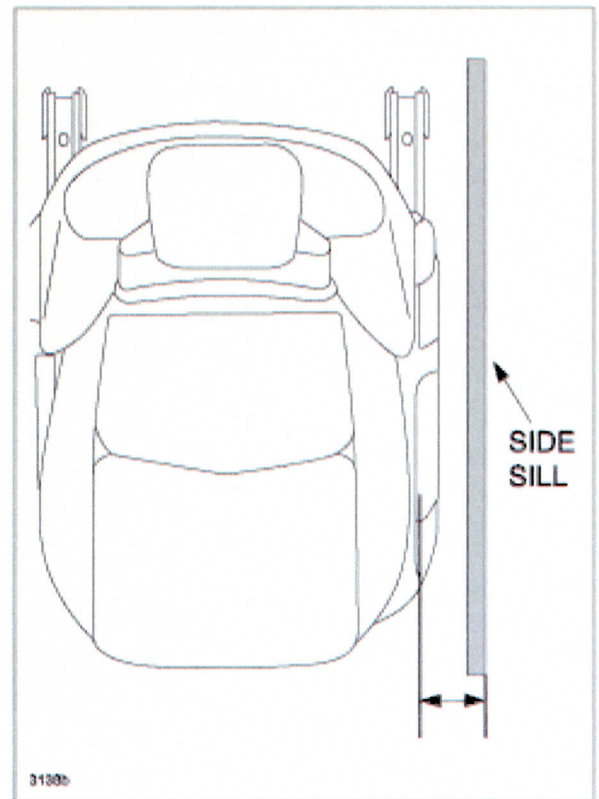
1. The seat is positioned near the side sill. When getting in and out of the vehicle, the driver's leg may push down the seat height adjustment lever, causing the seat to move downward.
2. Operational force of the seat height adjustment lever is low and free play of the lever is short; so seat downward movement is likely to happen with light contact.
