## **MULTI-MODEL**

### ***POP / CRACK NOISE WHILE DRIVING***

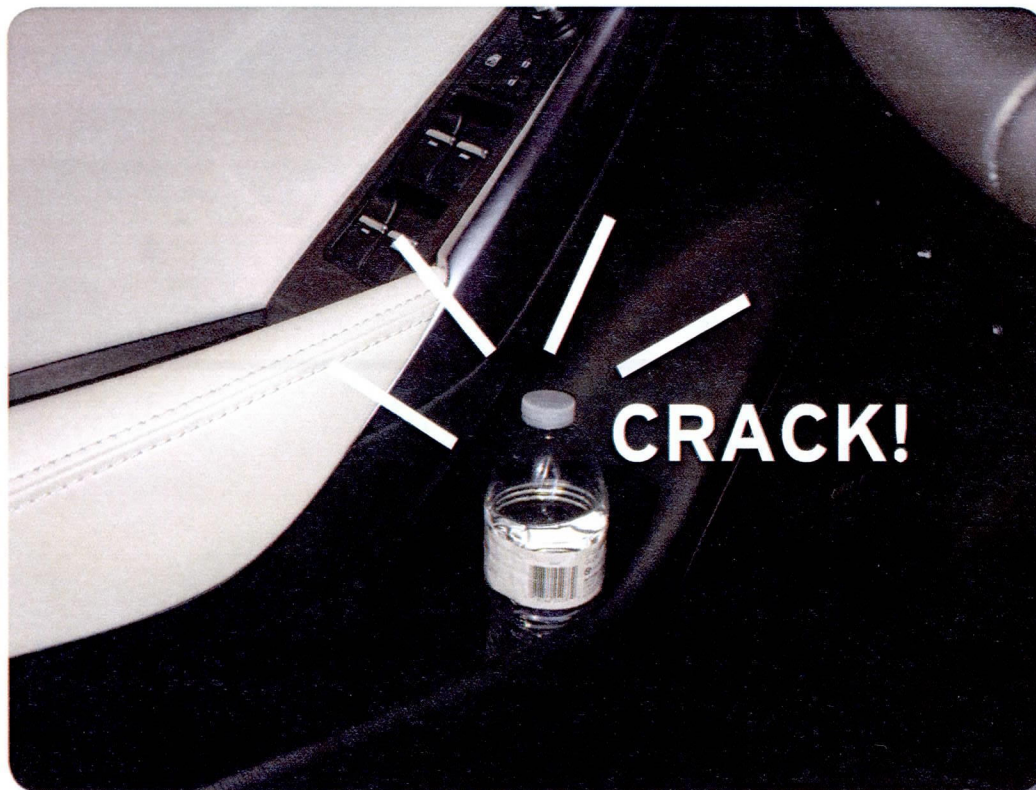
Some customers may complain about an intermittent loud pop or crack type noise while driving. The noise may be caused by a water bottle left in the car.

Water bottles left in a car on a hot day may expand with heat. When the vehicle is driven with the HVAC on, the vehicle interior cools, causing the water bottle to cool and contract (shrink). This may create a loud pop or crack type noise.

No repair is necessary. Explain to the customer that this is a normal condition if water bottles are left in the car.
