2016 CX-5 *INTERMITTENT NO CRANK / NO START*

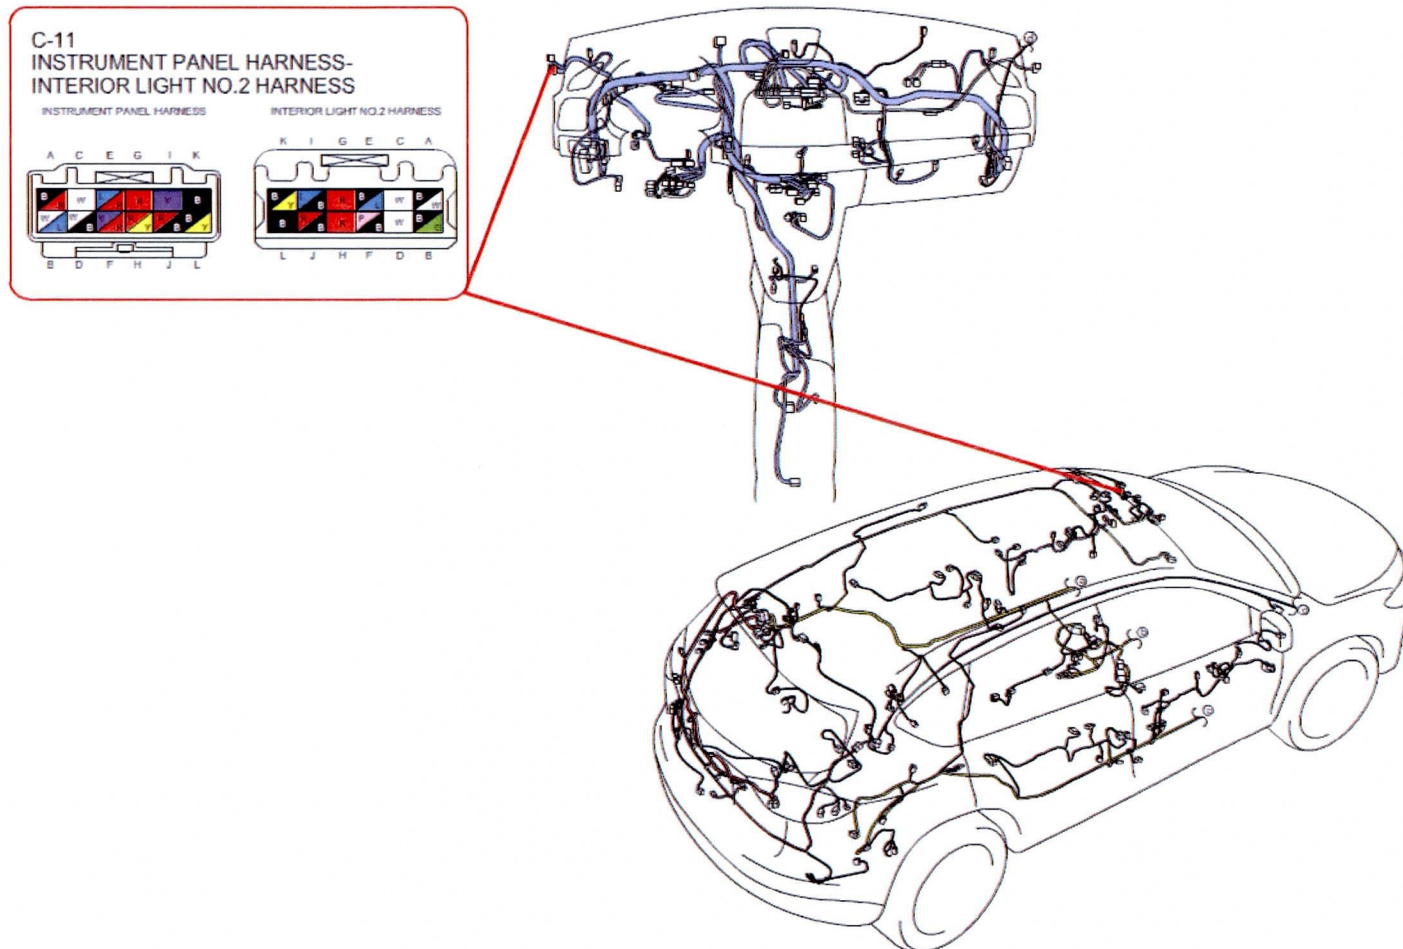
Some customers may complain about an intermittent no crank/no start. This may be caused by instrument panel wiring harness connector C-11 not fully seated (locked).

IDS may show several U codes stored in memory. Properly secure the instrument panel wiring harness connector C-11 to resolve customer complaint.
