2016 Mazda3 INTERMITTENT NO CRANK / NO START

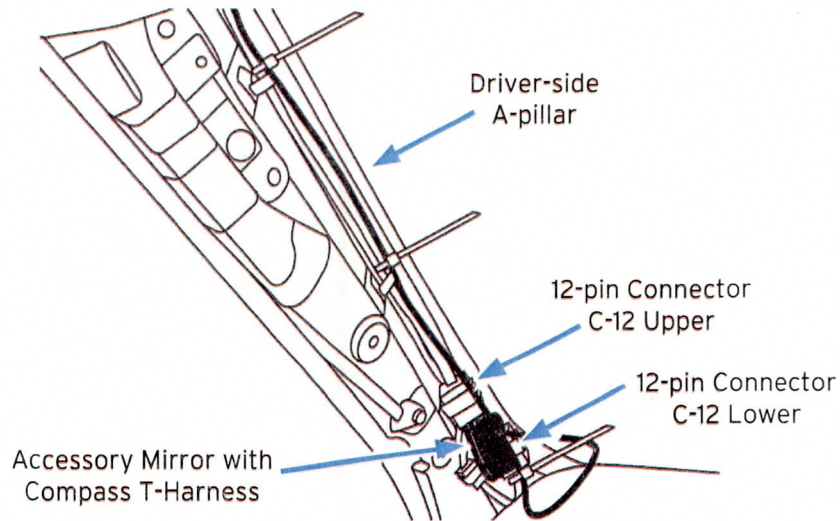
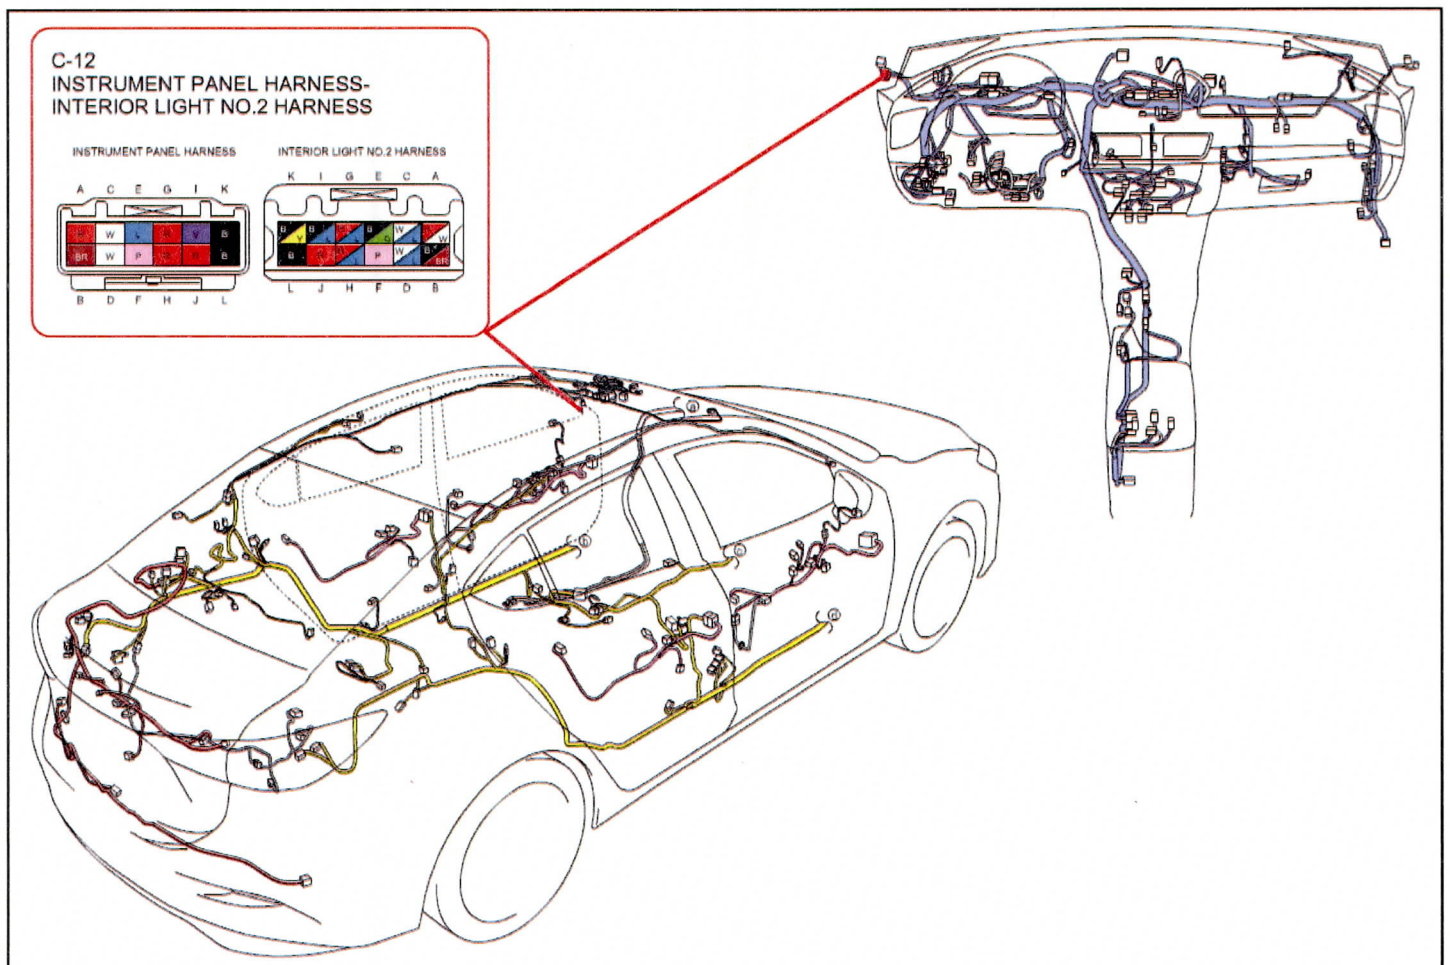
Some customers may complain about an intermittent no crank/no start. This may be caused by a poor instrument panel wiring harness connection C-12. The accessory mirror with compass T-harness connector at drivers side A-pillar may not be seated (locked).

Properly secure the instrument panel wiring harness, upper and lower C-12 connectors to resolve customer complaint.
