Subject: REVISION: N212348030-01 - Emission Recall
Engine Control Module Cannot Detect Catalyst
Revised Service Procedure

Models: 2015-2017 Chevrolet City Express

N212348030 Engine Control Module Cannot Detect Catalyst Inefficiency

Revision: 01

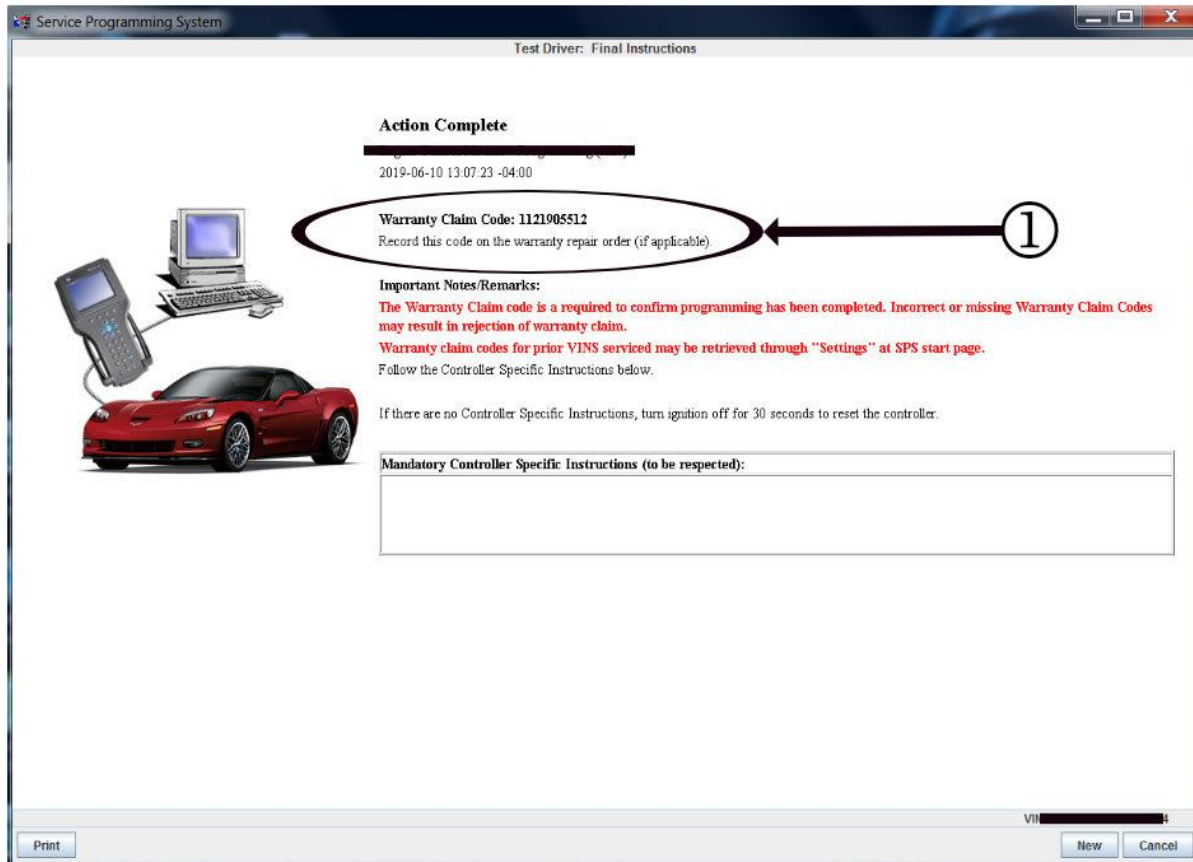
Important: TIS2WEB screen shown. Techline Connect screen is similar and will be included in the near future.

Important: To avoid warranty transaction rejections, you MUST record the warranty claim code provided on the SPS Warranty Claim Code (WCC) screen on the job card. Refer to callout 1 above for the location of the WCC on the SPS screen.

2. Record SPS Warranty Claim Code on job card for warranty transaction submission.
3. CALIFORNIA VEHICLES ONLY: Complete a "Proof of Correction" certificate and provide to the vehicle owner upon recall completion.
