## STAR ONLINE PUBLICATION

**Case Number:** S1918000008 Rev. A

**Release Date:** 01/16/2021

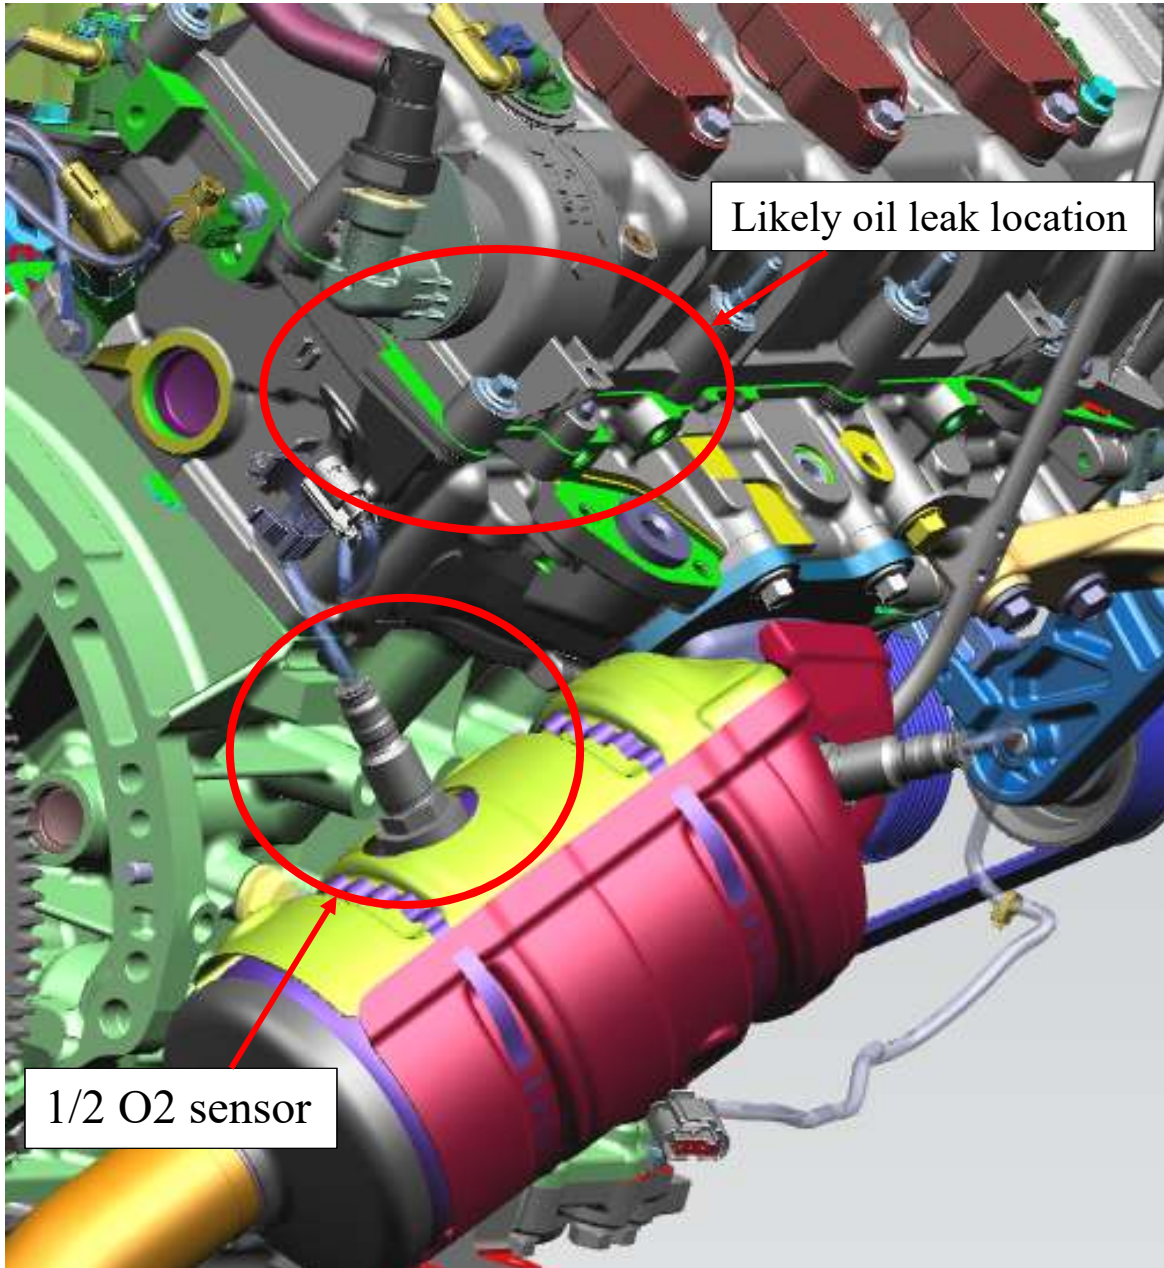
**Symptom/Vehicle Issue:** Customer's complaint may include a MIL-on with one or more of the following DTCs (Active, Pending, or Stored) in the PCM: P0133, P0137, P0171, P0300, P2096. The root cause could be due to oil leaking from Bank 1 valve cover seal on to the 1/2 (Bank 1 downstream) O2 sensor. This can adversely affect the 1/2 O2 sensor signal reading and lead to listed DTCs. Before performing normal diagnostic routines for the above codes, check for the condition listed above.

**Discussion:** Inspect the 1/2 O2 sensor for signs of oil on top of the sensor. If oil is found, replace the 1/2 O2 sensor and inspect Bank 1 valve cover for signs of leakage. If leakage found, repair the valve cover leak as necessary.
