STAR ONLINE PUBLICATION

Case Number: S1923000026 Rev A

Symptom/Vehicle Issue: Water Leak At A Pillar Onto Floor

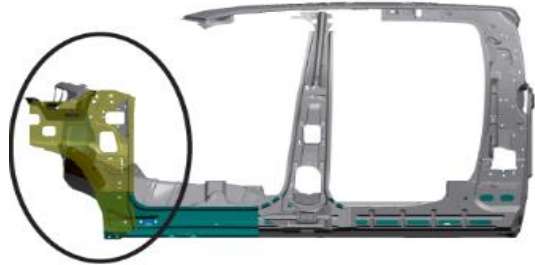
Fender Removed -
spray hose from
bottom of A-pillar up
along black adhesive
seam

- Remove fender and spray with hose starting from bottom up along black adhesive seam

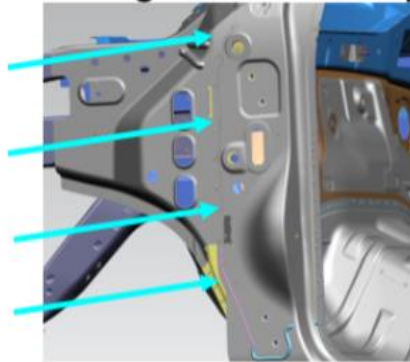
- Typical black adhesive voids are located in these areas:

Pull back carpet
check for water

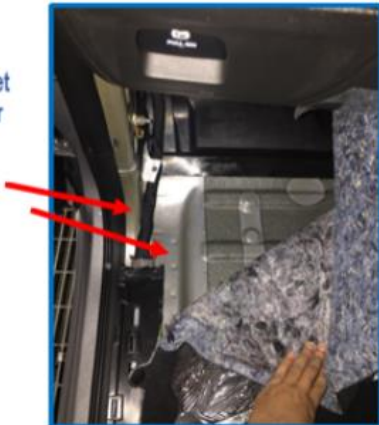
Check behind weatherstrip flange,
under foot scuff, under wire trough

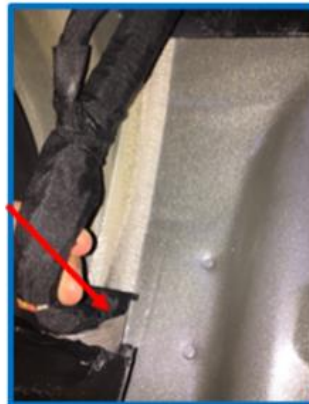
Lift wire trough
and check for
water underneath

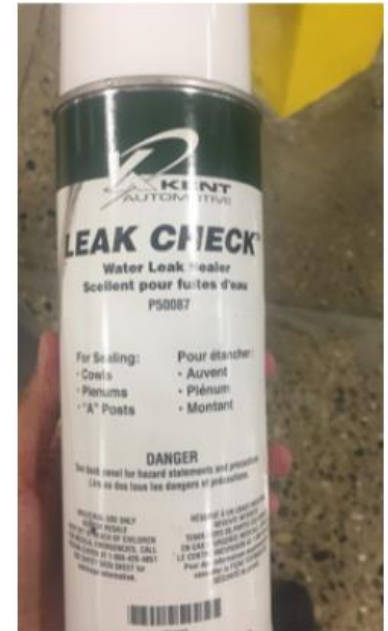
Black adhesive A-pillar water leak

*Note: This black adhesive seam is a very hard seam to seal due to weld access panel. Ensure all attempts of sealers are added before approaching butyl fix.

1. Remove fender
2. Apply kent black spray can sealer with straw along entire seam, especially in upper A-pillar area (see image)
3. Apply 2 coats
4. Apply butyl along entire seam (see image)
5. Water test and validate

Kent leak check sealant spray
to right

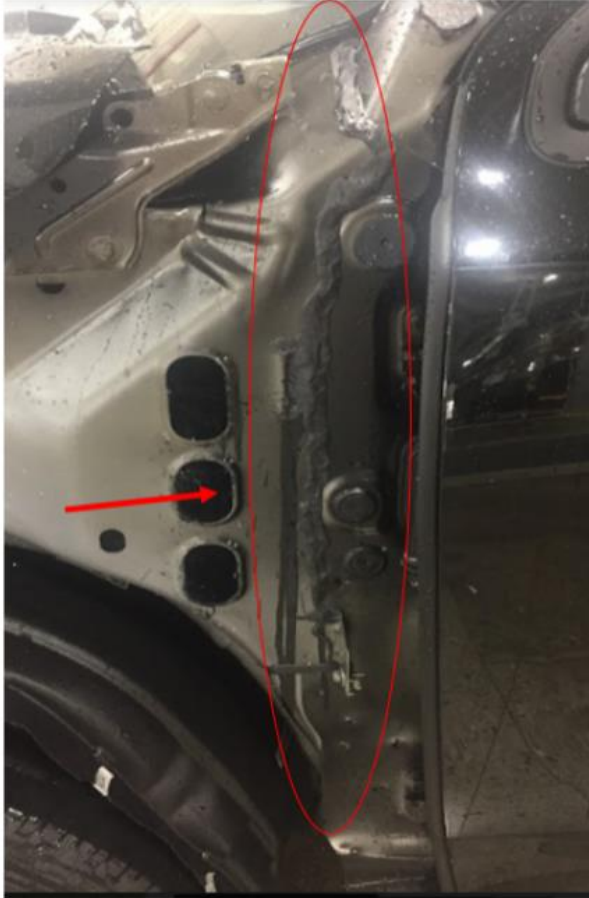
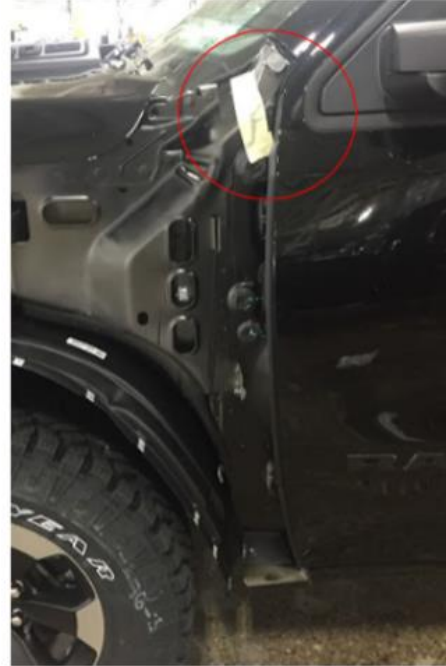
Black adhesive A-pillar water leak

Make sure to tape off top of aperture to prevent spray sealer from spraying on windshield/door

Spray inside aperture holes with black spray sealer indicated by red arrow - if that did not fully seal use butyl along entire aperture weld sea, - you're trying to cut off the water from touching black adhesive hidden underneath.

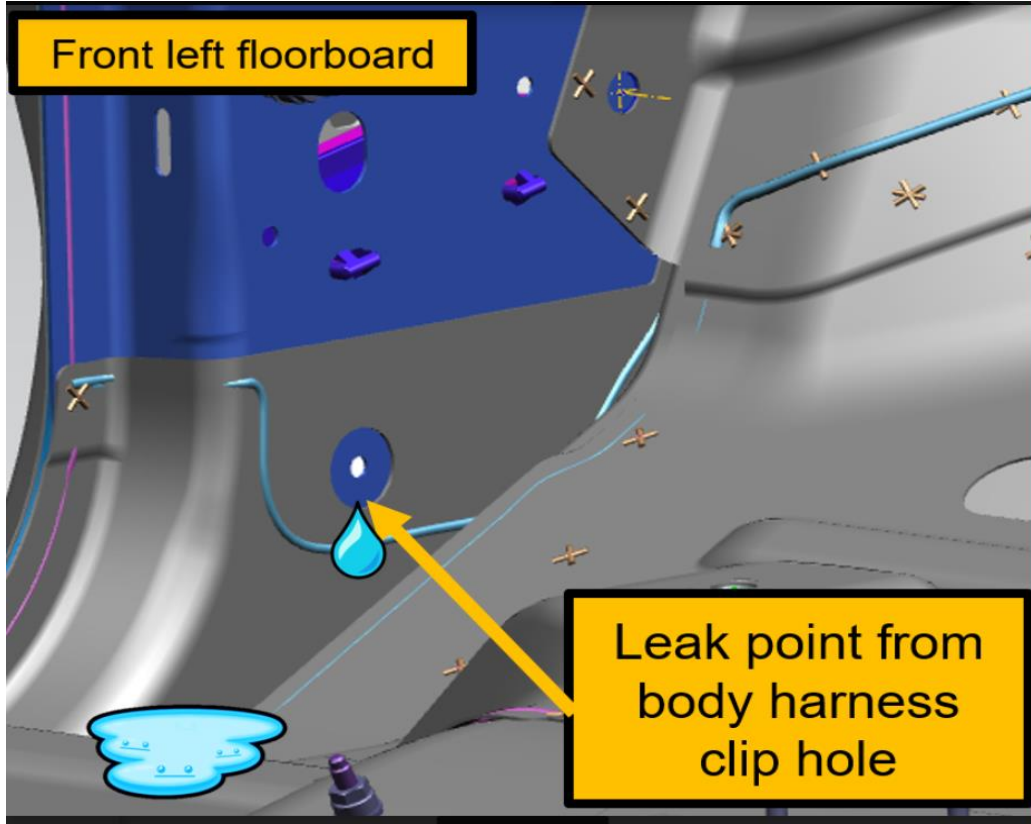
Next, see the below image. Inspect the interior side of the left (driver side) lower a pillar. A harness attaching clip hole if not fully sealed could allow water. Remove the lower a pillar kick panel cover. See image below. Use either Kent Leak Check Spray Seam sealer or butyl to seal the around the clip hole.

Seal above clip hole with butyl or Kent Leak Check Spray Sealer.
